Hazardous Building Materials Assessment

Whites Creek Stables

31-39 White Street,
Lilyfield NSW 2040

Inner West Council
April 2018

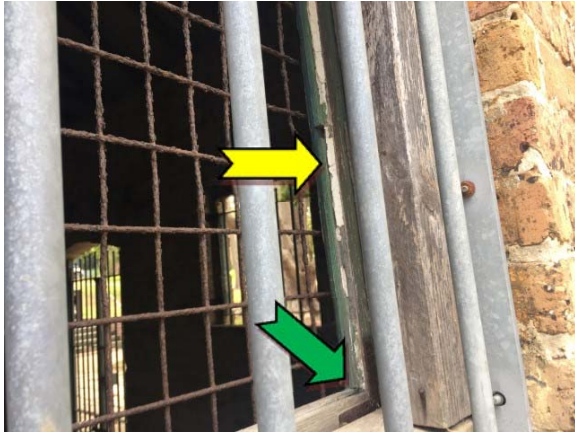
Exterior	Northeast elevation	Window frames	Green (dark) - upper coloured paint system	Lead Paint - Swab	-	Positive	-	Low	Fair	Low	1 m ²	Confirm status by quantitative test method, maintain in current condition, over paint with a lead-free paint as part of ongoing maintenance. Remove under controlled conditions in accordance with AS 4361.2:2017 Guide to hazardous paint management prior to renovation or demolition works.	-	-	-	1

Photo 1. Exterior, north-east elevation, window frames – non asbestos-containing window caulking and suspected lead-containing green upper paint systems.

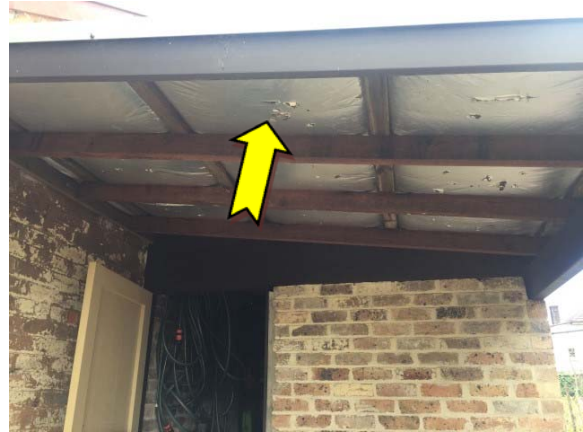
Photo 2. Exterior, west elevation, awning – suspected SMF sarking insulation material.

- SMF sarking insulation was suspected throughout the store room ceiling and western elevation exterior awning.

- SMF materials that are likely to be disturbed during any proposed demolition/refurbishment works should be handled in accordance with the *Code of Practice for the Safe Use of Synthetic Mineral Fibres* [NOHSC:2006(1990)]. If these materials are impacted upon by accident or by pre-planned works, the Inner West Council must be informed via the contact detailed within Section 7: *Accidental Disturbance of Known or Suspected Hazardous Building Materials*. Following disturbance, inspection by a competent person should be undertaken.

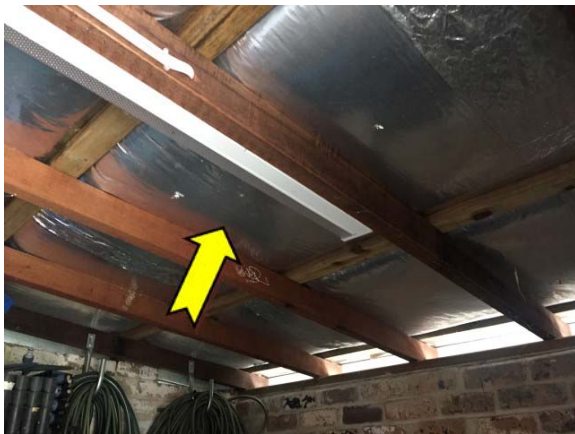
Photo 3. Interior, store room, ceiling – suspected SMF sarking insulation material.

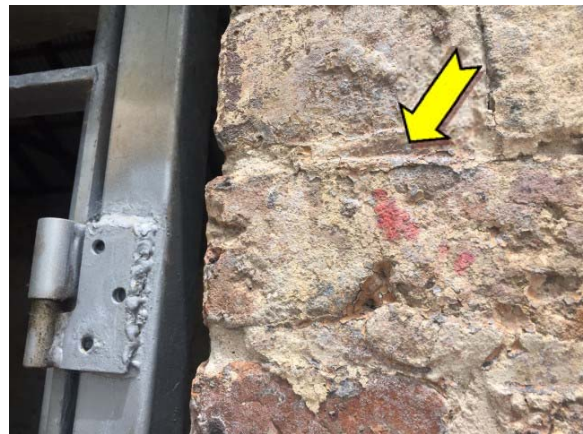
Throughout	-	-	-	PCBs	-	-	-	-	-	-	-	No suspect PCB-containing capacitors identified at the time of the assessment.	-	-	-	-
Exterior	Throughout	Walls - external	Brown - lower coloured paint system	Lead Paint - Swab	-	Positive	-	Medium	Poor	Medium	100 m ²	Paint systems appear to have been removed by means of paint stripping in the past. Residual lead-containing paint remains to all external surfaces. Remove flaking sections and over paint with a lead-free paint. Remove under controlled conditions in accordance with AS 4361.2:2017 Guide to hazardous paint management prior to renovation or demolition works.	-	-	-	4
Exterior	Stable gates	Wooden lintel	Beige - upper coloured paint system	Lead Paint - Swab	-	Suspected Positive	-	Medium	Poor	Medium	1 m ²	Confirm status by quantitative test method, remove flaking sections, over paint with a lead-free paint as part of ongoing maintenance. Remove under controlled conditions in accordance with AS 4361.2:2017 Guide to hazardous paint management prior to renovation or demolition works.	-	-	-	5

Photo 4. Exterior, throughout, walls – lead-containing brown lower coloured paint system.

- Remove flaking lead containing paint to the walls and timber lintels throughout the property in accordance with AS4361.2-2017 Guide to Hazardous Paint Management and relevant legislation.

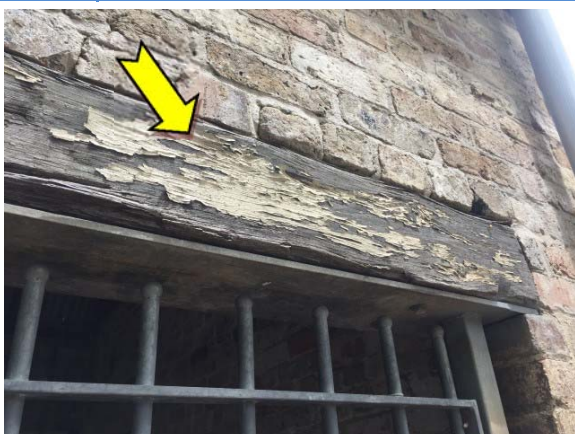
Photo 5. Exterior, trusses to stable gates, wooden lintel – suspected lead-containing beige upper paint systems.
