Hazardous Building Materials Assessment

Murray May Early Learning Centre Shed

35 Premier Street
Marrickville NSW 2204

Inner West Council
April 2018

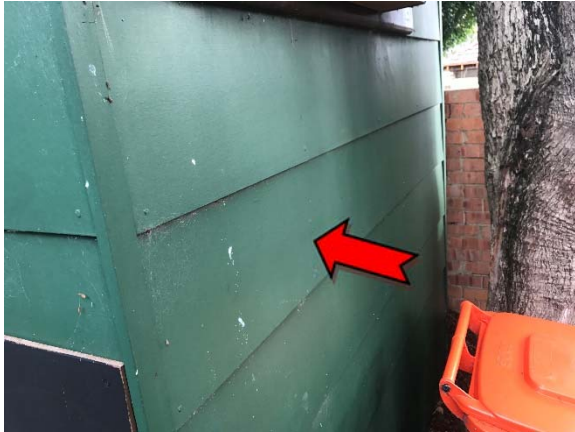
Photo 1. Exterior, throughout, wall paneling – non asbestos-containing fibre cement sheeting.

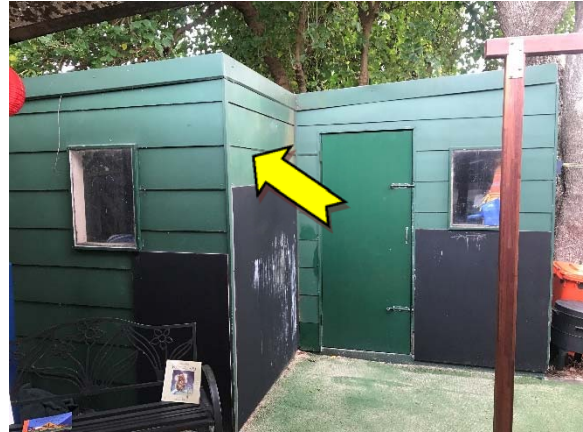
Photo 2. Exterior, throughout, wall paneling – suspected lead-containing green upper paint system.

- LCP was suspected in the form of green upper coloured paint systems throughout the exterior of the shed.

- The *LeadCheck* paint swab method can detect lead in paint at concentrations of 0.5% and above, and may indicate lead in some paint films as low as 0.2%. As paint with a lead content greater than 0.1% by dry weight is now considered to be lead-containing, Prensa recommends confirming status of suspected LCP identified during the Assessment by quantitative test method.

- The safest method of dealing with LCP is to replace or remove the items in their entirety that have LCP on them and replace them with new items that do not contain lead. This allows the items to be disposed of as regular building or demolition unsegregated waste in accordance with the NSW Environment Protection Authority (EPA) *Waste Classification Guidelines 2014 Part 1 – Classifying Waste*. The advantage of this method is the reduction in labour requirements to remove the lead paint and also this reduces the risk to workers from exposure to lead dust or fumes. If the removal of the LCP or coatings is the preferred or required option this may generate significant amounts of potential hazardous waste. This waste must be removed, collected and disposed of by an appropriately licensed contractor under controlled conditions that minimises the release to air, water and soil. Disposal of lead waste must be disposed of as hazardous waste at an approved waste facility.

- Advise all relevant site personnel and site contractors of the results of the LCP and the safe work procedures required and/or work practices to be avoided in the areas of confirmed LCP.

- Any remediation works that may generate dust or fumes (i.e. sanding, burning) must be performed under controlled conditions by a suitably resourced and experienced hazardous material/waste abatement contractor (e.g. a Class A licensed asbestos removal contractor).
