Hazardous Building Materials Assessment Mackey Park Clubhouse and Kiosk Carrington Rd & Richardson's Crescent Marrickville NSW 2204

Inner West Council
April 2018

Job No.: 57722-053

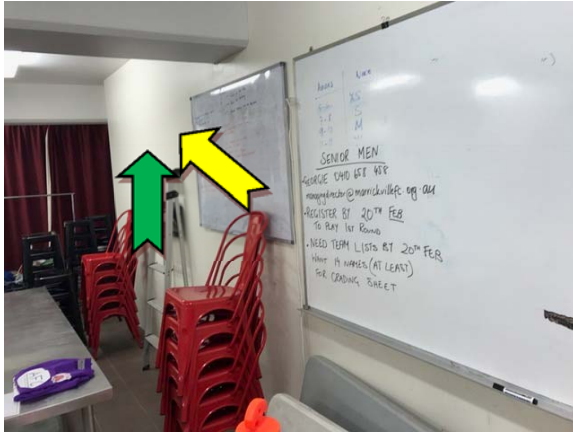
Photo 1. Interior, ground level, throughout – non asbestos-containing wall panels with SMF containing paint system.

- SMF was identified within the paint coat to wall panels throughout.

- SMF materials that are likely to be disturbed during any proposed demolition/refurbishment works should be handled in accordance with the *Code of Practice for the Safe Use of Synthetic Mineral Fibres* [NOHSC:2006(1990)]. If these materials are impacted upon by accident or by pre-planned works, the Inner West Council must be informed via the contact detailed within Section 7: *Accidental Disturbance of Known or Suspected Hazardous Building Materials*. Following disturbance, inspection by a competent person should be undertaken.

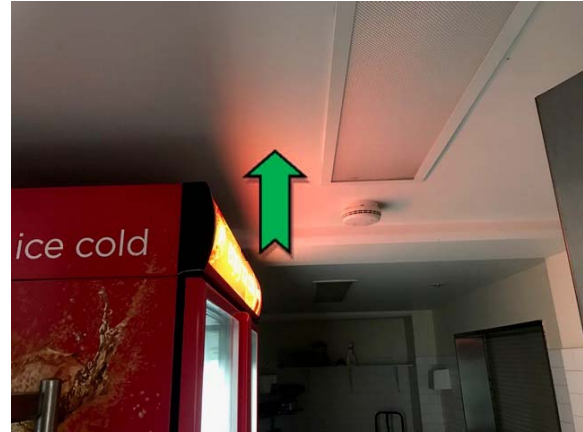
Photo 2. Interior, ground level, throughout, ceiling – non asbestos-containing fibre cement sheeting.

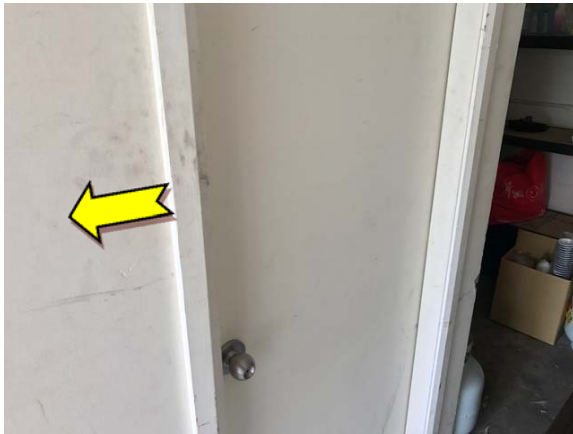
Photo 3. Interior, ground level, throughout, walls - suspected lead-containing beige upper paint system.

- LCP was suspected in the beige upper coloured paint systems located throughout all walls in the building.

- The *LeadCheck* paint swab method can detect lead in paint at concentrations of 0.5% and above, and may indicate lead in some paint films as low as 0.2%. As paint with a lead content greater than 0.1% by dry weight is now considered to be lead-containing, Prensa recommends confirming status of suspected LCP identified during the Assessment by quantitative test method.

- The safest method of dealing with LCP is to replace or remove the items in their entirety that have LCP on them and replace them with new items that do not contain lead. This allows the items to be disposed of as regular building or demolition unsegregated waste in accordance with the NSW Environment Protection Authority (EPA) *Waste Classification Guidelines 2014 Part 1 – Classifying Waste*. The advantage of this method is the reduction in labour requirements to remove the lead paint and also this reduces the risk to workers from exposure to lead dust or fumes. If the removal of the LCP or coatings is the preferred or required option this may generate significant amounts of potential hazardous waste. This waste must be removed, collected and disposed of by an appropriately licensed contractor under controlled conditions that minimises the release to air, water and soil. Disposal of lead waste must be disposed of as hazardous waste at an approved waste facility.

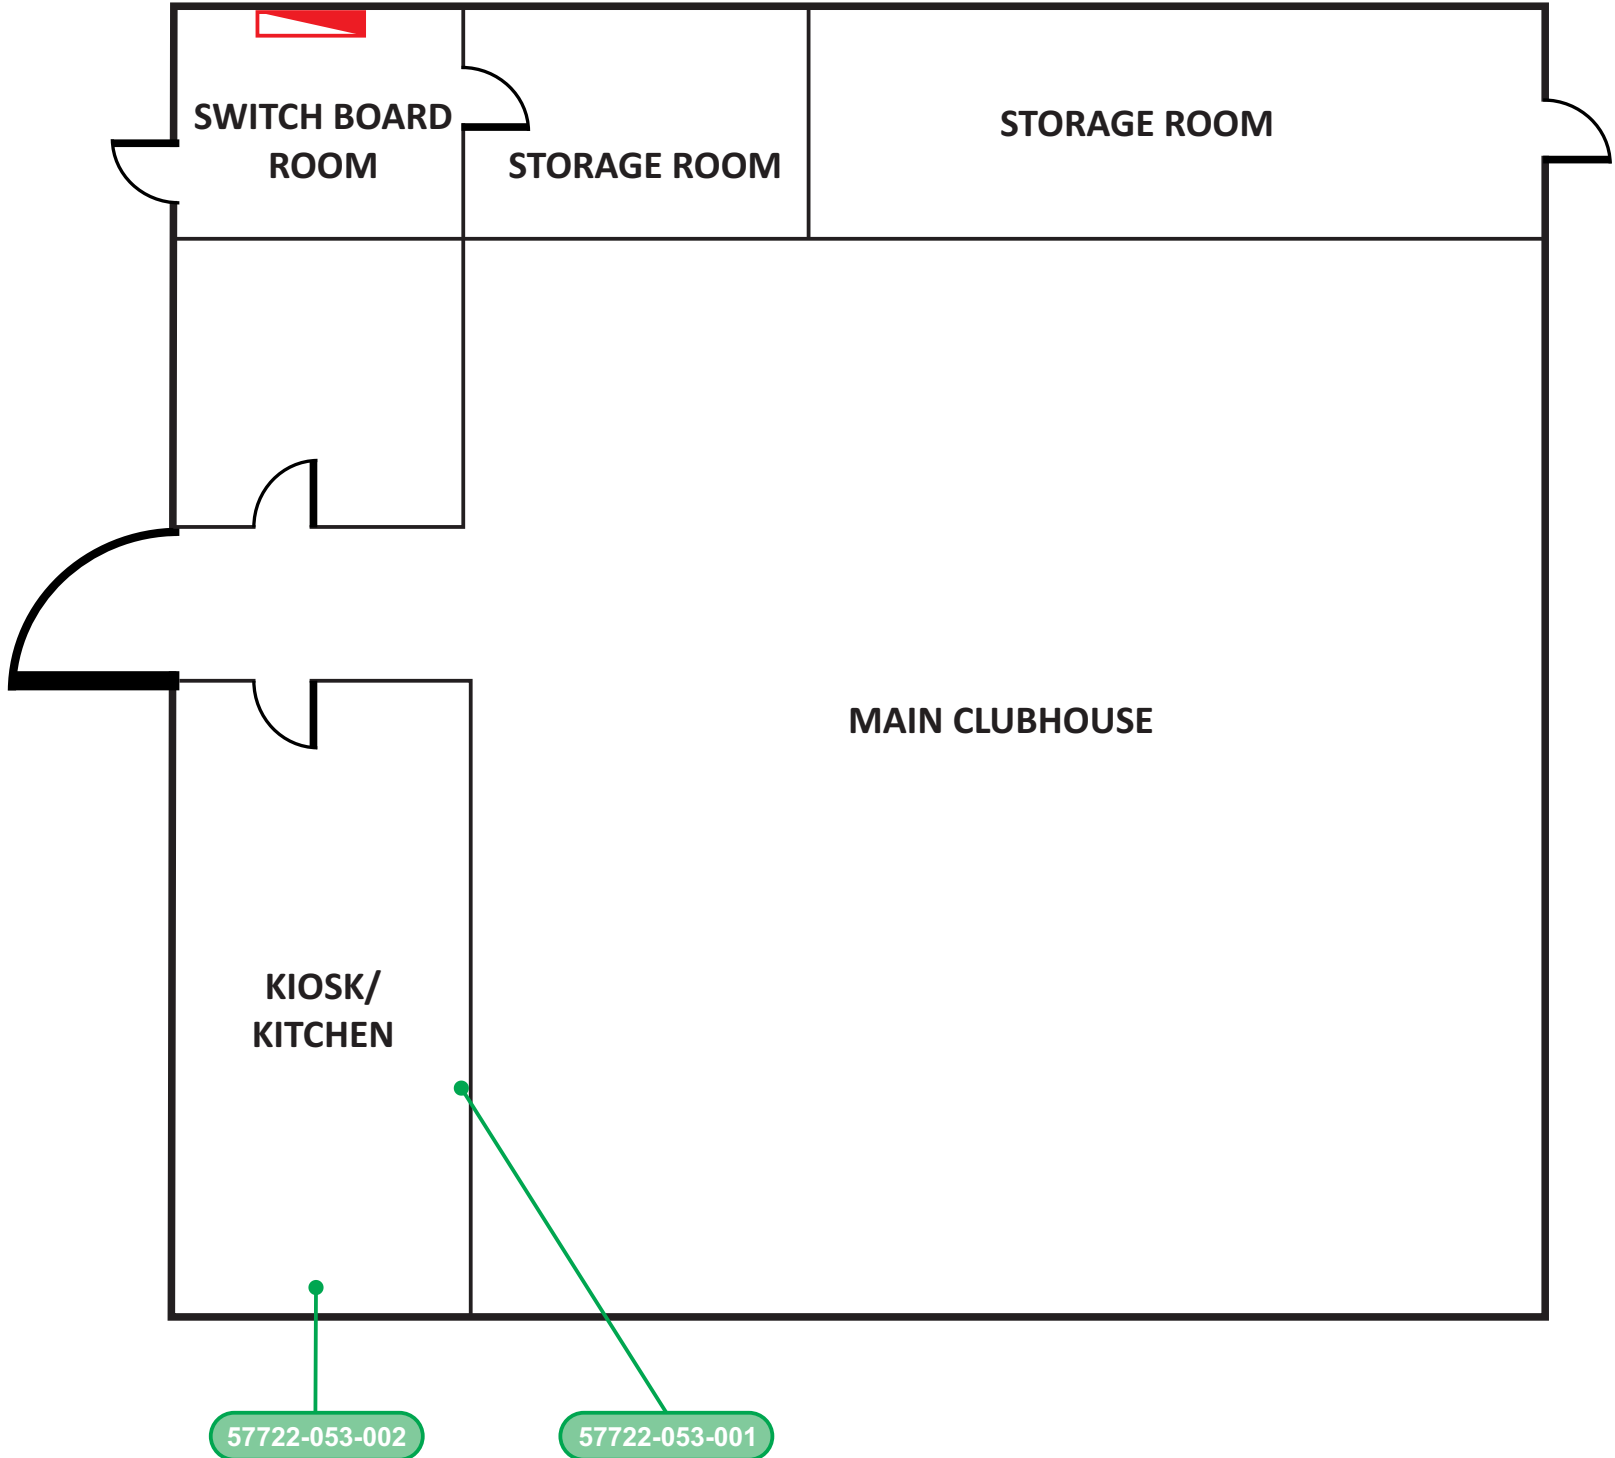
Mackey Park Clubhouse/Kiosks Marrickville, Ground Level

- Non-friable asbestos was suspected in the form of fibre cement sheeting to the electrical backing board within the switchboard cupboard.
