Hazardous Building Materials Assessment Mackey Park Amenities Carrington Road & Richardson Crescent Marrickville NSW 2204

Inner West Council
April 2018

Job No.: 57722-172

Count ID: CID: 247

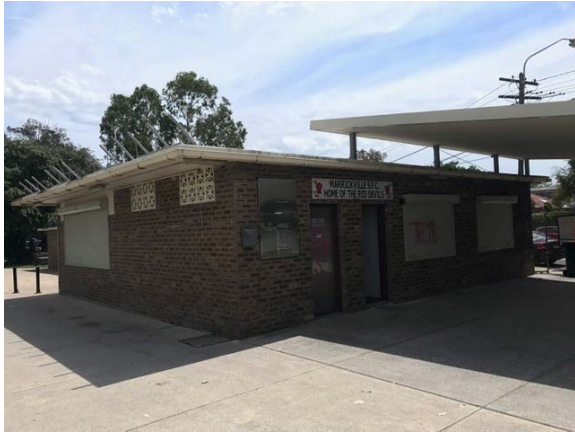
Photo 1. No hazardous building materials suspected or identified at the time of inspection.
