Hazardous Building Materials Assessment Mackey Park Canoe Club Carrington Road & Richardson Crescent Marrickville NSW 2204

Inner West Council
April 2018

Job No.: 57722-090

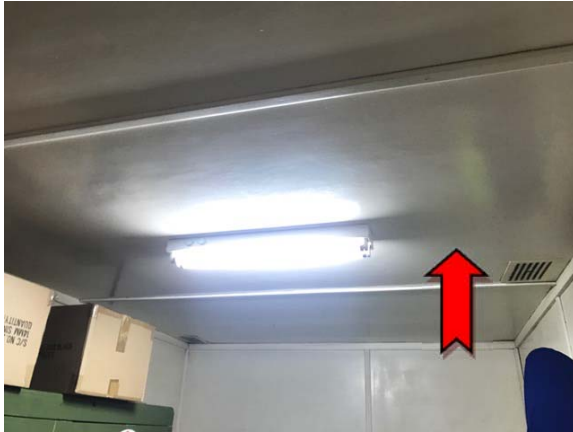
Photo 1. Interior, level 1, bathrooms, storage rooms and kitchen, ceiling – non-friable asbestos-containing fibre cement sheeting.

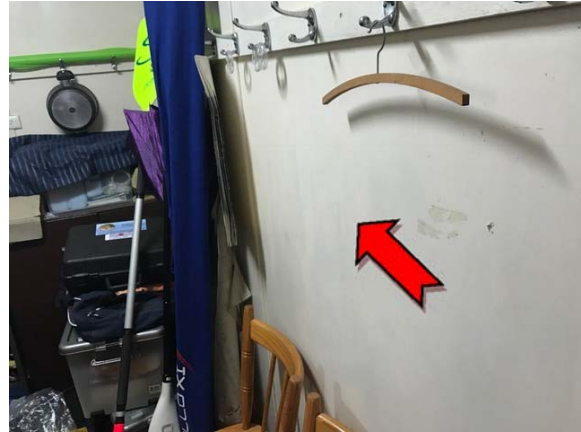
Interior, level 1	Bathrooms, storage rooms & kitchen	Walls - internal	Fibre cement sheet	Asbestos	57722-090-002	Positive	Non-friable	Low	Good	Low	80 m ²	Label as containing asbestos and maintain in current condition if to remain in-situ. Remove under controlled non-friable asbestos removal conditions prior to refurbishment or demolition works by a Class B (non-friable) licensed asbestos removal contractor.	P4	Feb-23	2
Throughout	-	-	-	SMF	-	-	-	-	-	-	-	No suspect SMF material identified at the time of the assessment.	-	-	-
Throughout	-	-	-	PCBs	-	-	-	-	-	-	-	No suspect PCB-containing capacitors identified at the time of the assessment.	-	-	-
Interior throughout	Throughout	Walls - internal	White - upper coloured paint system	Lead Paint - Swab	-	Suspected Positive	-	Low	Good	Low	80 m ²	Confirm status by quantitative test method, maintain in current condition, over paint with a lead-free paint as part of ongoing maintenance. Remove under controlled conditions in accordance with AS 4361.2:2017 Guide to hazardous paint management prior to renovation or demolition works.	-	-	-

Photo 2. Interior, level 1, bathrooms, storage rooms and kitchen, wall – non-friable asbestos-containing fibre cement sheeting.

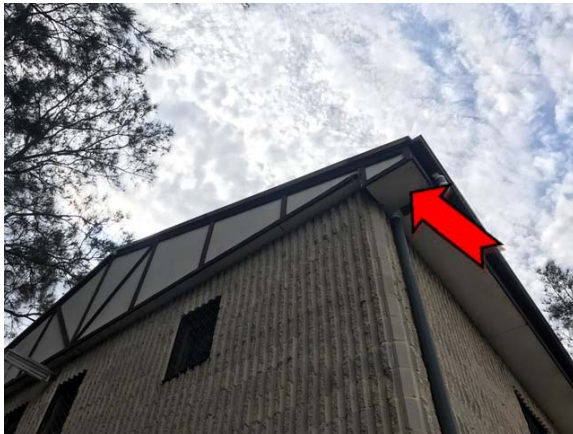
Area / Level	Room & Location	Feature	Item Description	Hazard Type	Sample No.	Sample Status	Friability	Disturb. Potential	Condition	Risk Status	Approx. Quantity	Recommendations & Comments	Control Priority	Reinspect Date	Photo No.
Exterior, level 1	Building surrounds	Eaves	Fibre cement sheet	Asbestos	57722-090-003	Positive	Non-friable	Low	Good	Low	100 m ²	Label as containing asbestos and maintain in current condition if to remain in-situ. Remove under controlled non-friable asbestos removal conditions prior to refurbishment or demolition works by a Class B (non-friable) licensed asbestos removal contractor.	P4	Feb-23	3
Exterior, level 1	East elevation	Gable end	Fibre cement sheet	Asbestos	Not sampled: Height restriction	Suspected Positive	Non-friable	Low	Good	Low	10 m ²	Label as containing asbestos and maintain in current condition if to remain in-situ. Remove under controlled non-friable asbestos removal conditions prior to refurbishment or demolition works by a Class B (non-friable) licensed asbestos removal contractor.	P4	Feb-23	3

Photo 3. Exterior, east elevation, gable ends and eaves – non-friable asbestos-containing fibre cement sheeting.

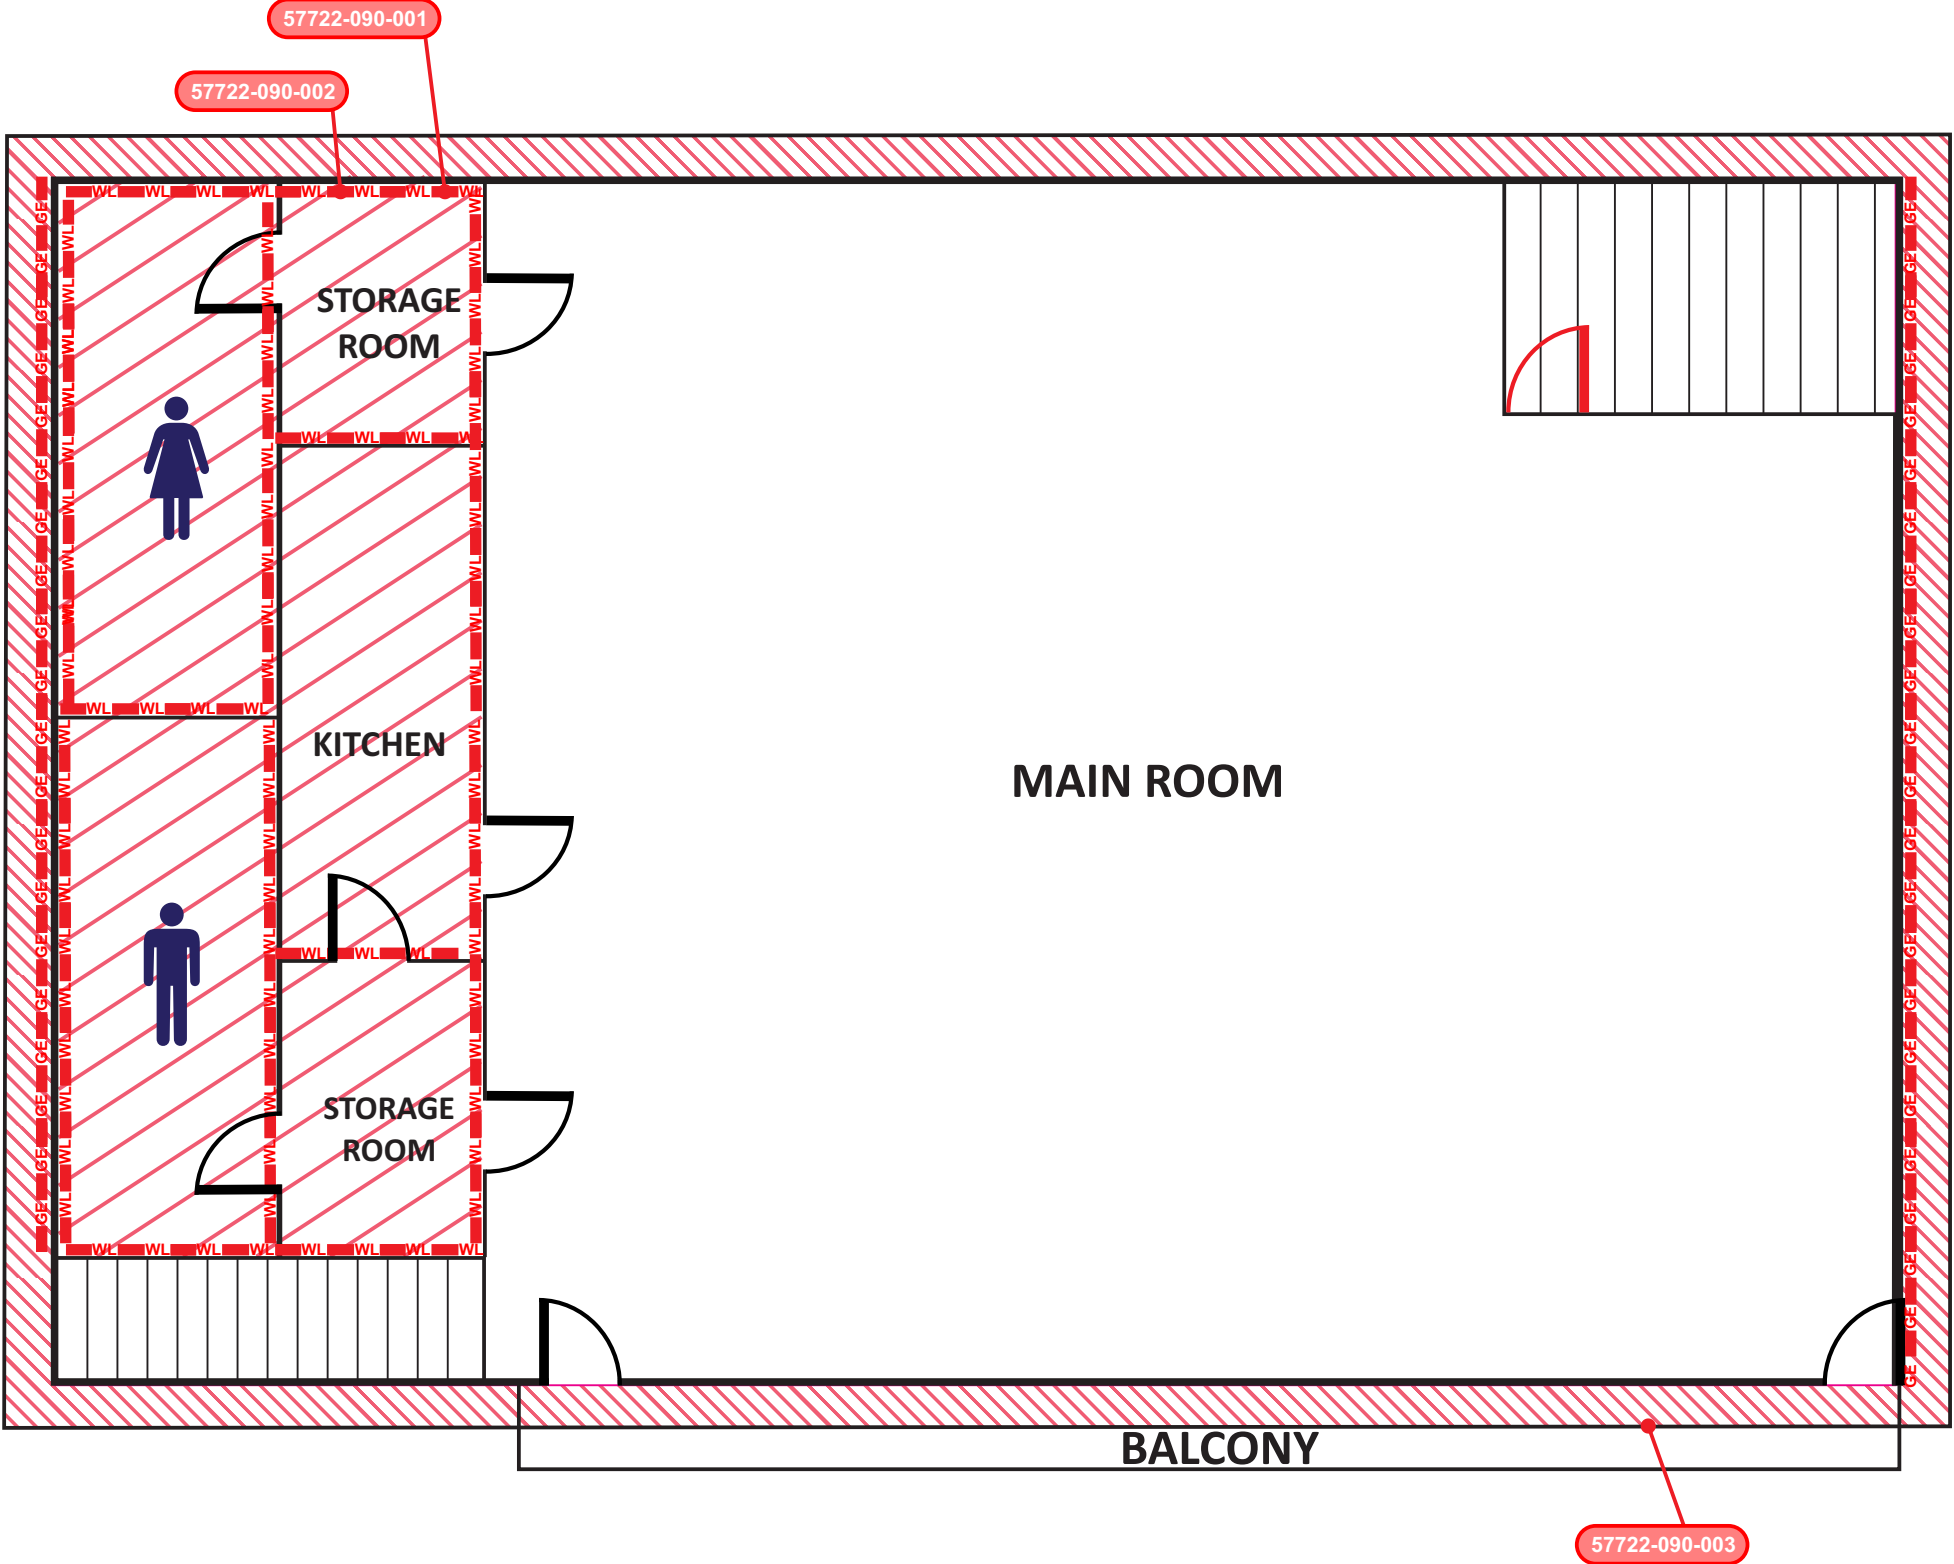
Mackey Park Canoe Club Marrickville- Level One

- Friable asbestos was identified in the form of fibre cement sheeting internal insulation to fire door in stairwell.
- Non-friable asbestos was identified in the form of fibre cement sheeting walls and ceiling in bathrooms, storage rooms and kitchen to the level 1.
- Non-friable asbestos was identified in the form of fibre cement sheeting gable ends and eaves to the exterior.
