Hazardous Building Materials Assessment Henson Park Tennis Building Centennial Street Marrickville NSW 2204

Inner West Council
April 2018

Job No.: 57722-167

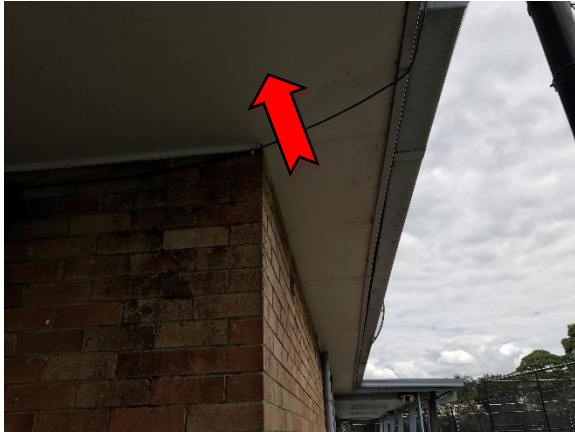
Photo 1. Exterior, throughout, eaves – non-friable asbestos-containing fibre cement sheeting.

- Non-friable asbestos was identified in the form of fibre cement sheeting eaves throughout the exterior of the building.
- Non-friable asbestos was identified in the form of fibre cement sheeting ceiling to store room 1.
- Non-friable asbestos was suspected in the form of corrugated fibre cement sheeting wall and ceilings within roof space.

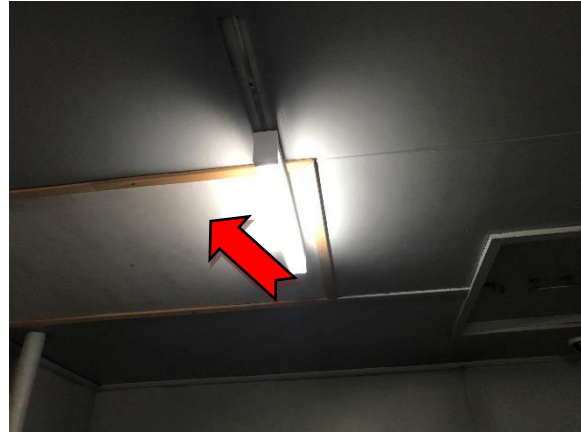
Photo 2. Interior, store room 1, ceiling – non-friable asbestos-containing fibre cement sheeting

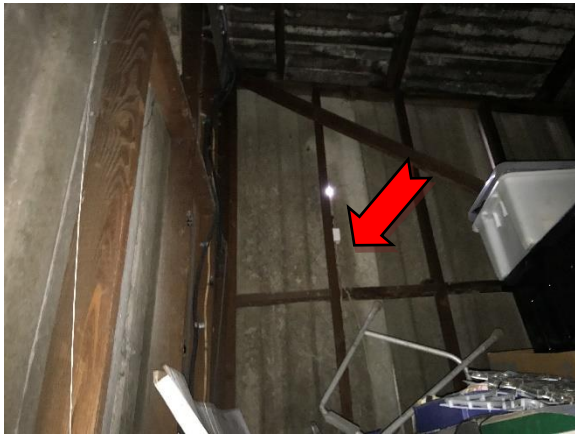
Photo 3. Interior, roof space, wall and ceiling – suspected non-friable asbestos-containing corrugated fibre cement sheeting

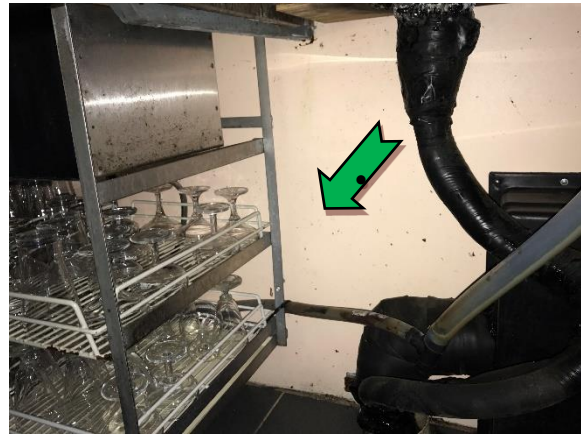
Photo 4. Interior, main club room, beneath bar, infill panel – non asbestos-containing fibre cement sheeting

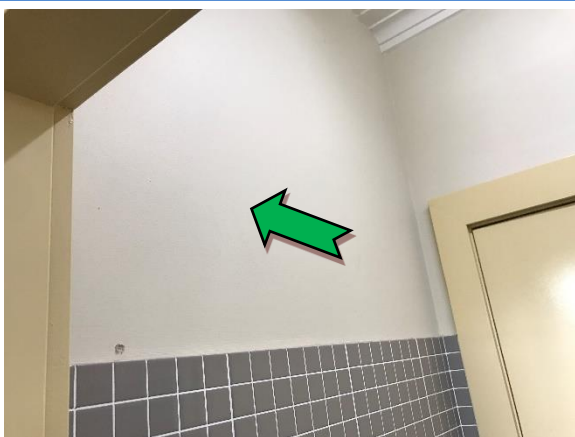
Photo 5. Interior, male and female toilets, wall panels – non asbestos-containing fibre cement sheeting

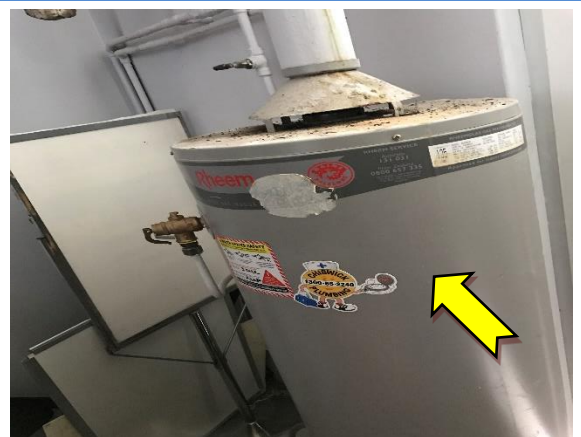
Photo 6. Interior, male change room, hot water heater – suspected SMF internal insulation.

- Suspected SMF in the form of internal insulation to hot water heater within the male change room.

- SMF materials that are likely to be disturbed during any proposed demolition/refurbishment works should be handled in accordance with the *Code of Practice for the Safe Use of Synthetic Mineral Fibres* [NOHSC:2006(1990)]. If these materials are impacted upon by accident or by pre-planned works, the Inner West Council must be informed via the contact detailed within Section 7: *Accidental Disturbance of Known or Suspected Hazardous Building Materials*. Following disturbance, inspection by a competent person should be undertaken.

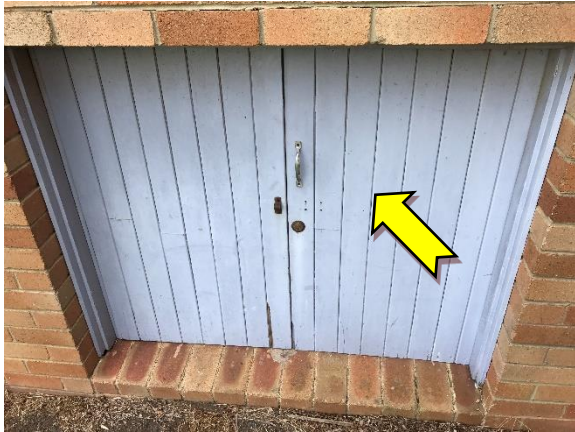
Photo 7. Exterior, south elevation, doors - suspected lead-containing blue upper paint system.

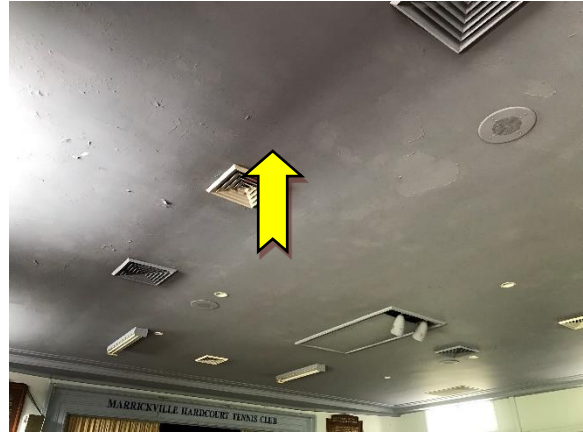
Interior	Throughout	Ceiling	White - lower coloured paint system	Lead Paint - Swab	-	Suspected Positive	-	Low	Good	Low	100 m ²	Confirm status by quantitative test method, maintain in current condition, over paint with a lead-free paint as part of ongoing maintenance. Remove under controlled conditions in accordance with AS 4361.2:2017 Guide to hazardous paint management prior to renovation or demolition works.	-	-	8
Interior	Throughout	Walls	White - lower coloured paint system	Lead Paint - Swab	-	Suspected Positive	-	Low	Good	Low	300 m ²	Confirm status by quantitative test method, maintain in current condition, over paint with a lead-free paint as part of ongoing maintenance. Remove under controlled conditions in accordance with AS 4361.2:2017 Guide to hazardous paint management prior to renovation or demolition works.	-	-	-
Throughout	-	-	-	Ozone Depleting Substances	-	-	-	-	-	-	-	No suspect ODS's identified at the time of the assessment.	-	-	-

Photo 8. Interior, throughout. Ceiling - suspected lead-containing white upper paint system.

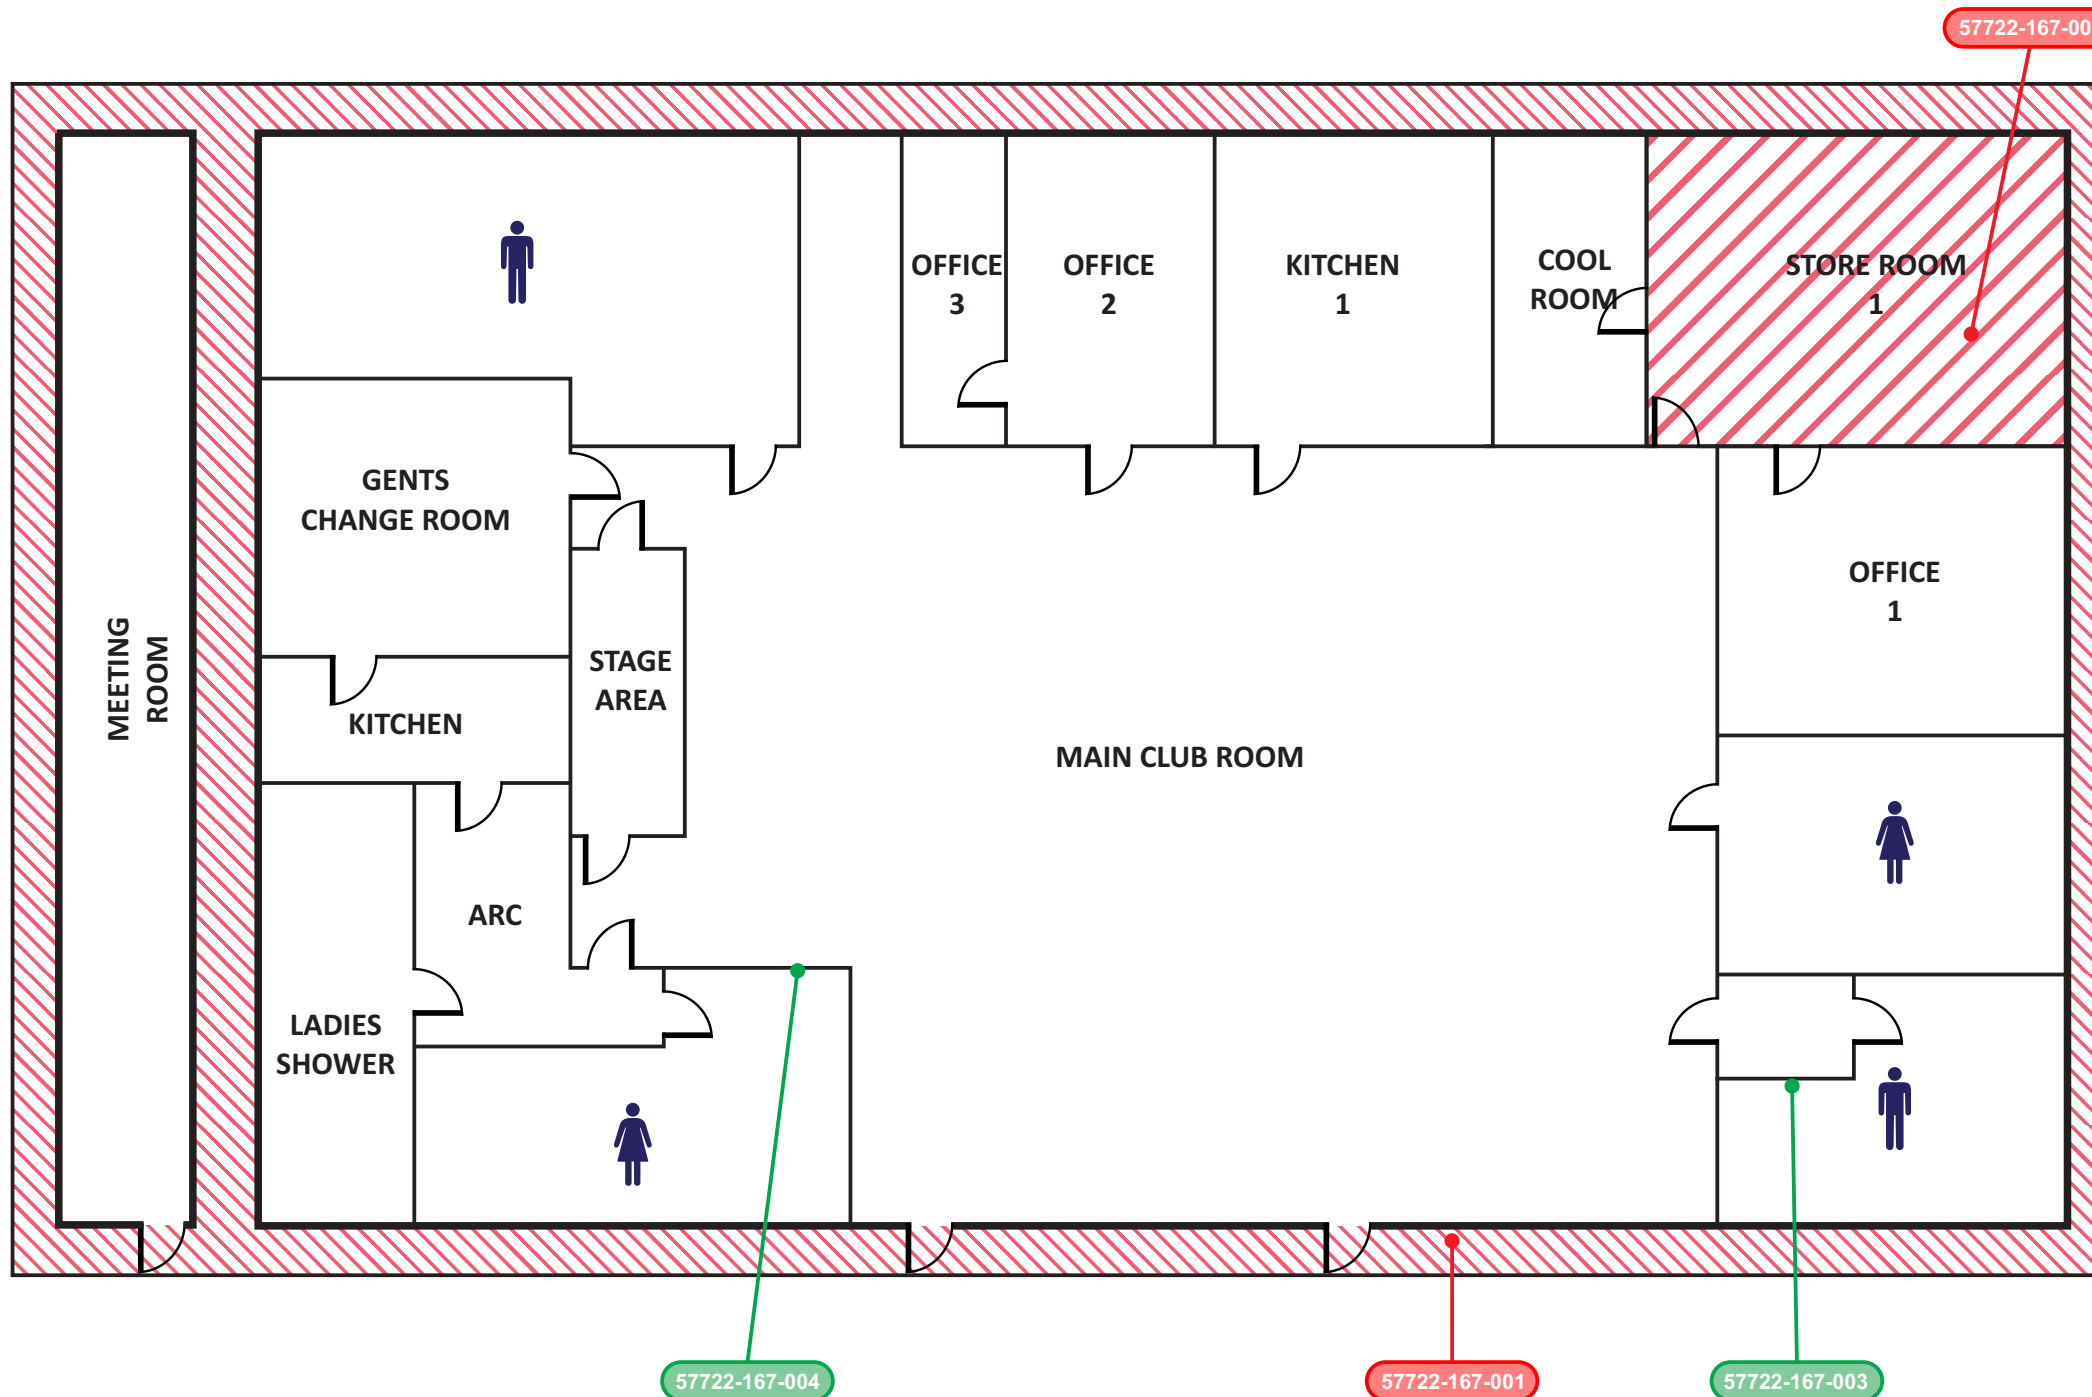
Henson Park Tennis Building, Marrickville - Ground Level

Note: No roof space plan. ACMs present.
Please refer to register.
