Hazardous Building Materials Assessment

Mallam Reserve Toilets

43 Dulwich Street
Marrickville NSW 2204

Inner West Council
April 2018

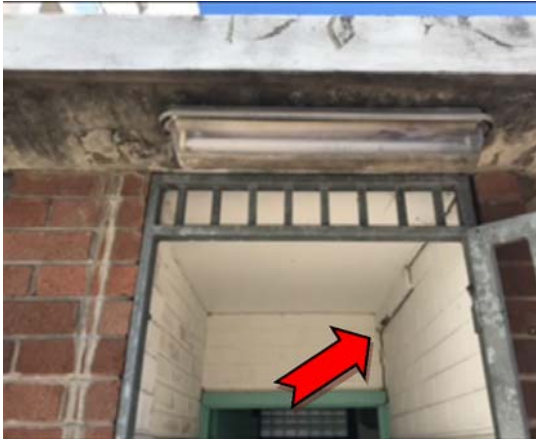
Area / Level	Room & Location	Feature	Item Description	Hazard Type	Sample No.	Sample Status	Friability	Disturb. Potential	Condition	Risk Status	Approx. Quantity	Recommendations & Comments	Control Priority	Reinspect Date	Photo No.
Exterior	Entrance to state transit room, to wall	Expansion Joint	Bituminous Material	Asbestos	57722-088-001	Positive	Non-friable	Low	Good	Low	5 m	Maintain in current condition if to remain in-situ. Remove under controlled non-friable asbestos removal conditions prior to refurbishment or demolition works by a Class B (non-friable) licensed asbestos removal contractor.	P4	Feb-23	1
Exterior	State transit room, to wall	Expansion Joint	Bituminous Material	Asbestos	Same as: 57722-088-001	Positive	Non-friable	Low	Good	Low	10 m	Maintain in current condition if to remain in-situ. Remove under controlled non-friable asbestos removal conditions prior to refurbishment or demolition works by a Class B (non-friable) licensed asbestos removal contractor.	P4	Feb-23	-

Photo 1. Exterior, entrance to state transit room, to wall, expansion joint – non-friable asbestos-containing bituminous material.

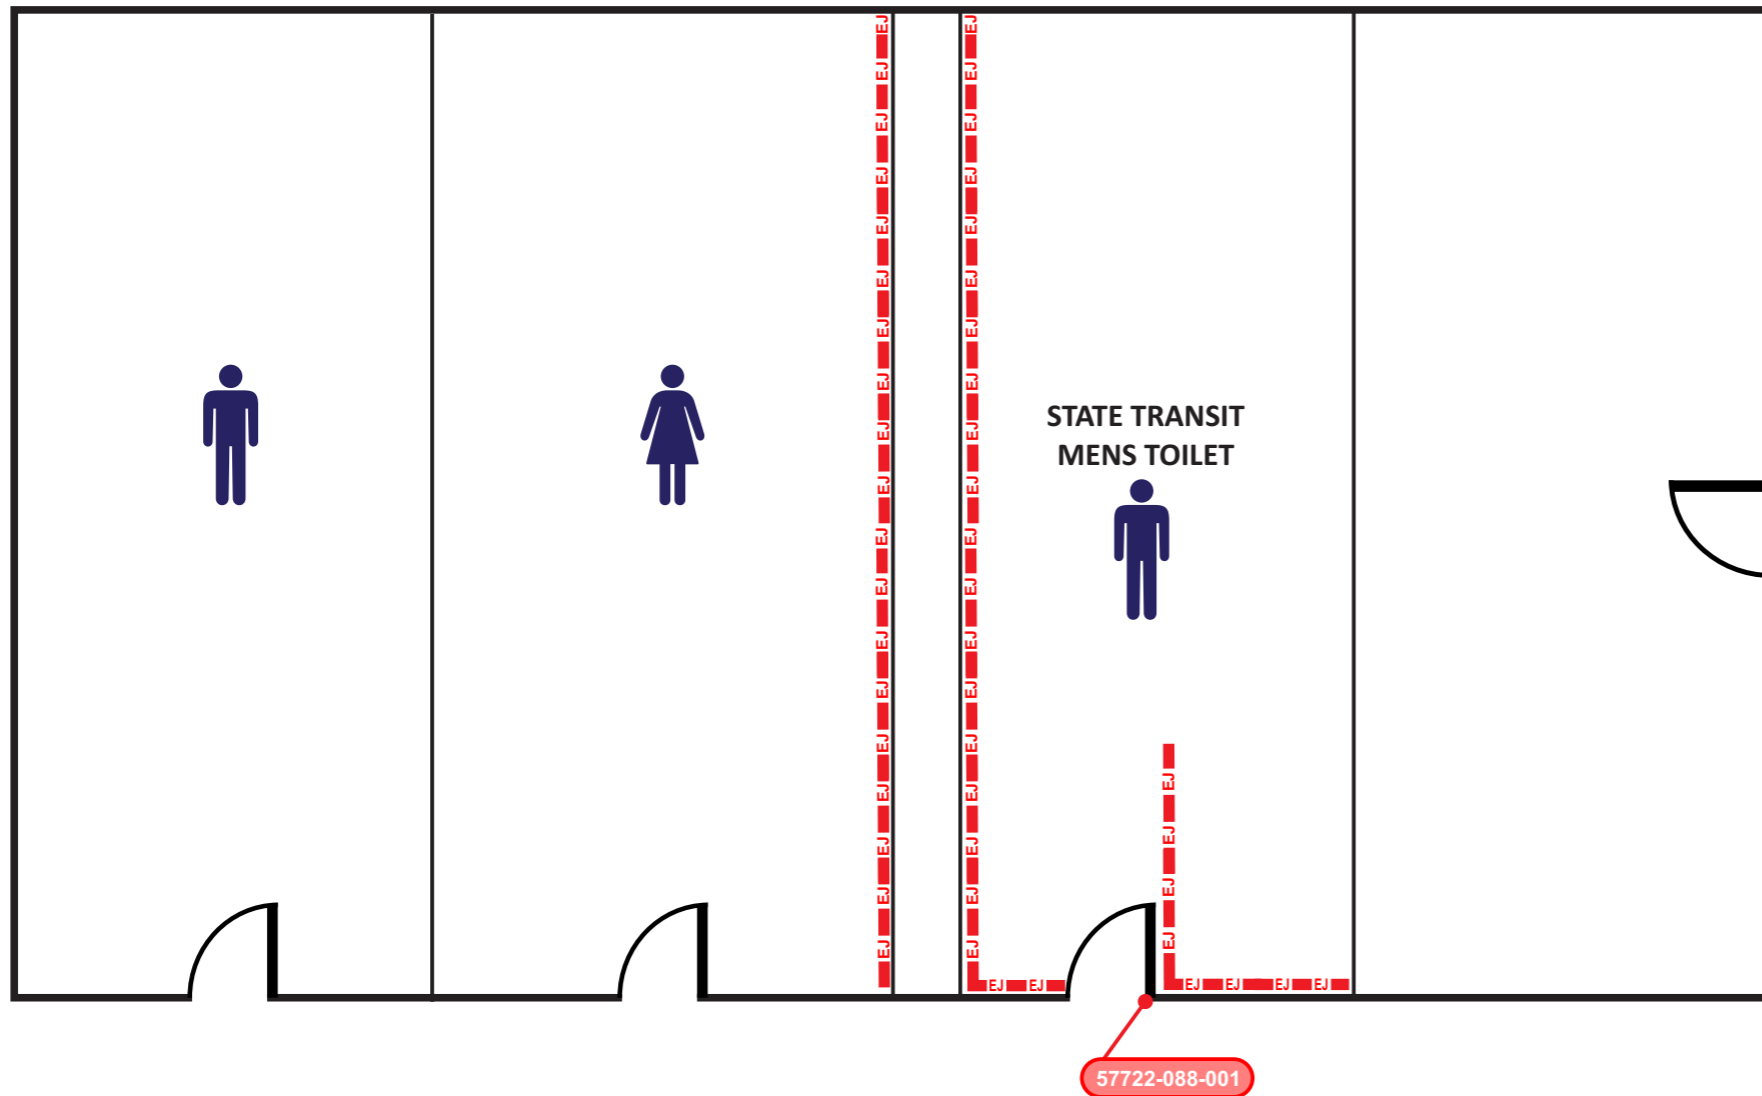
Drawing Title:
Mallam Reserve Toilets

- Non-friable asbestos was identified in the form of bituminous material located to the entrance to the transit room, transit room and female bathroom at the site.
