Hazardous Building Materials Assessment

Enmore Resource Centre

Enmore & Victoria Roads

Inner West Council
April 2018

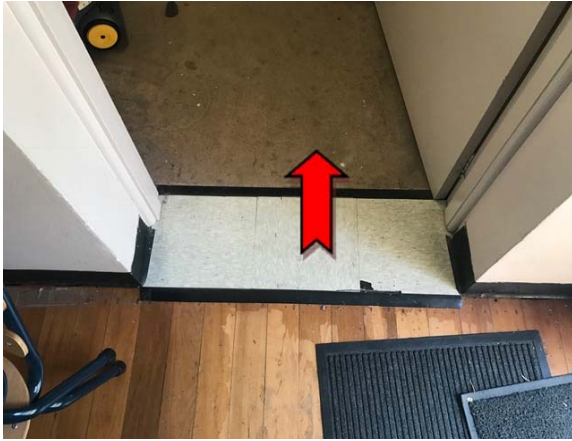
Photo 1. Interior, ground level, doorway to store 1, cream floor coverings– non asbestos-containing vinyl floor tiles.
