Hazardous Building Materials Assessment Marrickville Park Croquet Club Fraser Street and Lawson Avenue Marrickville NSW 2204

Inner West Council
April 2018

Job No.: 57722-127

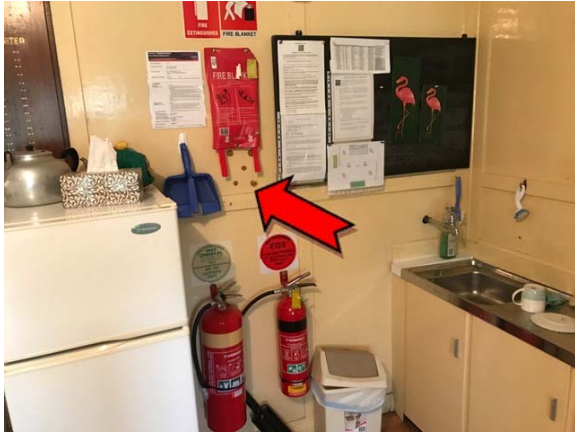
Photo 1. Interior, ground level, club room wall – asbestos-containing fibre cement sheeting.

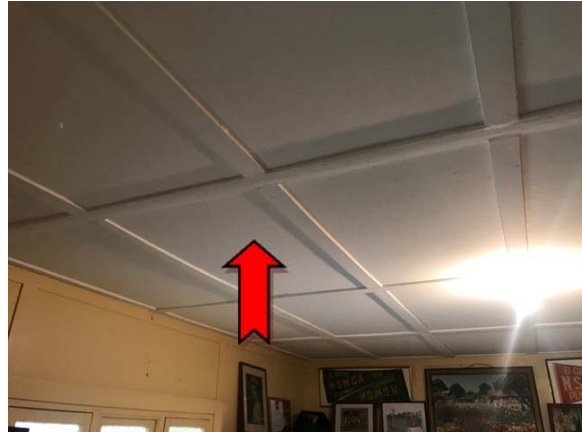
Photo 2. Interior, ground level, club room ceiling – assumed asbestos-containing fibre cement sheeting.

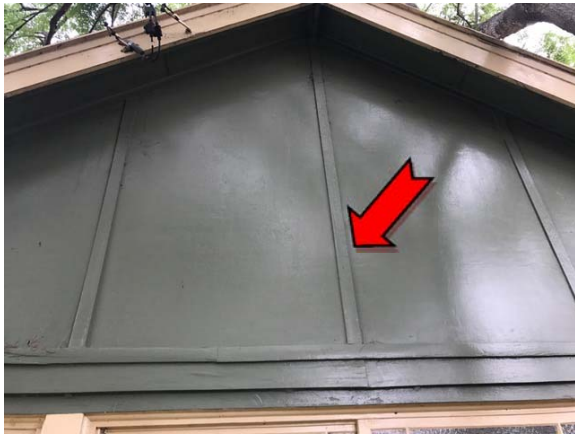
Photo 3. Exterior, western elevation, gable end – assumed asbestos-containing fibre cement sheeting.

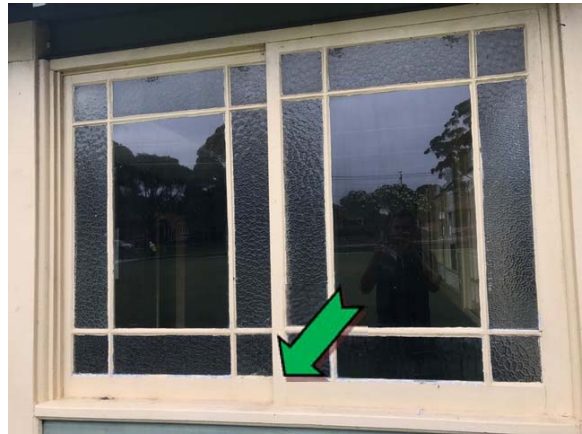
Photo 4. Exterior, throughout, window frames – non asbestos-containing window caulking.

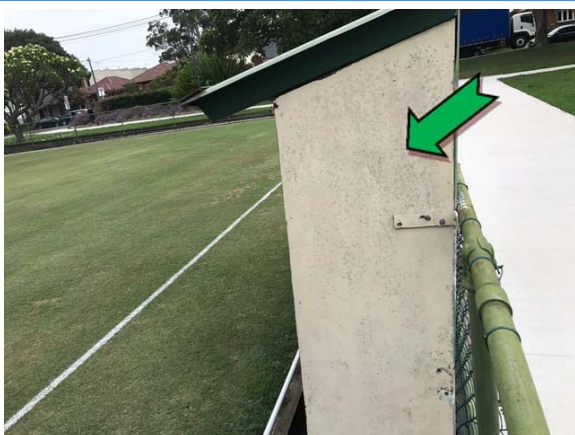
Exterior	North western elevation, hut	Wall panels	Fibre cement sheeting	Asbestos	57722-127-005	Negative	-	-	-	-	-	-	-	-	5
Exterior	North eastern elevation, hut	Wall panels	Fibre cement sheeting	Asbestos	Same as: 57722-127-005	Negative	-	-	-	-	-	-	-	-	-
Interior	Clubroom	Wall panels	Fibre cement sheeting	Asbestos	57722-127-003	Positive	Non-friable	Low	Good	Low	30 m ²	Label as containing asbestos and maintain in current condition if to remain in-situ. Remove under controlled non-friable asbestos removal conditions prior to refurbishment or demolition works by a Class B (non-friable) licensed asbestos removal contractor.	P4	Mar-23	1
Interior	Clubroom	Ceiling	Fibre cement sheeting	Asbestos	Same as: 57722-127-003	Assumed Positive	Non-friable	Low	Good	Low	30 m ²	Label as containing asbestos and maintain in current condition if to remain in-situ. Remove under controlled non-friable asbestos removal conditions prior to refurbishment or demolition works by a Class B (non-friable) licensed asbestos removal contractor.	P4	Mar-23	2

Photo 5. Exterior north west elevation hut, wall – non asbestos-containing fibre cement sheeting.

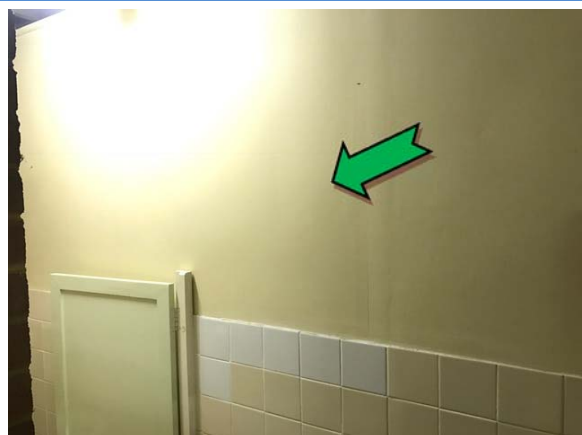
Interior	Male toilets	Wall panels	Fibre cement sheeting	Asbestos	57722-127-004	Negative	-	-	-	-	-	-	-	-	6
Throughout	-	-	-	SMF	-	-	-	-	-	-	-	No suspect SMF material identified at the time of the assessment.	-	-	-
Throughout	-	-	-	PCBs	-	-	-	-	-	-	-	No suspect PCB-containing capacitors identified at the time of the assessment.	-	-	-
Exterior	Throughout	Window frames	Yellow (light) - upper coloured paint system	Lead Paint - Swab	-	-	-	Low	Good	Low	50 m ²	Confirm status by quantitative test method, maintain in current condition, over paint with a lead-free paint as part of ongoing maintenance. Remove under controlled conditions in accordance with AS 4361.2:2017 Guide to hazardous paint management prior to renovation or demolition works.	-	-	-
Exterior	Throughout	Walls	Green (light) - upper coloured paint system	Lead Paint - Swab	-	-	-	Low	Good	Low	100 m ²	Confirm status by quantitative test method, maintain in current condition, over paint with a lead-free paint as part of ongoing maintenance. Remove under controlled conditions in accordance with AS 4361.2:2017 Guide to hazardous paint management prior to renovation or demolition works.	-	-	-

Photo 6. Interior, ground level, male toilets, wall – non asbestos-containing fibre cement sheeting.
