Hazardous Building Materials Assessment

ESP Gallery

228-230 Illawarra Road
Marrickville NSW 2204

Inner West Council
April 2018

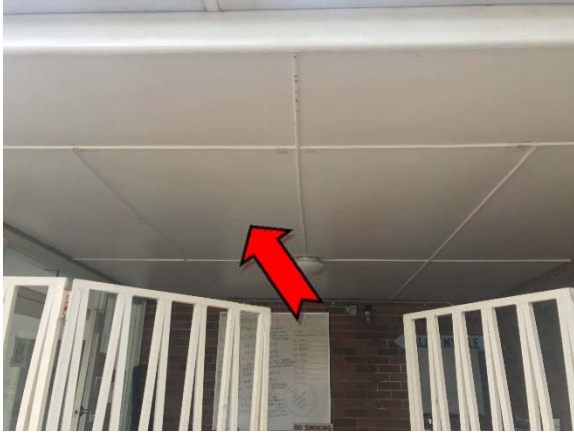
Photo 1. Exterior, throughout, awning – asbestos-containing fibre cement sheeting.

- Non-friable asbestos was identified in the form of fibre cement sheeting eaves and awning to exterior of the ESP gallery.

Area / Level	Room & Location	Feature	Item Description	Hazard Type	Sample No.	Sample Status	Friability	Disturb. Potential	Condition	Risk Status	Approx. Quantity	Recommendations & Comments	Control Priority	Reinspect Date	Photo No.
Exterior	Throughout	Eaves	Fibre cement sheeting	Asbestos	57722-126-001	Positive	Non-friable	Low	Good	Low	40 m ²	Label as containing asbestos and maintain in current condition if to remain in-situ. Remove under controlled non-friable asbestos removal conditions prior to refurbishment or demolition works by a Class B (non-friable) licensed asbestos removal contractor.	P4	Mar-23	-
Exterior	Throughout	Awning	Fibre cement sheeting	Asbestos	Same as: 57722-126-001	Assumed Positive	Non-friable	Low	Good	Low	25 m ²	Label as containing asbestos and maintain in current condition if to remain in-situ. Remove under controlled non-friable asbestos removal conditions prior to refurbishment or demolition works by a Class B (non-friable) licensed asbestos removal contractor.	P4	Mar-23	1

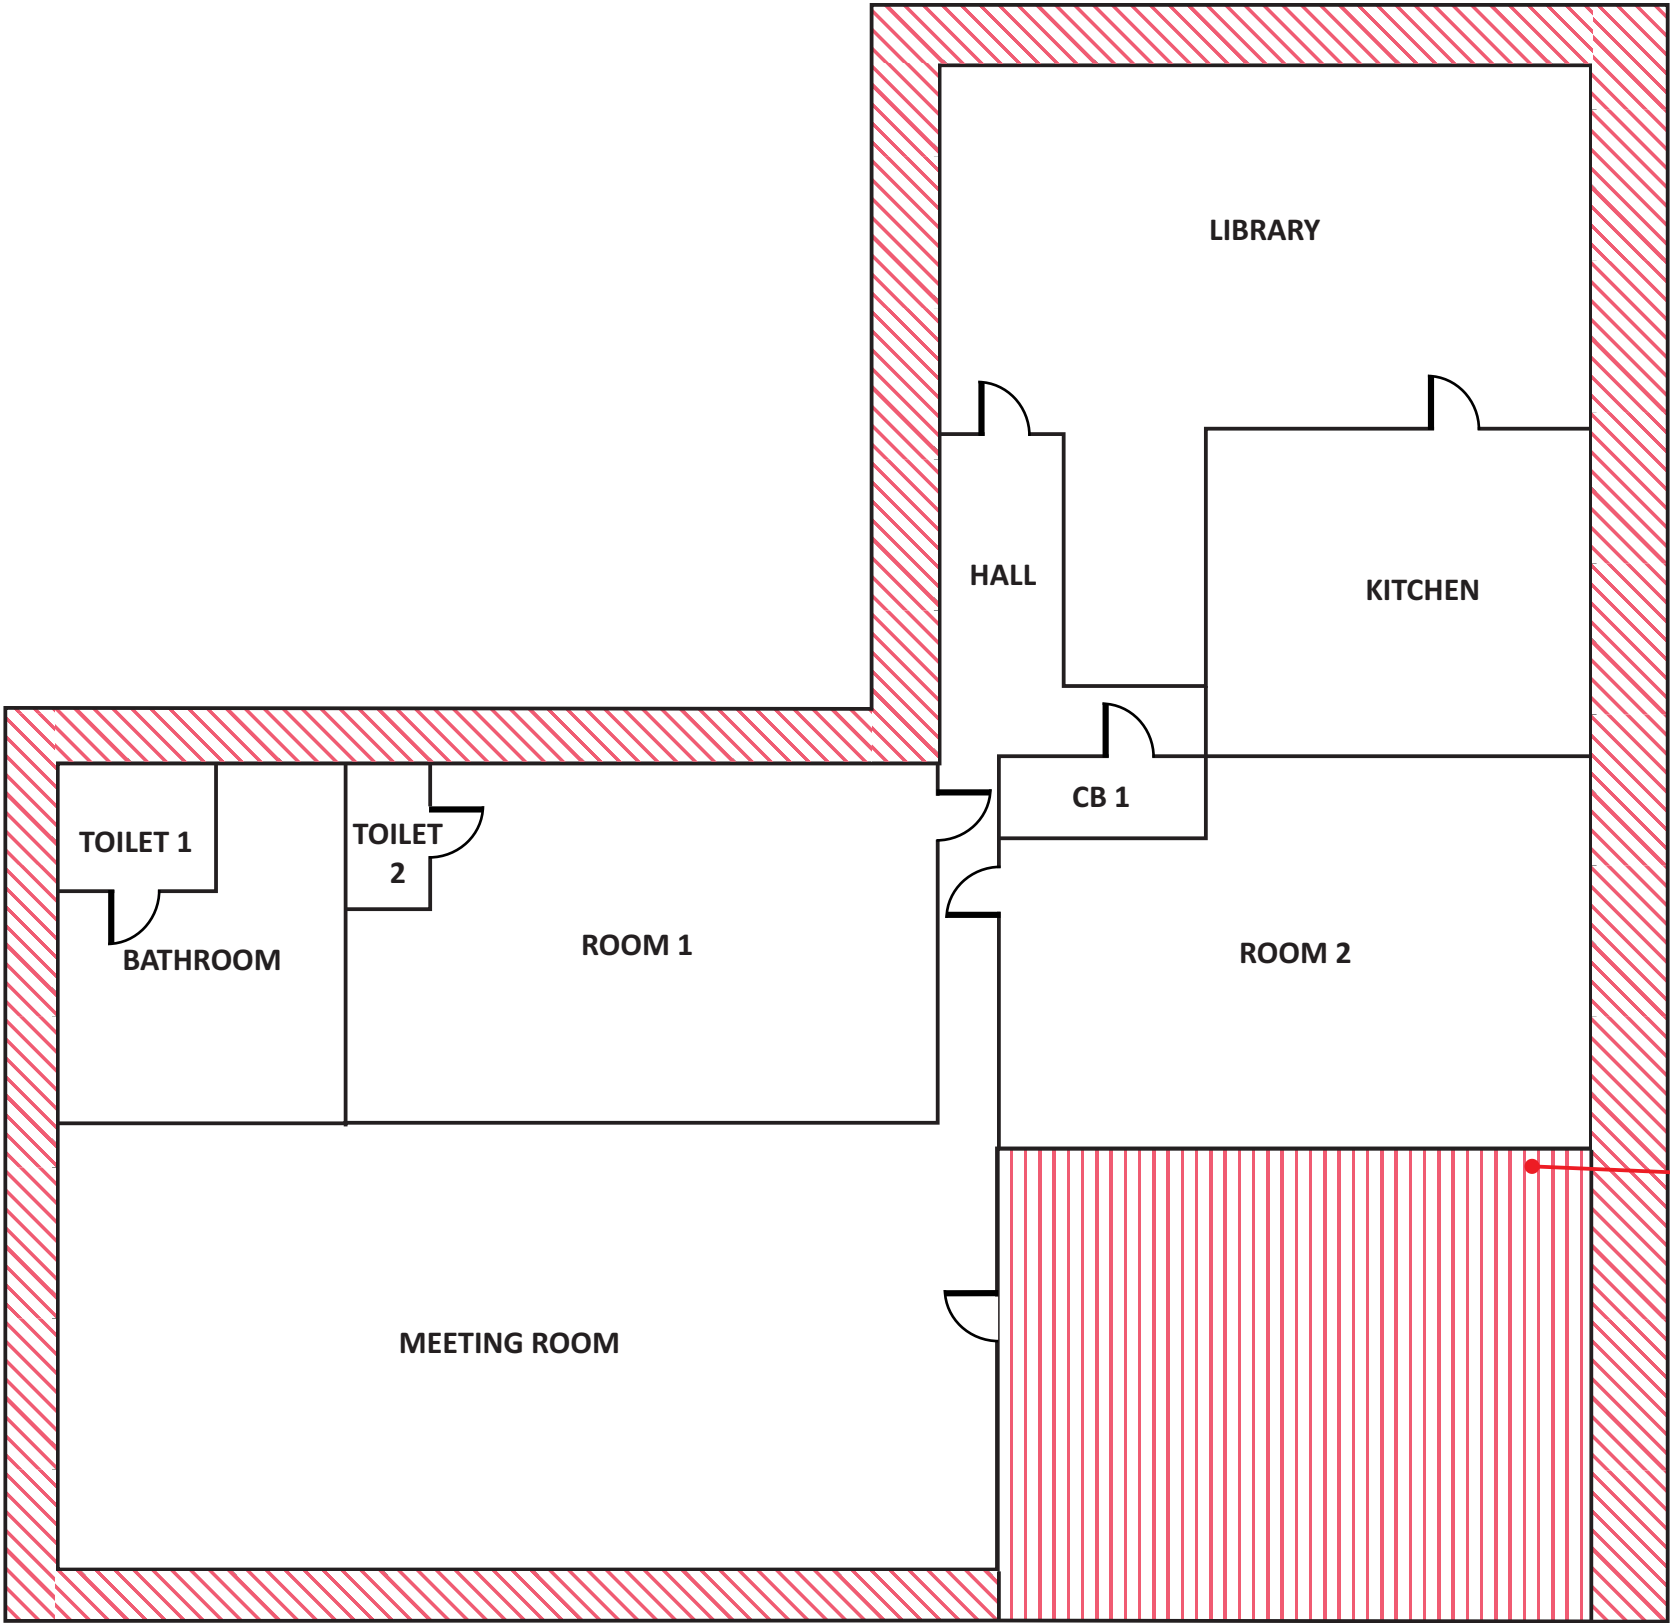
ESP Gallery, Marrickville - Ground Level

57722-126-xxx	Positive Asbestos Sample
 		Eaves
 		Awning
