Hazardous Building Materials Assessment Marrickville SDN Children's Services 247-259 Illawarra Road Marrickville NSW 2204

Inner West Council
April 2018

Job No.: 57722-125

Count ID: CID: 264

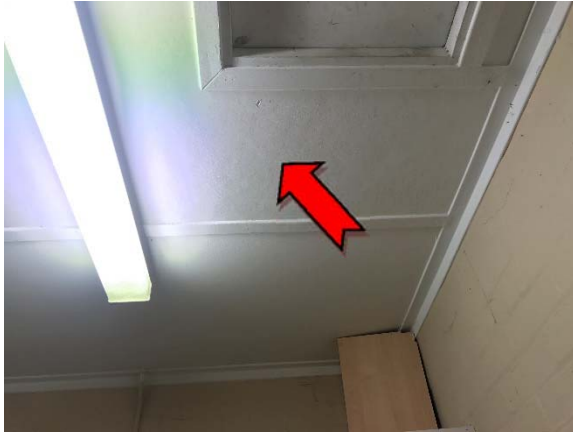
Photo 1. Interior, ground level, laundry room, ceiling – asbestos-containing fibre cement sheeting

- Non-friable asbestos was identified in the form of fibre cement sheet ceiling to the laundry room.
- Non-friable asbestos was identified in the form of moulded fibre cement down pipe located to the wall within staff toilet.

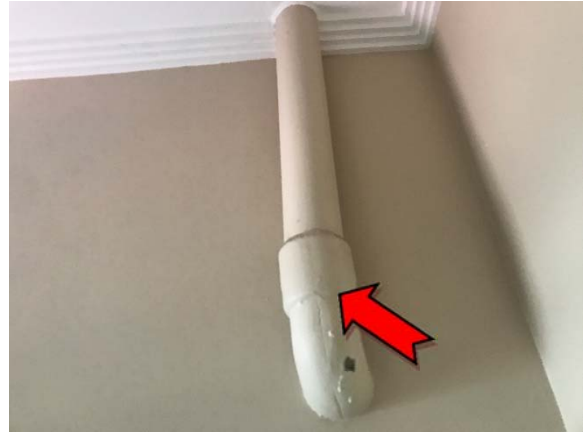
Photo 2. Interior, ground level, staff toilet adjacent to staffroom, down pipe – asbestos-containing moulded fibre cement.

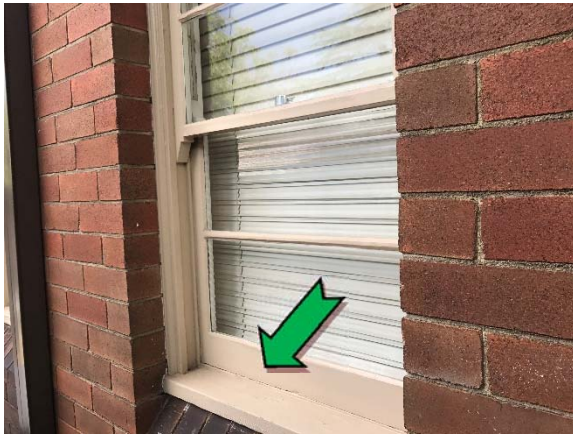
Photo 3. Interior, window frames, throughout –non asbestos-containing window caulking.
