Hazardous Building Materials Assessment Residential Properties at 290-292 Illawarra Road 290-292 Illawarra Road Marrickville NSW 2044

Inner West Council
April 2018

Job No.: 57722-170

Count ID: CID: 002

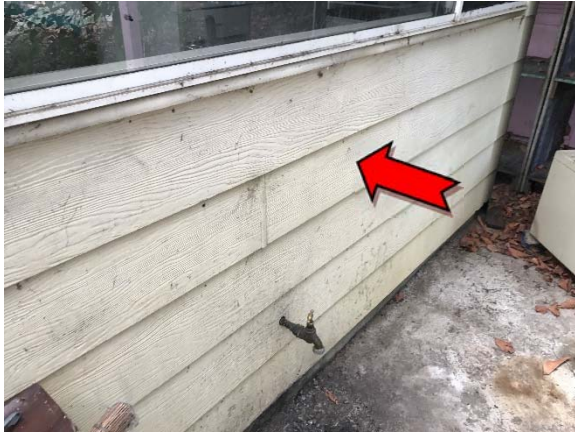
Photo 1. Exterior, northern and eastern elevation, wall cladding – non asbestos-containing fibre cement sheeting.

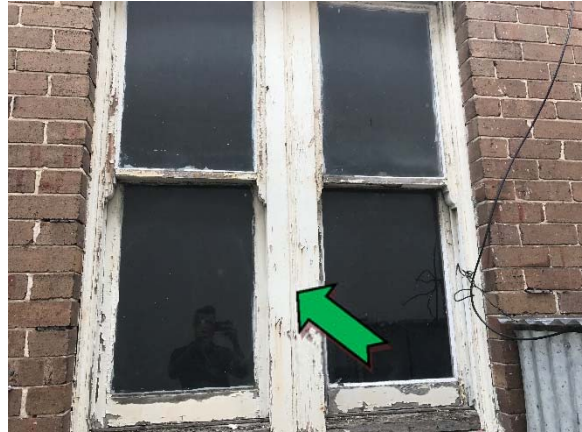
Photo 2. Exterior, throughout, window frames – non asbestos-containing window caulking.

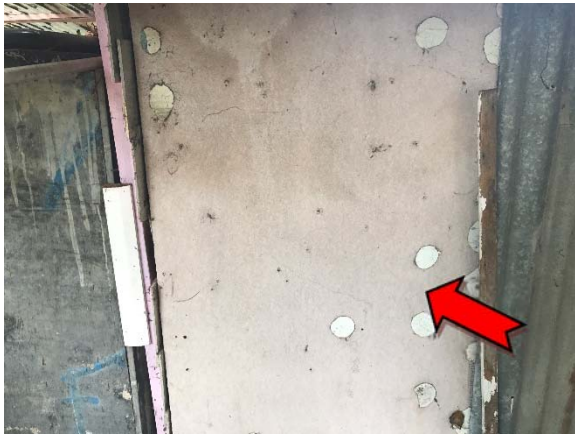
Photo 3. Exterior, store 1, wall cladding – asbestos-containing fibre cement sheeting.

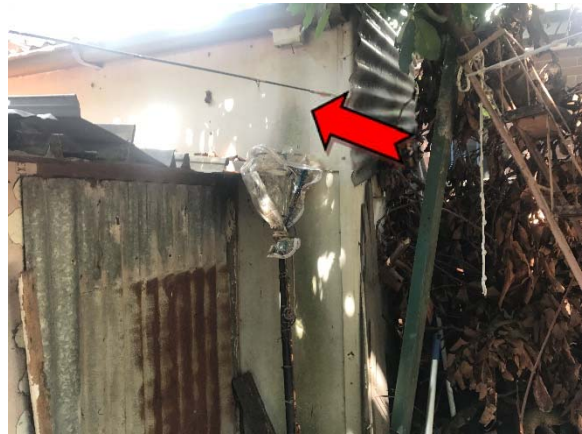
Area / Level	Room & Location	Feature	Item Description	Hazard Type	Sample No.	Sample Status	Friability	Disturb. Potential	Condition	Risk Status	Approx. Quantity	Recommendations & Comments	Control Priority	Reinspect Date	Photo No.
Exterior	Northern and eastern elevations	Wall cladding	Fibre cement sheeting	Asbestos	57722-170-001	Negative	-	-	-	-	-	-	-	-	1
Exterior	Throughout	Window frames	Window caulking	Asbestos	57722-170-002	Negative	-	-	-	-	-	-	-	-	2
Exterior	Store 1	Wall cladding	Fibre cement sheeting	Asbestos	57722-170-003	Positive	Non-friable	Low	Good	Low	20 m ²	Maintain in current condition if to remain in-situ. Remove under controlled non-friable asbestos removal conditions prior to refurbishment or demolition works by a Class B (non-friable) licensed asbestos removal contractor.	P4	Mar-23	3
Exterior	Store 2	Wall cladding	Fibre cement sheeting	Asbestos	57722-170-004	Positive	Non-friable	Low	Good	Low	10 m ²	Maintain in current condition if to remain in-situ. Remove under controlled non-friable asbestos removal conditions prior to refurbishment or demolition works by a Class B (non-friable) licensed asbestos removal contractor.	P4	Mar-23	4

Photo 4. Exterior, store 2, wall cladding – asbestos-containing fibre cement sheeting.

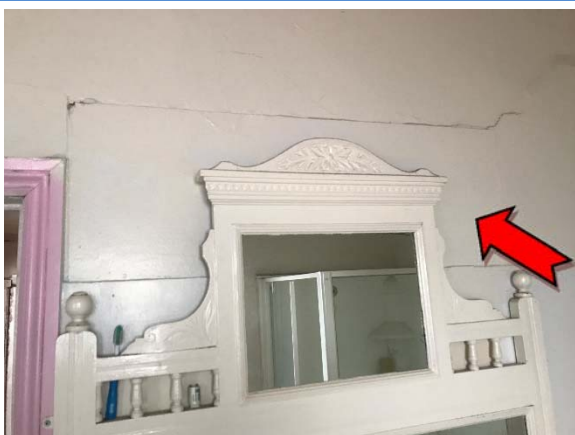
Photo 5. Interior, bathroom, wall panels – asbestos-containing fibre cement sheeting.

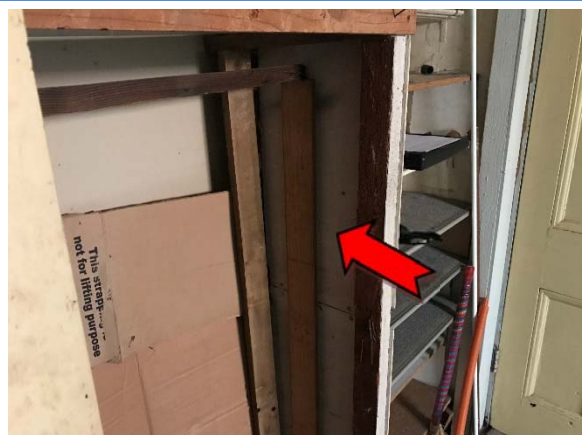
Photo 6. Interior, room 4, wall panels – asbestos-containing fibre cement sheeting.

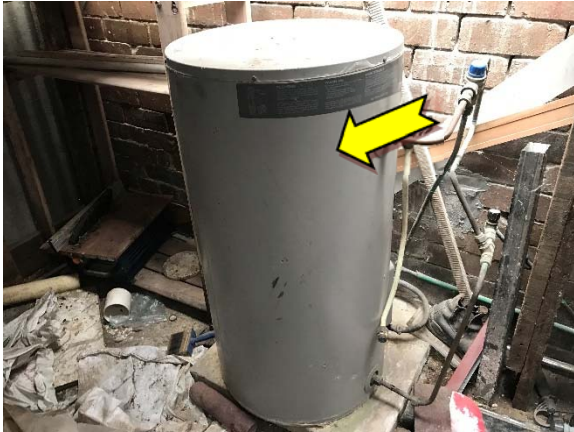
Interior	Bathroom, throughout	Wall panels	Fibre cement sheeting	Asbestos	57722-170-006	Positive	Non-friable	Low	Good	Low	20 m ²	Maintain in current condition if to remain in-situ. Remove under controlled non-friable asbestos removal conditions prior to refurbishment or demolition works by a Class B (non-friable) licensed asbestos removal contractor.	P4	Mar-23	5
Interior	Room 4, north-eastern corner	Wall panels	Fibre cement sheeting	Asbestos	57722-170-007	Positive	Non-friable	Low	Good	Low	6 m ²	Maintain in current condition if to remain in-situ. Remove under controlled non-friable asbestos removal conditions prior to refurbishment or demolition works by a Class B (non-friable) licensed asbestos removal contractor.	P4	Mar-23	6
Exterior	Eastern elevation	Hot water heater	Insulation material - internal	SMF	-	Suspected Positive	Non-friable	Low	Good	Low	1 unit	Maintain in current condition if to remain in-situ. Remove under controlled SMF conditions as per the Code of Practice for the Safe Use of Synthetic Mineral Fibres [NOHSC: 2006 (1990)].	-	-	7

Photo 7. Exterior, eastern elevation, hot water heater – suspected SMF internal insulation.

- SMF materials that are likely to be disturbed during any proposed demolition/refurbishment works should be handled in accordance with the *Code of Practice for the Safe Use of Synthetic Mineral Fibres* [NOHSC:2006(1990)]. If these materials are impacted upon by accident or by pre-planned works, the Inner West Council must be informed via the contact detailed within Section 7: *Accidental Disturbance of Known or Suspected Hazardous Building Materials*. Following disturbance, inspection by a competent person should be undertaken.

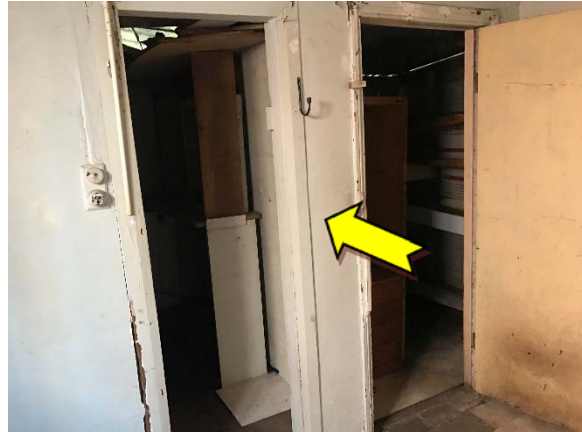
Area / Level	Room & Location	Feature	Item Description	Hazard Type	Sample No.	Sample Status	Friability	Disturb. Potential	Condition	Risk Status	Approx. Quantity	Recommendations & Comments	Control Priority	Reinspect Date	Photo No.
Exterior	Throughout	Brick wall	White - upper coloured paint system	Lead Paint - Swab	-	Suspected Positive	-	Low	Fair	Low	40 m ²	Confirm status by quantitative test method, maintain in current condition, over paint with a lead-free paint as part of ongoing maintenance. Remove under controlled conditions in accordance with AS 4361.2:2017 Guide to hazardous paint management prior to renovation or demolition works.	-	-	-
Interior	Throughout	Walls	White - upper coloured paint system	Lead Paint - Swab	-	Suspected Positive	-	Low	Good	Low	180 m ²	Confirm status by quantitative test method, maintain in current condition, over paint with a lead-free paint as part of ongoing maintenance. Remove under controlled conditions in accordance with AS 4361.2:2017 Guide to hazardous paint management prior to renovation or demolition works.	-	-	8

Photo 8. Interior, throughout, wall - suspected lead-containing white upper paint system.

- The *LeadCheck* paint swab method can detect lead in paint at concentrations of 0.5% and above, and may indicate lead in some paint films as low as 0.2%. As paint with a lead content greater than 0.1% by dry weight is now considered to be lead-containing, Prensa recommends confirming status of suspected LCP identified during the Assessment by quantitative test method.

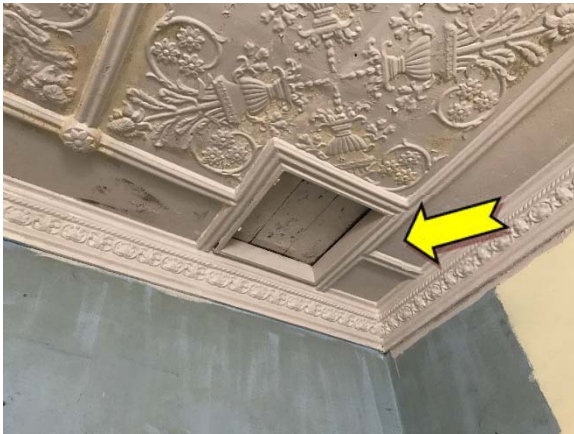
Interior	Throughout	Ceilings	White - upper coloured paint system	Lead Paint - Swab	-	Suspected Positive	-	Low	Good	Low	100 m ²	Confirm status by quantitative test method, maintain in current condition, over paint with a lead-free paint as part of ongoing maintenance. Remove under controlled conditions in accordance with AS 4361.2:2017 Guide to hazardous paint management prior to renovation or demolition works.	-	-	9
Interior	Throughout	Door frames	Pink (dark) - upper coloured paint system	Lead Paint - Swab	-	Suspected Positive	-	Low	Good	Low	30 m ²	Confirm status by quantitative test method, maintain in current condition, over paint with a lead-free paint as part of ongoing maintenance. Remove under controlled conditions in accordance with AS 4361.2:2017 Guide to hazardous paint management prior to renovation or demolition works.	-	-	-

Photo 9. Interior, throughout, ceiling - suspected lead-containing white upper paint system.
