Hazardous Building Materials Assessment

Marrickville Legal Centre

338 Illawarra Road
Marrickville NSW 2204

Inner West Council
April 2018

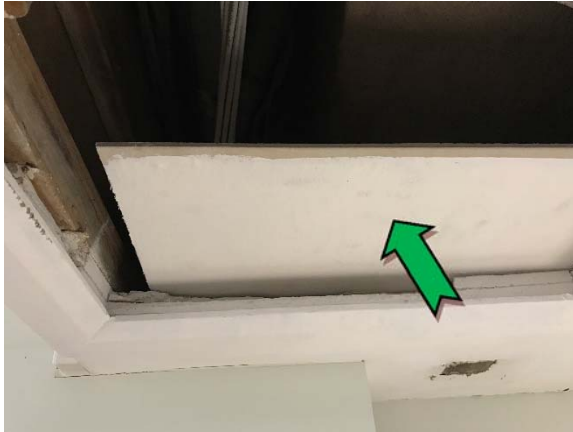
Photo 1. Interior, ground level, open plan office, ceiling access hatch – non asbestos-containing fibre cement sheeting.

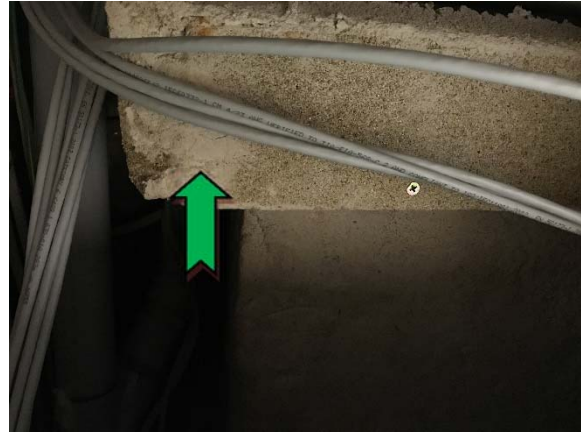
Photo 2. Interior, ground level, open plan office, ceiling access hatch – non asbestos-containing vermiculite.

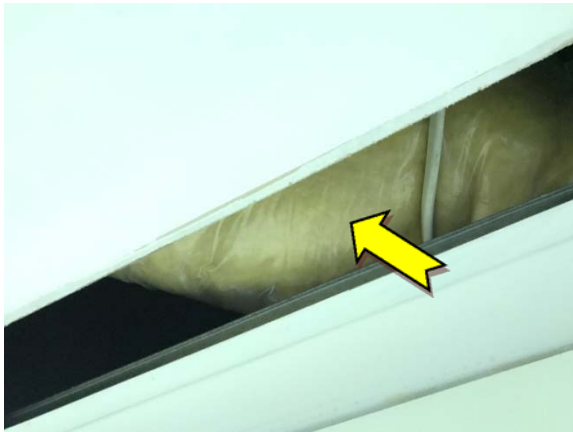
Photo 3. Interior, ground level, throughout above suspended ceiling – suspected SMF sarking insulation.

- Suspected SMF sarking insulation was located above suspended ceiling throughout the site.

- SMF materials that are likely to be disturbed during any proposed demolition/refurbishment works should be handled in accordance with the *Code of Practice for the Safe Use of Synthetic Mineral Fibres* [NOHSC:2006(1990)]. If these materials are impacted upon by accident or by pre-planned works, the Inner West Council must be informed via the contact detailed within Section 7: *Accidental Disturbance of Known or Suspected Hazardous Building Materials*. Following disturbance, inspection by a competent person should be undertaken.
