Hazardous Building Materials Assessment

Debbie & Abbey Borgia Centre

531-565 Illawarra Road
Marrickville, NSW 2204

Inner West Council
April 2018

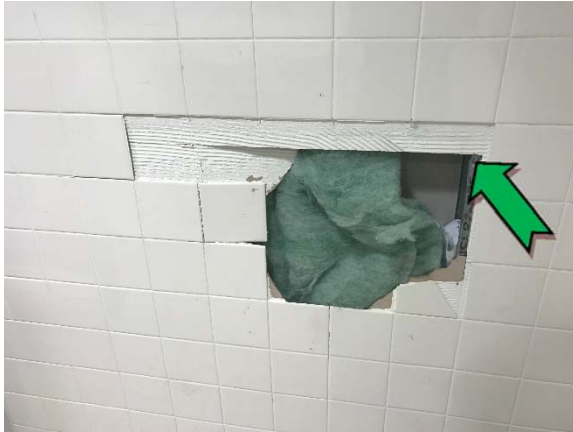
Photo 1. Interior, level 1, male and female toilets, wall lining – non asbestos-containing fibre cement sheeting.

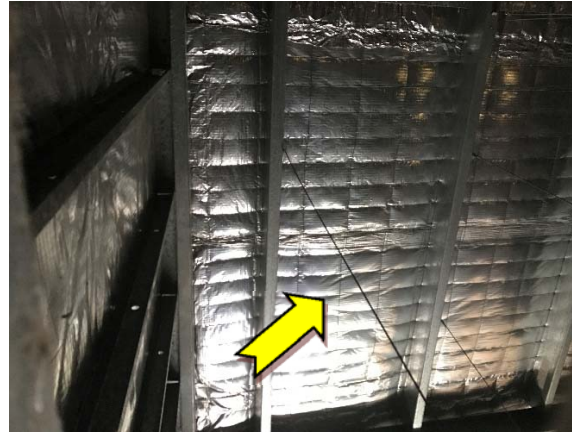
Photo 2. Interior, throughout, above suspended ceiling, sarking insulation – suspected SMF insulation.

- Suspected SMF in the form of sarking insulation above suspended ceiling throughout the building; and
- Suspected SMF internal insulation located within hot water heaters to the level 1 kitchen.

- SMF materials that are likely to be disturbed during any proposed demolition/refurbishment works should be handled in accordance with the *Code of Practice for the Safe Use of Synthetic Mineral Fibres* [NOHSC:2006(1990)]. If these materials are impacted upon by accident or by pre-planned works, the Inner West Council must be informed via the contact detailed within Section 7: *Accidental Disturbance of Known or Suspected Hazardous Building Materials*. Following disturbance, inspection by a competent person should be undertaken.

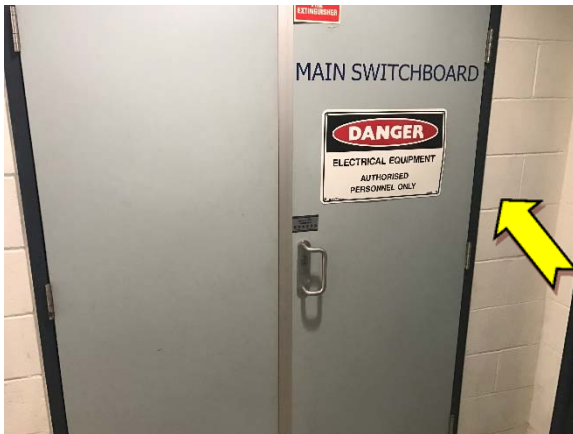
Photo 3. Interior, throughout (except courts), walls – suspected lead-containing white upper paint system.

- LCP was identified in white coloured upper paint systems to walls and ceilings throughout site with the exception of the courts.

- The *LeadCheck* paint swab method can detect lead in paint at concentrations of 0.5% and above, and may indicate lead in some paint films as low as 0.2%. As paint with a lead content greater than 0.1% by dry weight is now considered to be lead-containing, Prensa recommends confirming status of suspected LCP identified during the Assessment by quantitative test method.

- The safest method of dealing with LCP is to replace or remove the items in their entirety that have LCP on them and replace them with new items that do not contain lead. This allows the items to be disposed of as regular building or demolition unsegregated waste in accordance with the NSW Environment Protection Authority (EPA) *Waste Classification Guidelines 2014 Part 1 – Classifying Waste*. The advantage of this method is the reduction in labour requirements to remove the lead paint and also this reduces the risk to workers from exposure to lead dust or fumes. If the removal of the LCP or coatings is the preferred or required option this may generate significant amounts of potential hazardous waste. This waste must be removed, collected and disposed of by an appropriately licensed contractor under controlled conditions that minimises the release to air, water and soil. Disposal of lead waste must be disposed of as hazardous waste at an approved waste facility.

- Advise all relevant site personnel and site contractors of the results of the LCP and the safe work procedures required and/or work practices to be avoided in the areas of confirmed LCP.

- Any remediation works that may generate dust or fumes (i.e. sanding, burning) must be performed under controlled conditions by a suitably resourced and experienced hazardous material/waste abatement contractor (e.g. a Class A licensed asbestos removal contractor).
