Hazardous Building Materials Assessment HJ Mahoney Memorial Reserve 531-565 Illawarra Road Marrickville NSW 2204

Inner West Council
April 2018

Job No.: 57722-123

Count ID: CID: 155

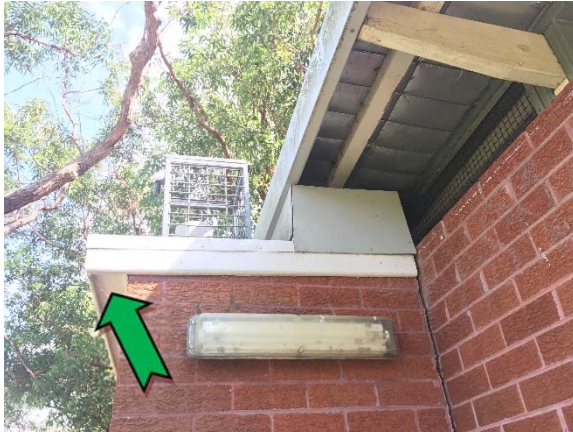
Photo 1. Exterior, throughout, eaves – non asbestos-containing fibre cement sheeting.

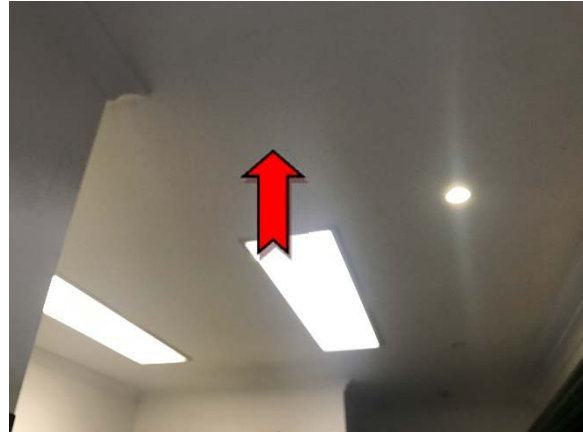
Photo 2. Interior, ground level, kiosk, ceiling – non asbestos-containing fibre cement sheeting.

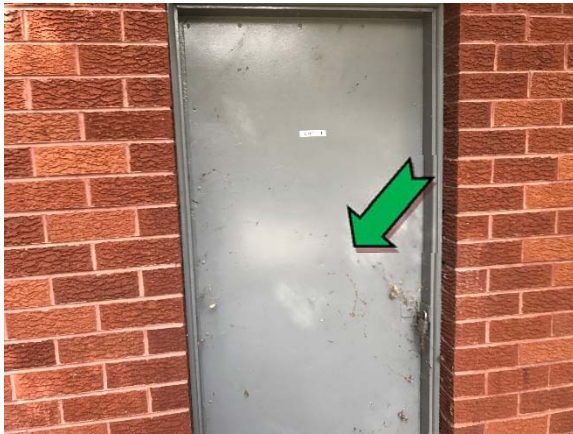
Exterior	Throughout	Door frames	Grey - upper coloured paint system	Lead Paint - Swab	-	Suspected Positive	-	Low	Good	Low	100 m ²	Confirm status by quantitative test method, maintain in current condition, over paint with a lead-free paint as part of ongoing maintenance. Remove under controlled conditions in accordance with AS 4361.2:2017 Guide to hazardous paint management prior to renovation or demolition works.	-	-	3
Interior	Kiosk	Walls	White - upper coloured paint system	Lead Paint - Swab	-	Suspected Positive	-	Low	Good	Low	20 m ²	Confirm status by quantitative test method, maintain in current condition, over paint with a lead-free paint as part of ongoing maintenance. Remove under controlled conditions in accordance with AS 4361.2:2017 Guide to hazardous paint management prior to renovation or demolition works.	-	-	-
Interior	Kiosk	Ceiling	White - upper coloured paint system	Lead Paint - Swab	-	Suspected Positive	-	Low	Good	Low	10 m ²	Confirm status by quantitative test method, maintain in current condition, over paint with a lead-free paint as part of ongoing maintenance. Remove under controlled conditions in accordance with AS 4361.2:2017 Guide to hazardous paint management prior to renovation or demolition works.	-	-	-

Photo 3. Exterior, throughout, door frames – suspected lead-containing white upper paint system.

- LCP was identified in white and grey coloured upper paint systems throughout the building.

- The safest method of dealing with LCP is to replace or remove the items in their entirety that have LCP on them and replace them with new items that do not contain lead. This allows the items to be disposed of as regular building or demolition unsegregated waste in accordance with the NSW Environment Protection Authority (EPA) *Waste Classification Guidelines 2014 Part 1 – Classifying Waste*. The advantage of this method is the reduction in labour requirements to remove the lead paint and also this reduces the risk to workers from exposure to lead dust or fumes. If the removal of the LCP or coatings is the preferred or required option this may generate significant amounts of potential hazardous waste. This waste must be removed, collected and disposed of by an appropriately licensed contractor under controlled conditions that minimises the release to air, water and soil. Disposal of lead waste must be disposed of as hazardous waste at an approved waste facility.

- Advise all relevant site personnel and site contractors of the results of the LCP and the safe work procedures required and/or work practices to be avoided in the areas of confirmed LCP.

- Any remediation works that may generate dust or fumes (i.e. sanding, burning) must be performed under controlled conditions by a suitably resourced and experienced hazardous material/waste abatement contractor (e.g. a Class A licensed asbestos removal contractor).
