# Hazardous Building Materials Assessment

## Steel Park Groundsmans Shed

531-565 Illawarra Road  
Marrickville NSW 2204

Inner West Council  
April 2018

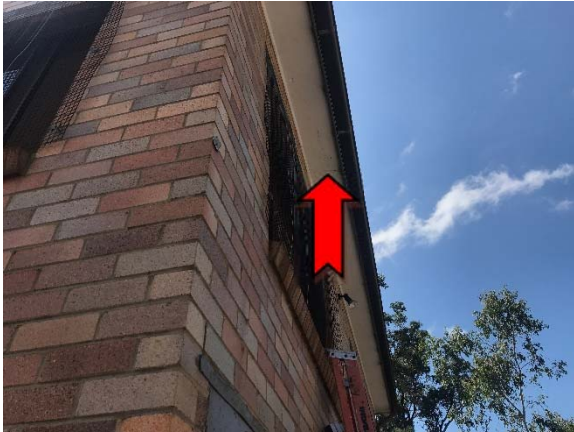
**Photo 1.** Exterior, throughout, eaves – suspected asbestos-containing fibre cement sheeting.

- Non-friable asbestos was suspected in the form of fibre cement sheeting to eaves to the exterior of the northern elevation of the building.

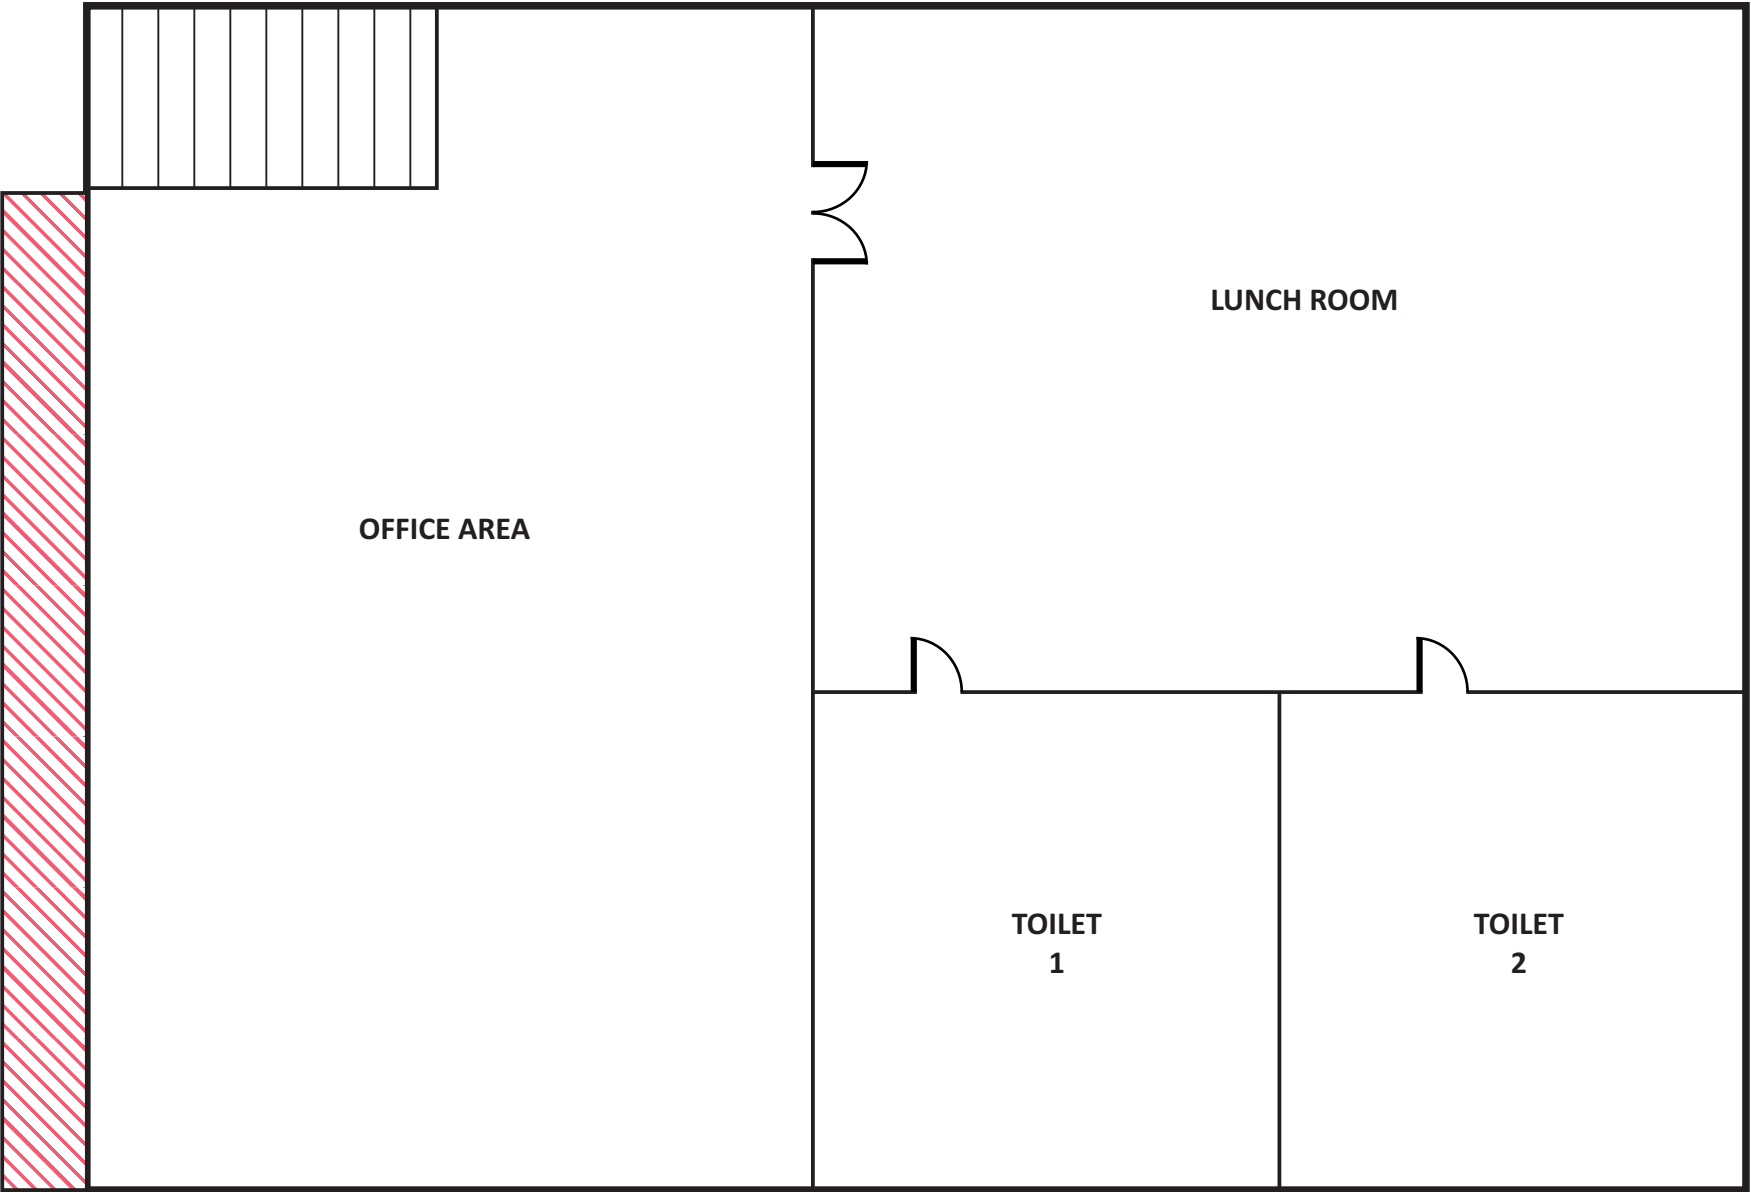
# Steel Park Groundsmans Shed Marrickville - Level 1

Eaves
