Hazardous Building Materials Assessment

Plum Tree

Jarvie Park, Malakoff Street

Inner West Council
April 2018

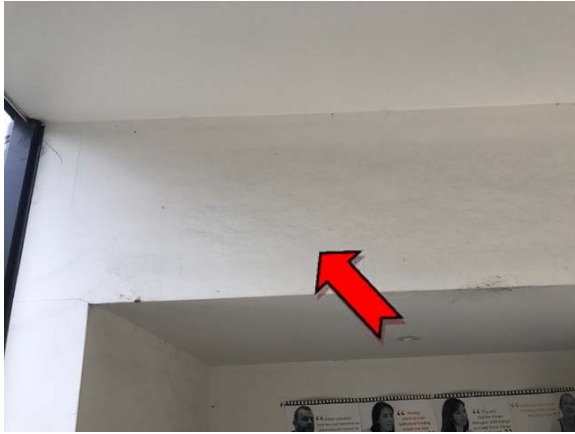
Photo 1. Exterior, northern elevation, walls – non asbestos-containing fibre cement sheeting.

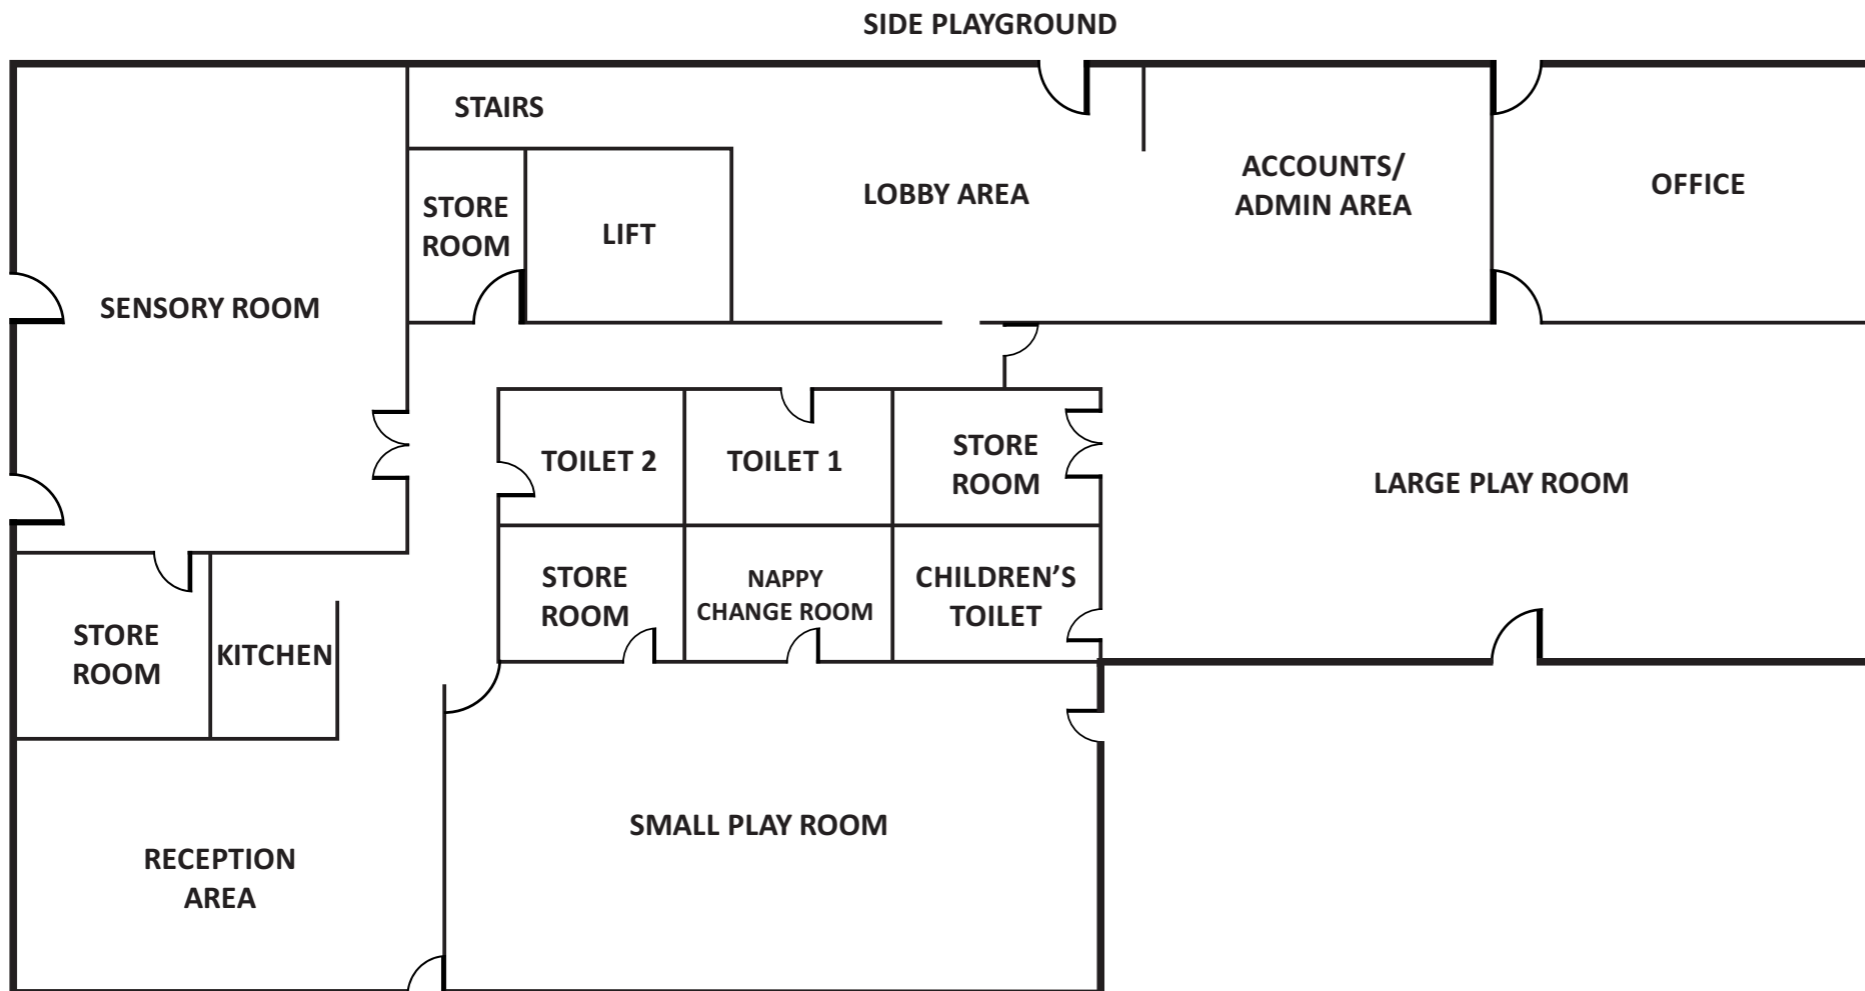
Plum Tree, Marrickville - Ground Level

57722-128-001
