Hazardous Building Materials Assessment

McNeilly Girl Guides Hall

Jersey Street
Marrickville NSW 2204

Inner West Council
April 2018

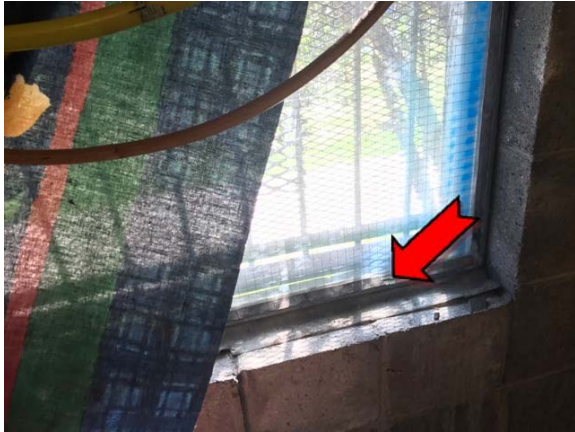
Photo Interior, throughout, window frames –
1. asbestos-containing caulking material.

- Non-friable asbestos was identified in the form of window caulking to the interior window frames throughout the building.
