Hazardous Building Materials Assessment

McNeilly Park Toilets

Jersey Street

Inner West Council
April 2018

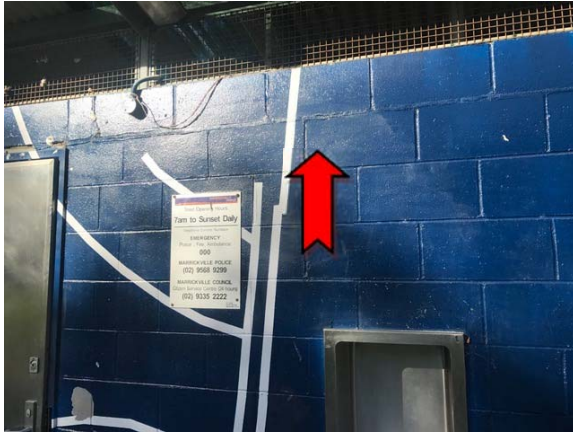
Photo 1. Exterior, throughout, walls - suspected lead-containing blue upper paint system.

- LCP was suspected in the form of white and blue upper coloured paint systems throughout the exterior and interior of the site.

- The safest method of dealing with LCP is to replace or remove the items in their entirety that have LCP on them and replace them with new items that do not contain lead. This allows the items to be disposed of as regular building or demolition unsegregated waste in accordance with the NSW Environment Protection Authority (EPA) *Waste Classification Guidelines 2014 Part 1 – Classifying Waste*. The advantage of this method is the reduction in labour requirements to remove the lead paint and also this reduces the risk to workers from exposure to lead dust or fumes. If the removal of the LCP or coatings is the preferred or required option this may generate significant amounts of potential hazardous waste. This waste must be removed, collected and disposed of by an appropriately licensed contractor under controlled conditions that minimises the release to air, water and soil. Disposal of lead waste must be disposed of as hazardous waste at an approved waste facility.

- Advise all relevant site personnel and site contractors of the results of the LCP and the safe work procedures required and/or work practices to be avoided in the areas of confirmed LCP.

- Any remediation works that may generate dust or fumes (i.e. sanding, burning) must be performed under controlled conditions by a suitably resourced and experienced hazardous material/waste abatement contractor (e.g. a Class A licensed asbestos removal contractor).

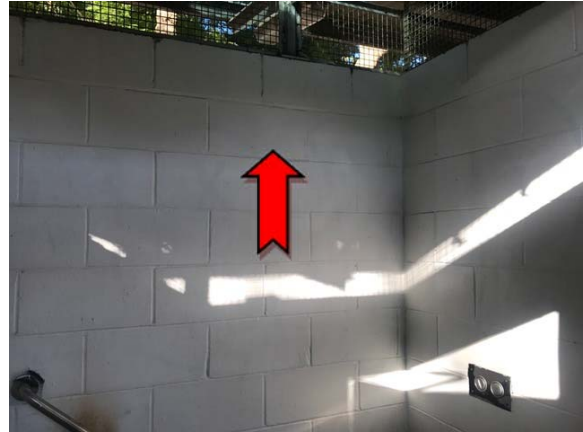
Interior	Throughout	Walls	White - upper coloured paint system	Lead Paint - Swab	-	-	-	Low	Good	Low	20 m ²	Confirm status by quantitative test method, maintain in current condition, over paint with a lead-free paint as part of ongoing maintenance. Remove under controlled conditions in accordance with AS 4361.2:2017 Guide to hazardous paint management prior to renovation or demolition works.	-	-	2
Throughout	-	-	-	Ozone Depleting Substances	-	-	-	-	-	-	-	No suspect ODS's identified at the time of the assessment.	-	-	-

Photo 2. Interior, throughout, walls - suspected lead-containing white upper paint system.
