Hazardous Building Materials Assessment Marrickville Park Tennis Club Livingstone Road Marrickville NSW 2204

Inner West Council
April 2018

Job No.: 57722-133

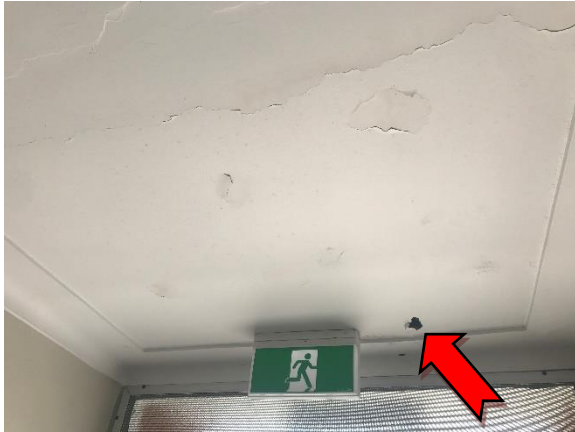
Photo 1. Interior, corridor, original ceiling above plasterboard ceiling – asbestos-containing fibre cement sheeting.

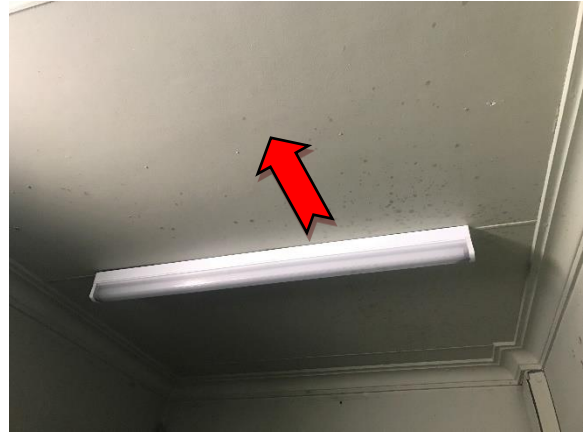
Photo 2. Interior, store 3, ceiling – asbestos-containing fibre cement sheeting.

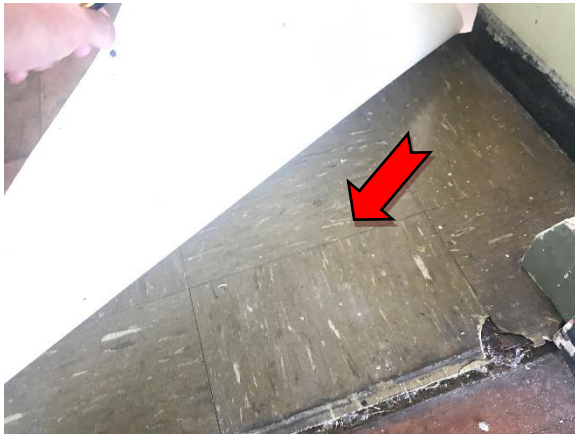
Photo 3. Interior, kitchen, floor coverings – asbestos-containing vinyl floor tiles.

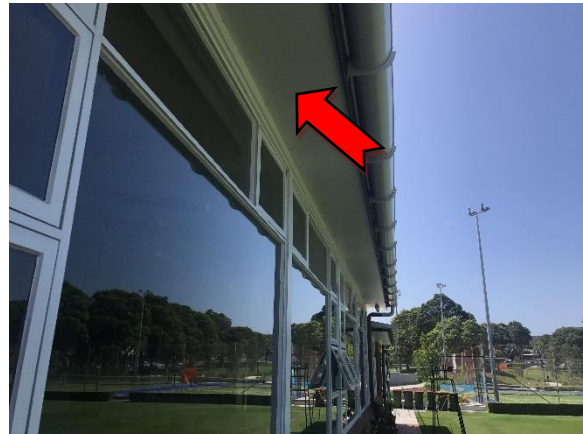
Photo 4. Exterior, throughout, eaves – suspected asbestos-containing fibre cement sheeting.

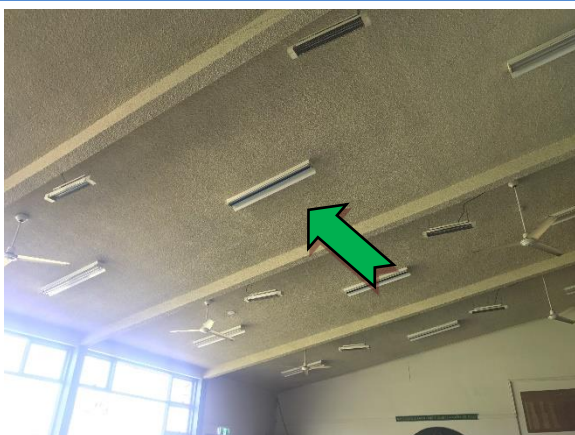
Photo 5. Interior, ground level, club house, ceiling coating – non asbestos-containing vermiculite.

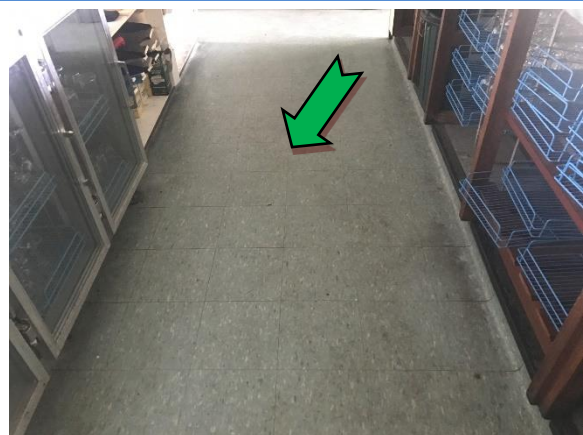
Photo 6. Interior, club house, floor coverings – non asbestos-containing vinyl floor tiles.
