Hazardous Building Materials Assessment Marrickville Crusader Kindergarten 53 Malakoff Street Marrickville NSW 2204

Inner West Council
April 2018

Job No.: 57722-129

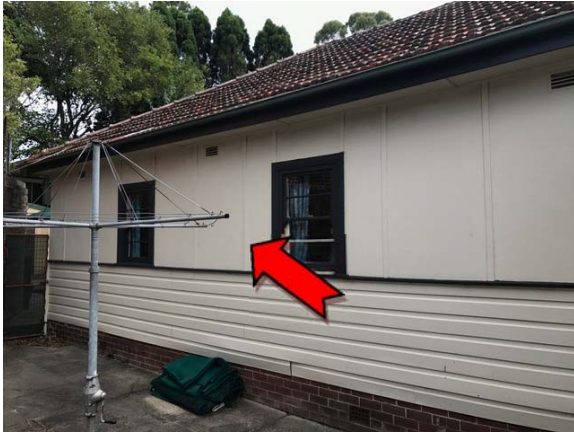
Photo 1. Exterior, throughout, wall paneling – asbestos-containing fibre cement sheeting.

- Non-friable asbestos was identified in the form of fibre cement sheeting wall panels and eaves throughout the exterior of the building.
- Non-friable asbestos was identified in the form of vinyl floor tiles to the southern storeroom.

Area / Level	Room & Location	Feature	Item Description	Hazard Type	Sample No.	Sample Status	Friability	Disturb. Potential	Condition	Risk Status	Approx. Quantity	Recommendations & Comments	Control Priority	Reinspect Date	Photo No.
Exterior	Throughout	Wall panelling	Fibre cement sheeting	Asbestos	57722-129-001	Positive	Non-friable	Low	Fair	Low	80 m ²	Label as containing asbestos and maintain in current condition if to remain in-situ. Remove under controlled non-friable asbestos removal conditions prior to refurbishment or demolition works by a Class B (non-friable) licensed asbestos removal contractor.	P4	Mar-23	1
Exterior	Throughout	Eaves	Fibre cement sheeting	Asbestos	57722-129-002	Positive	Non-friable	Low	Good	Low	40 m ²	Label as containing asbestos and maintain in current condition if to remain in-situ. Remove under controlled non-friable asbestos removal conditions prior to refurbishment or demolition works by a Class B (non-friable) licensed asbestos removal contractor.	P4	Mar-23	2

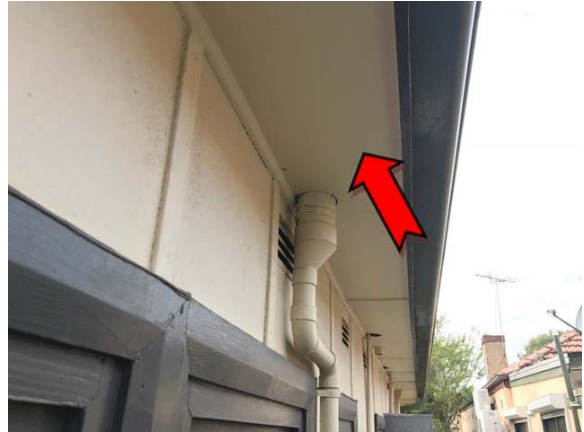
Photo 2. Exterior, throughout, eaves – asbestos-containing fibre cement sheeting.

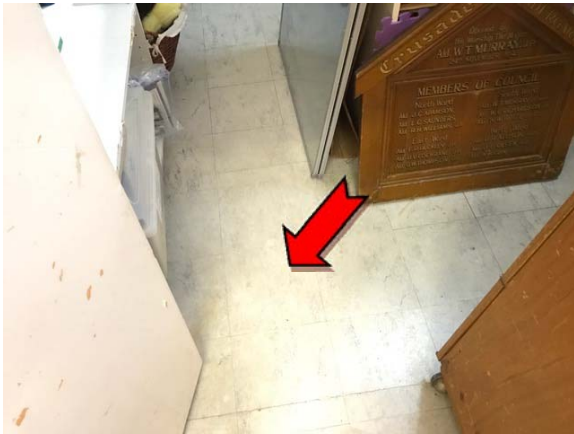
Interior	Southern storeroom	Floor coverings	Vinyl floor tiles	Asbestos	57722-129-003A	Positive	Non-friable	Low	Fair	Low	20 m ²	Label as containing asbestos and maintain in current condition if to remain in-situ. Remove under controlled non-friable asbestos removal conditions prior to refurbishment or demolition works by a Class B (non-friable) licensed asbestos removal contractor.	P4	Mar-23	3
Interior	Southern storeroom	Floor coverings	Adhesive	Asbestos	57722-129-003B	Negative	-	-	-	-	20 m ²	-	-	-	-
Throughout	-	-	-	SMF	-	-	-	-	-	-	-	No suspect SMF material identified at the time of the assessment.	-	-	-
Throughout	-	-	-	PCBs	-	-	-	-	-	-	-	No suspect PCB-containing capacitors identified at the time of the assessment.	-	-	-
Exterior	Throughout	Wall panelling	Beige - lower coloured paint system	Lead Paint - Swab	-	Suspected Positive	-	Low	Good	Low	200 m ²	Confirm status by quantitative test method, maintain in current condition, over paint with a lead-free paint as part of ongoing maintenance. Remove under controlled conditions in accordance with AS 4361.2:2017 Guide to hazardous paint management prior to renovation or demolition works.	-	-	-

Photo 3. Interior, ground level, southern store room, floor coverings – asbestos-containing vinyl floor tiles.

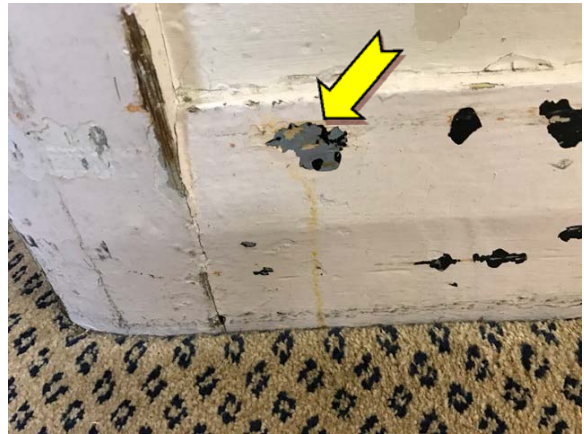
Interior	Southern corridor	Skirting boards	Beige - lower coloured paint system	Lead Paint - Swab	-	Suspected Positive	-	Low	Good	Low	20 m ²	Confirm status by quantitative test method, maintain in current condition, over paint with a lead-free paint as part of ongoing maintenance. Remove under controlled conditions in accordance with AS 4361.2:2017 Guide to hazardous paint management prior to renovation or demolition works.	-	-	4
Interior	Throughout	Walls	Beige - lower coloured paint system	Lead Paint - Swab	-	Suspected Positive	-	Low	Good	Low	200 m ²	Confirm status by quantitative test method, maintain in current condition, over paint with a lead-free paint as part of ongoing maintenance. Remove under controlled conditions in accordance with AS 4361.2:2017 Guide to hazardous paint management prior to renovation or demolition works.	-	-	-
Interior	Throughout	Ceiling	White - lower coloured paint system	Lead Paint - Swab	-	Suspected Positive	-	Low	Good	Low	200 m ²	Confirm status by quantitative test method, maintain in current condition, over paint with a lead-free paint as part of ongoing maintenance. Remove under controlled conditions in accordance with AS 4361.2:2017 Guide to hazardous paint management prior to renovation or demolition works.	-	-	-

Photo 4. Interior, ground level, southern corridor, skirting boards - suspected lead-containing green upper paint system.
