# Hazardous Building Materials Assessment

## Jarvie Park Youth Facility

Inner West Council  
April 2018

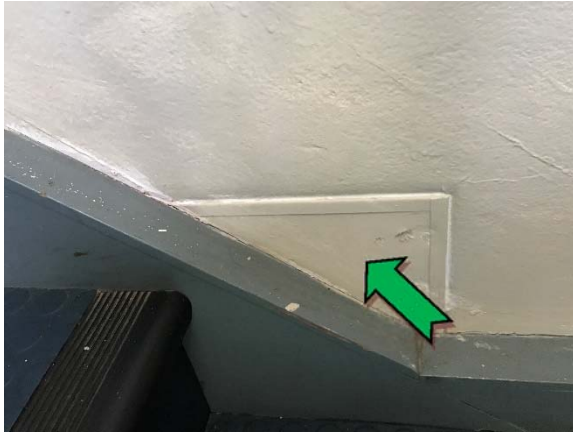
**Photo 1.** Interior, ground level, staircase, wall panels – non asbestos containing fibre cement sheeting.

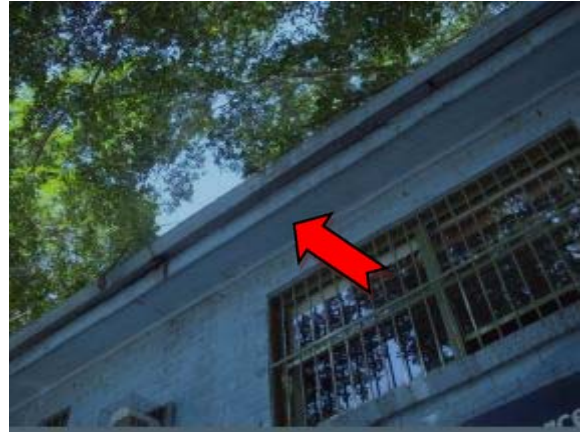
**Photo 2.** Exterior, north elevation, eaves – suspected asbestos-containing fibre cement sheeting.

- Non-friable asbestos was suspected in the form of fibre cement sheeting eaves to northern elevation of the building.

- When asbestos removal works are required, the person that commissions the works must ensure that this is undertaken by an appropriately licensed asbestos contractor. The asbestos removal works must be conducted under controlled asbestos removal working conditions.

- Most ACM were found not to be appropriately labelled. ACM on-site should be labelled in accordance with the relevant state / territory Legislation and AS 1319-1994 *Safety signs for the occupational environment* to warn of the dangers of disturbing these materials.

- Schedule periodic reassessment of ACM remaining on-site to monitor their aging/deterioration so that the site controller can be alerted if any ACM require encapsulation or removal – in accordance with the relevant state / territory Legislation and Codes of Practice.

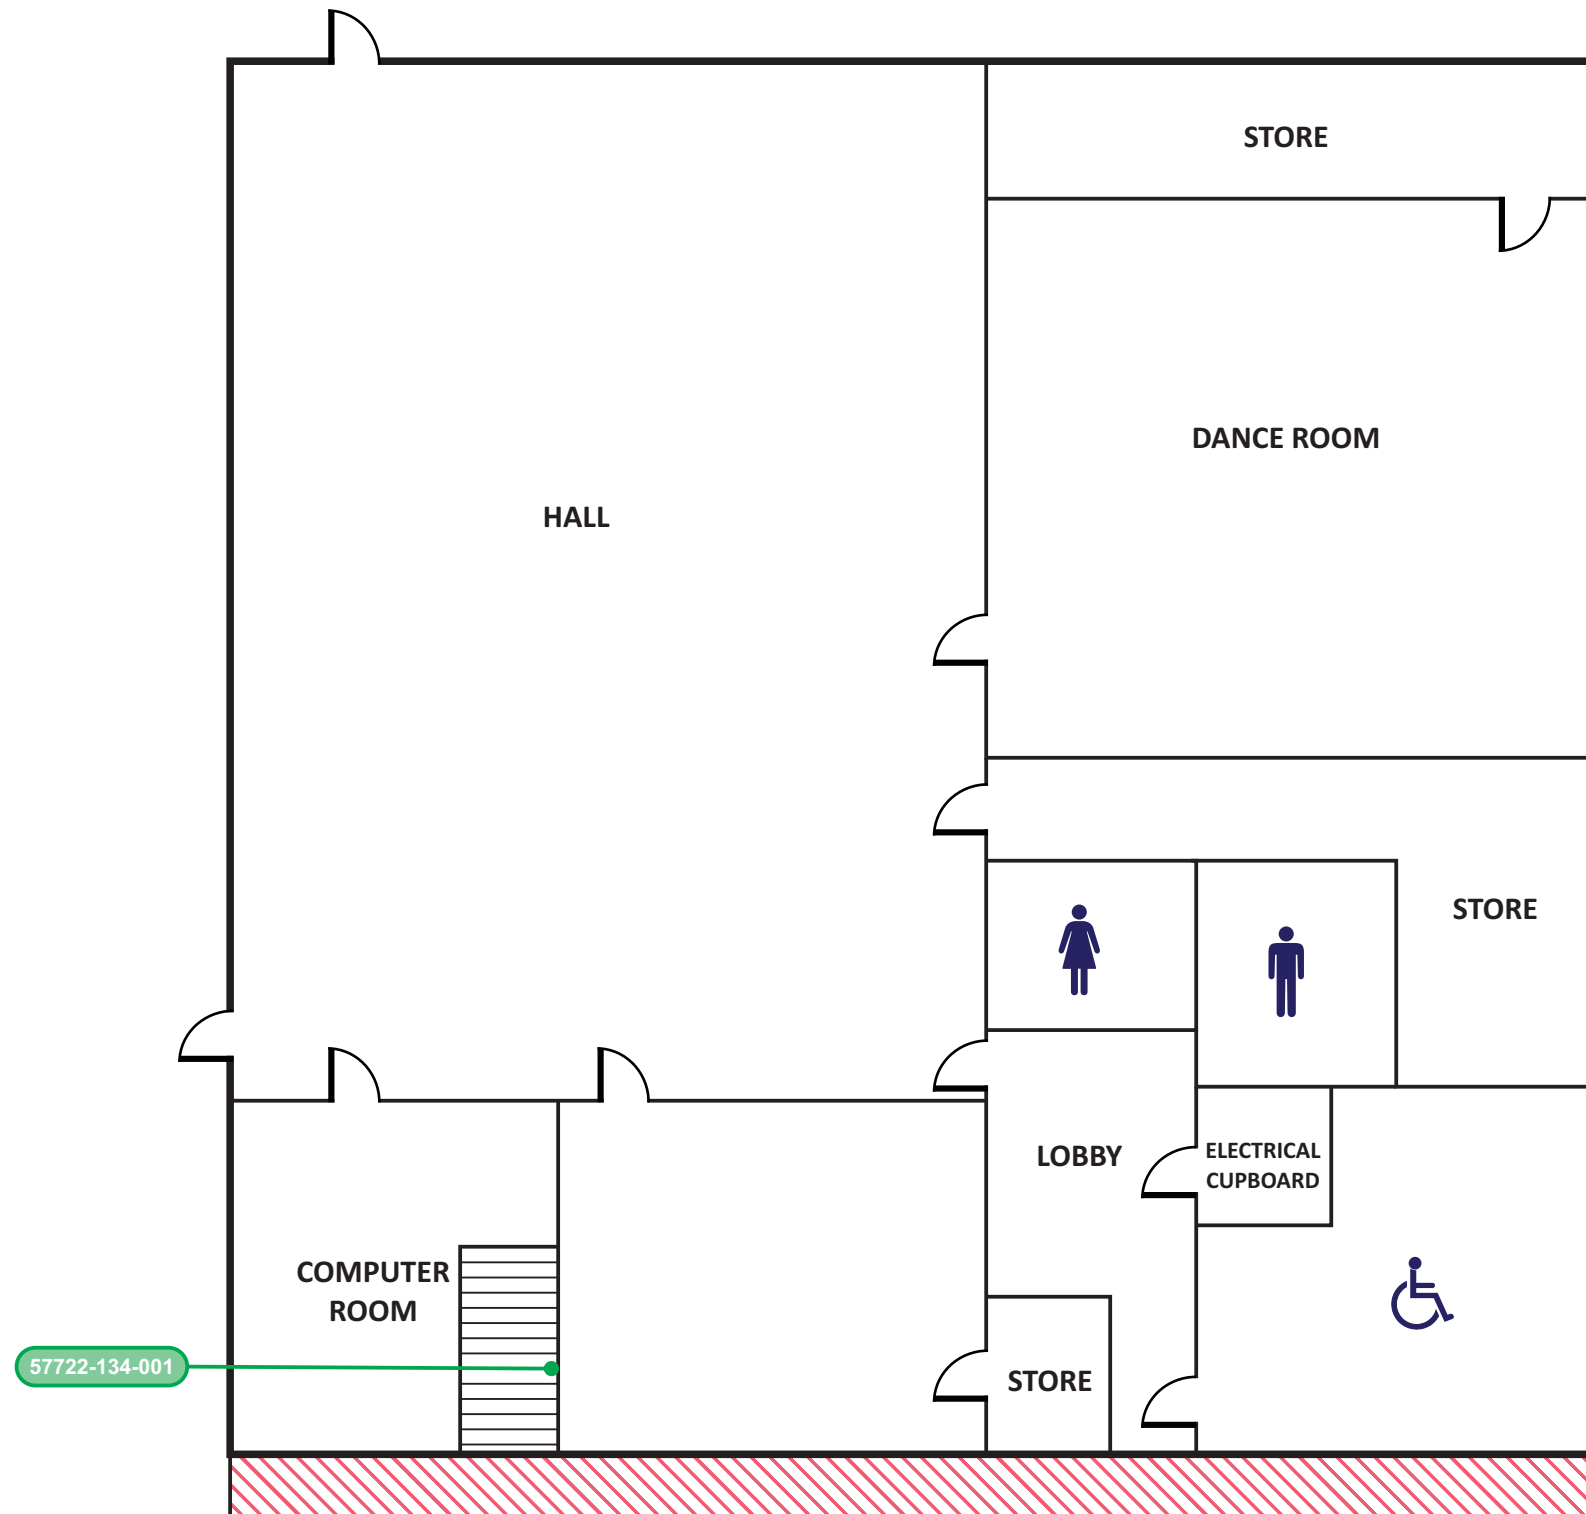
# Jarvie Park Youth Facility, Marrickville - Ground Level

Negative Asbestos Sample
	Eaves
