# Hazardous Building Materials Assessment Marrickville Town Hall Marrickville and Petersham Road Marrickville NSW 2204

Inner West Council  
April 2018

Job No.: 57722-132

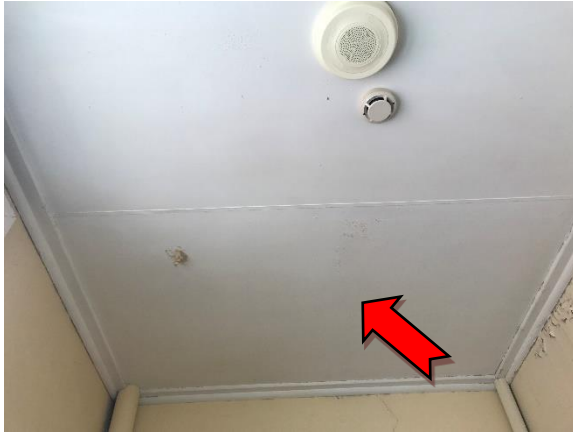
**Photo 1.** Interior, level 1, male bathroom, ceiling – asbestos-containing fibre cement sheeting.

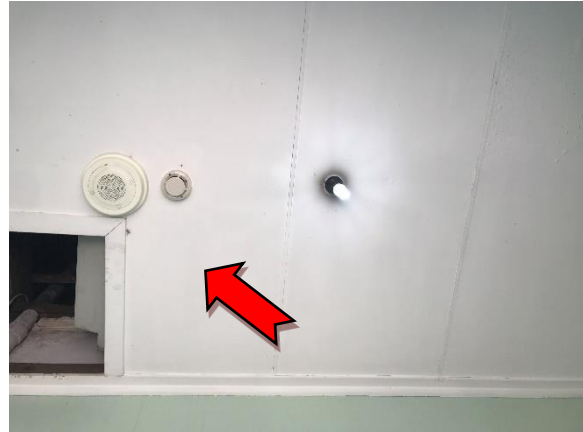
**Photo 2.** Interior, level 1, female bathroom, ceiling – asbestos-containing fibre cement sheeting.

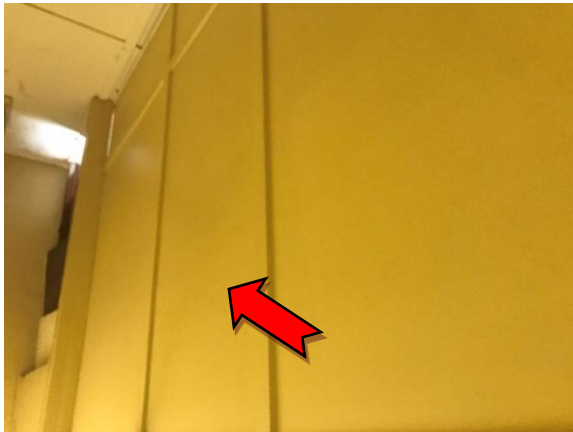
**Photo 3.** Interior, level 1, staircase, wall – asbestos-containing fibre cement sheeting.

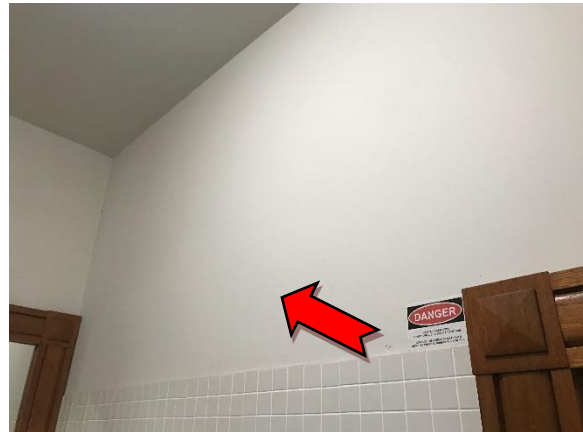
**Photo 4.** Interior, ground level, male change room – asbestos-containing fibre cement sheeting.

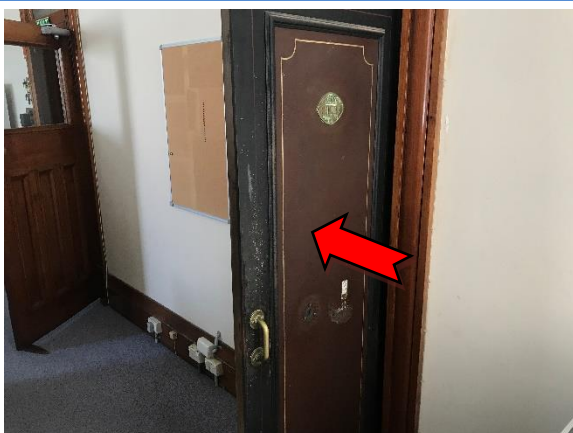
**Photo 5.** Interior, ground level, strong room, door – suspected asbestos-containing fibre cement sheeting.

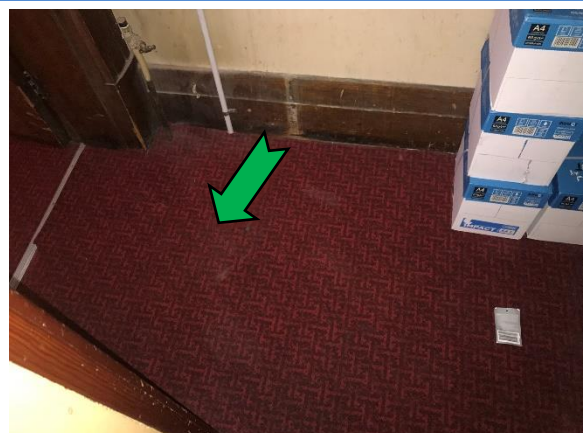
**Photo 6.** Interior, ground level, western stairs beneath carpet, debris – non asbestos-containing vinyl floor tiles.

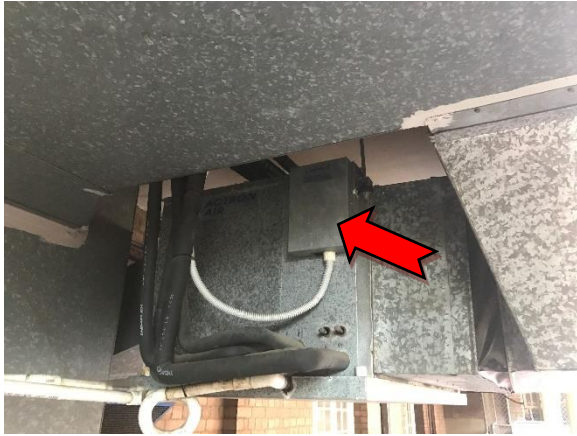
**Photo 7.** Exterior, western elevation, heater bank – suspected asbestos-containing millboard insulation.

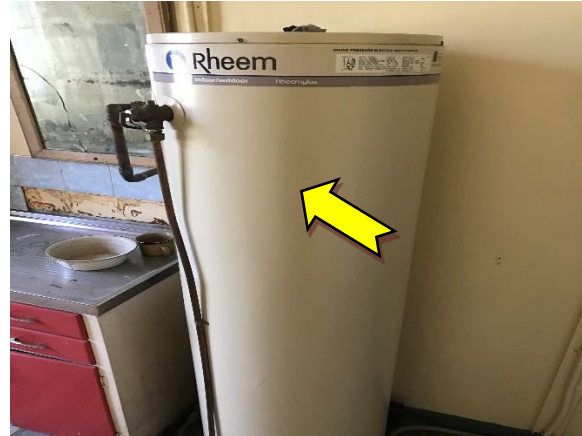
**Photo 8.** Interior, ground level, kitchen, hot water heater – suspected SMF internal insulation.

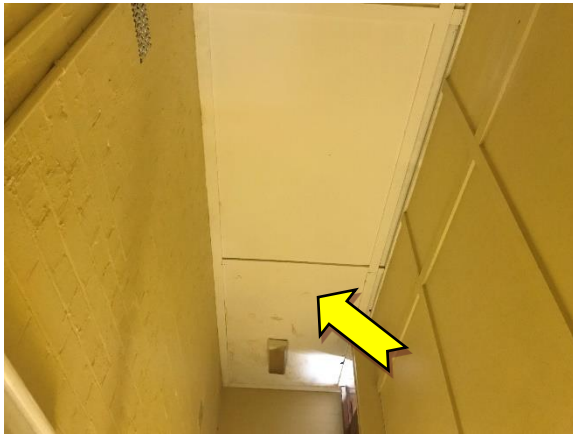
**Photo 9.** Interior, throughout, ceiling - suspected lead-containing white upper paint system.

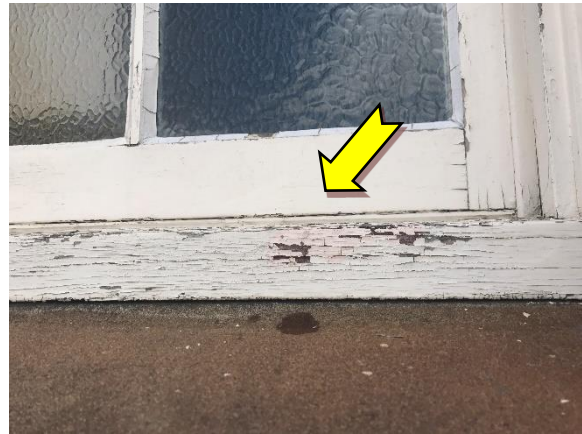
**Photo 10.** Exterior, throughout, window frames - suspected lead-containing white upper paint system.
