# Hazardous Building Materials Assessment

## Herb Greedy Hall

79 Petersham Road  
Marrickville NSW 2204

Inner West Council  
April 2018

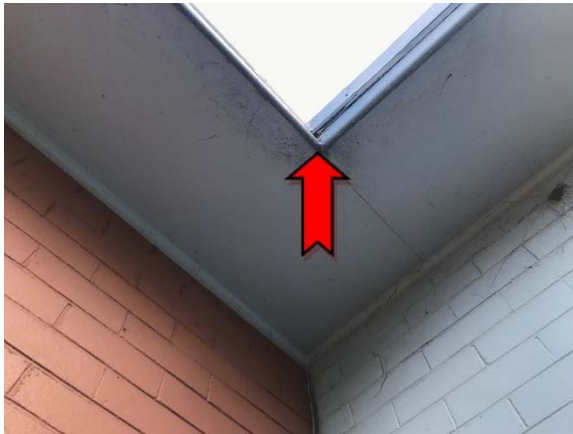
**Photo 1.** Exterior, throughout, eaves – asbestos-containing fibre cement sheeting.

- Non-friable asbestos was identified in the form of fibre cement sheeting eaves to the exterior of the building.

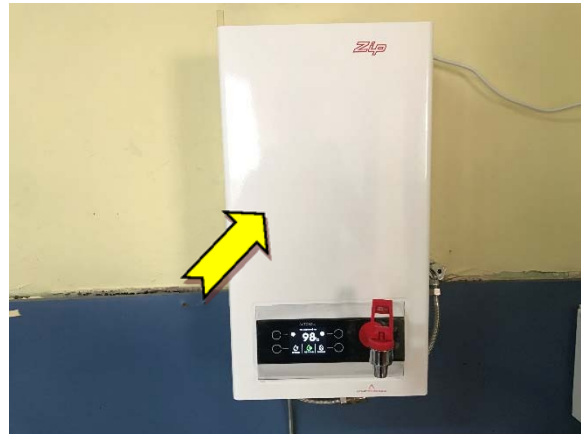
**Photo 2.** Interior, kitchen, hot water heater – suspected SMF internal insulation.

- Suspected SMF in the form of internal insulation within the hot water heater in the kitchen.

- SMF materials that are likely to be disturbed during any proposed demolition/refurbishment works should be handled in accordance with the *Code of Practice for the Safe Use of Synthetic Mineral Fibres* [NOHSC:2006(1990)]. If these materials are impacted upon by accident or by pre-planned works, the Inner West Council must be informed via the contact detailed within Section 7: *Accidental Disturbance of Known or Suspected Hazardous Building Materials*. Following disturbance, inspection by a competent person should be undertaken.

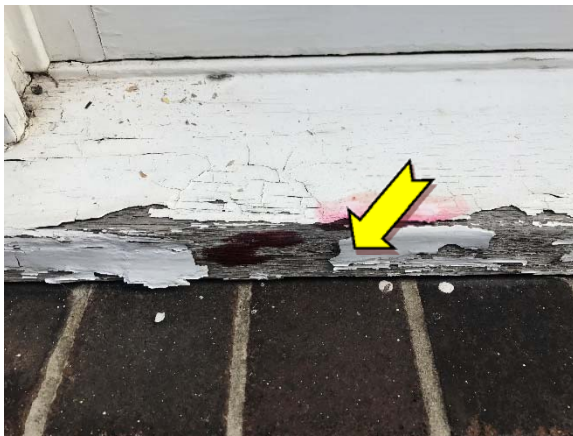
Throughout	-	-	-	PCBs	-	-	-	-	-	-	-	No suspect PCB-containing capacitors identified at the time of the assessment.	-	-	-
Exterior	Throughout	Window frames	White - upper coloured paint system	Lead Paint - Swab	-	Positive	-	Medium	Poor	Medium	10 m <sup>2</sup>	Remove flaking sections and over paint with a lead-free paint. Remove under controlled conditions in accordance with AS 4361.2:2017 Guide to hazardous paint management prior to renovation or demolition works.	-	-	3
Exterior	Throughout	Window frames	Blue (light) - upper coloured paint system	Lead Paint - Swab	-	Suspected Positive	-	Low	Good	Low	10 m <sup>2</sup>	Confirm status by quantitative test method, maintain in current condition, over paint with a lead-free paint as part of ongoing maintenance. Remove under controlled conditions in accordance with AS 4361.2:2017 Guide to hazardous paint management prior to renovation or demolition works.	-	-	-

**Photo 3.** Exterior, throughout, window frames – suspected lead-containing white upper paint system.

- Remove flaking lead containing paint to window surrounds throughout the property in accordance with AS4361.2-2017 Guide to Hazardous Paint Management and relevant legislation.

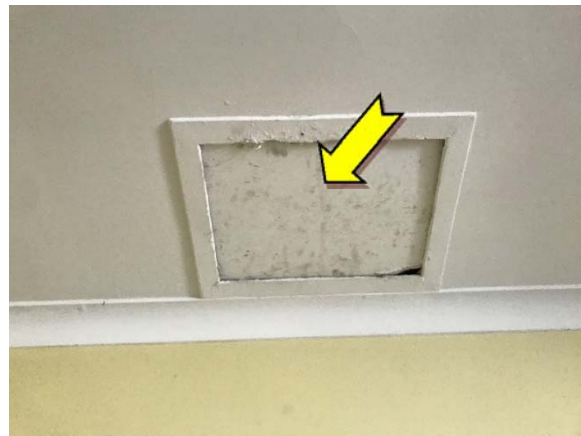
Interior	Throughout	Ceiling	White - upper coloured paint system	Lead Paint - Swab	-	Suspected Positive	-	Low	Good	Low	50 m <sup>2</sup>	Confirm status by quantitative test method, maintain in current condition, over paint with a lead-free paint as part of ongoing maintenance. Remove under controlled conditions in accordance with AS 4361.2:2017 Guide to hazardous paint management prior to renovation or demolition works.	-	-	4
Throughout	-	-	-	Ozone Depleting Substances	-	-	-	-	-	-	-	No suspect ODS's identified at the time of the assessment.	-	-	-

**Photo 4.** Interior, throughout, ceiling – suspected lead-containing white upper paint system.
