Hazardous Building Materials Assessment

May Murray Early Learning Centre

35 Premier Street
Marrickville NSW 2204

Inner West Council
April 2018

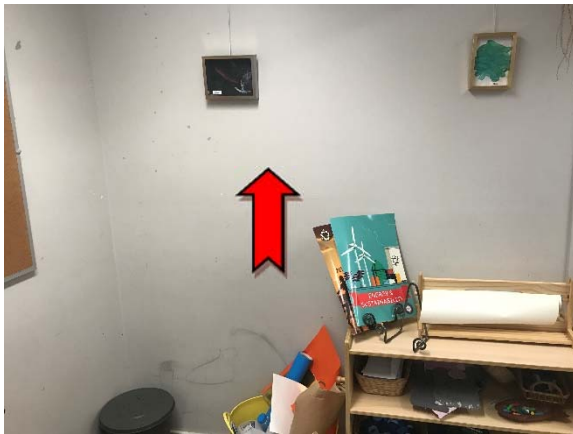
Interior, ground level	North eastern playroom	North wall panels	Fibre cement sheeting	Asbestos	57722-135-002	Positive	Non-friable	Low	Good	Low	12 m ²	Label as containing asbestos and maintain in current condition if to remain in-situ. Remove under controlled non-friable asbestos removal conditions prior to refurbishment or demolition works by a Class B (non-friable) licensed asbestos removal contractor.	P4	-	1
Interior, ground level	Laundry room	Ceiling	Fibre cement sheeting	Asbestos	Same as: 57722-135-001	Assumed Positive	Non-friable	Low	Good	Low	14 m ²	Label as containing asbestos and maintain in current condition if to remain in-situ. Remove under controlled non-friable asbestos removal conditions prior to refurbishment or demolition works by a Class B (non-friable) licensed asbestos removal contractor.	P4	-	2
Interior, ground level	Laundry room	Walls, throughout excluding partition	Fibre cement sheeting	Asbestos	Same as: 57722-135-002	Assumed Positive	Non-friable	Low	Good	Low	10 m ²	Label as containing asbestos and maintain in current condition if to remain in-situ. Remove under controlled non-friable asbestos removal conditions prior to refurbishment or demolition works by a Class B (non-friable) licensed asbestos removal contractor.	P4	-	3

Photo 1. Interior, ground level, north eastern playroom, northern wall panels – asbestos-containing fibre cement sheeting.

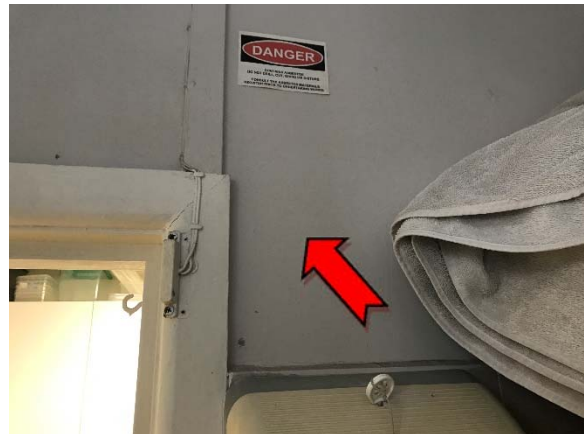
Photo 2. Interior, ground level, laundry room, wall – assumed asbestos-containing fibre cement sheeting.

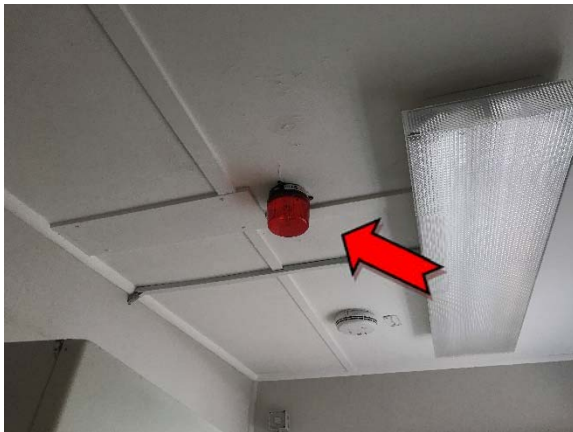
Photo 3. Interior, ground level, laundry room, ceiling – assumed asbestos-containing fibre cement sheeting.

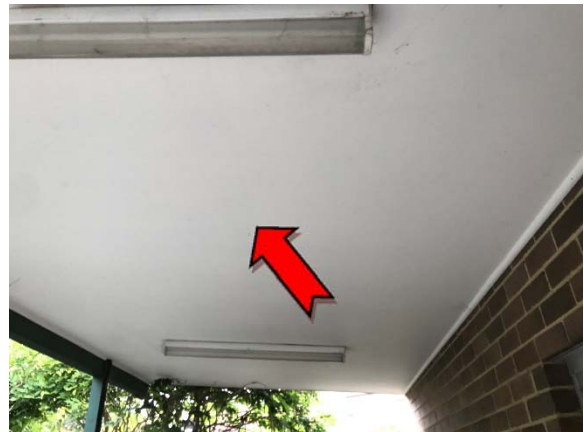
Photo 4. Exterior, rear verandah, awning – assumed asbestos-containing fibre cement sheeting.

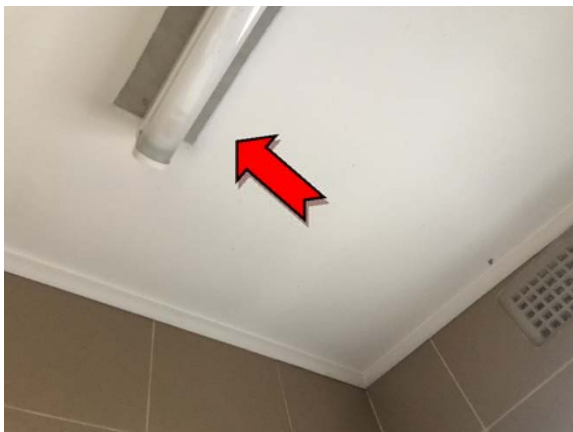
Photo 5. Interior, ground level, nappy change room, ceiling – assumed asbestos-containing fibre cement sheeting.

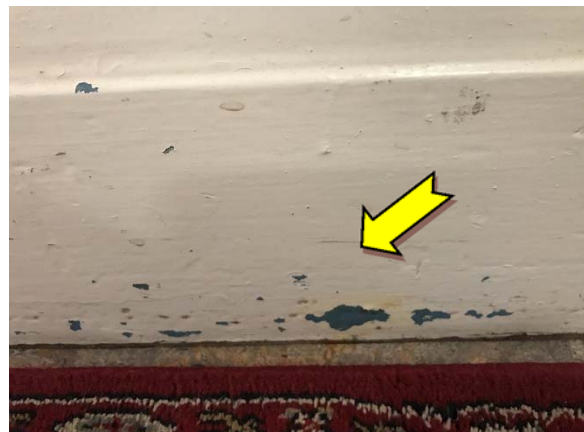
Interior	Ground floor, hall	Skirting board	Cream - upper coloured paint sytem	Lead Paint - Swab	-	Suspected Positive	-	Low	Fair	Low	20 m ²	Confirm status by quantitative test method, remove flaking sections and over paint with a lead-free paint. Remove under controlled conditions in accordance with AS 4361.2:2017 Guide to hazardous paint management prior to renovation or demolition works.	-	-	6
Throughout	-	-	-	Ozone Depleting Substances	-	-	-	-	-	-	-	No suspect ODS's identified at the time of the assessment.	-	-	-

Photo 6. Interior, throughout, skirting board – suspected lead-containing cream upper paint system.
