Hazardous Building Materials Assessment

Innari Housing

100A Silver Street

Inner West Council
April 2018

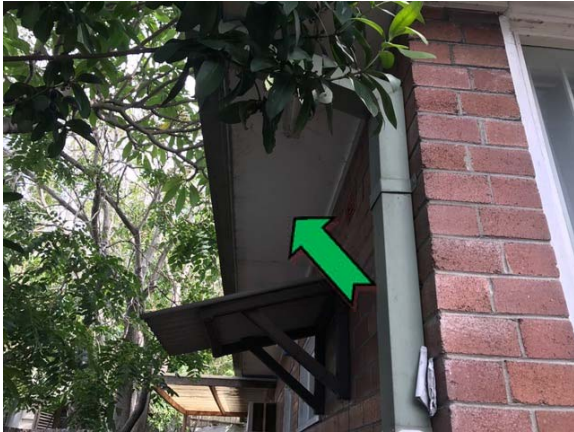
Photo 1. Exterior, throughout, eaves – non asbestos containing fibre cement sheeting.

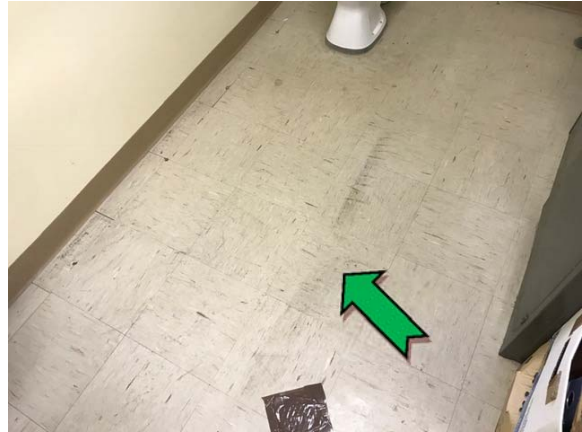
Photo 2. Interior, throughout, floor – non asbestos containing vinyl floor tiles.
