Hazardous Building Materials Assessment

Mackey Park Bowling Club

91 Sydenham Road
Marrickville NSW 2204

Inner West Council
April 2018

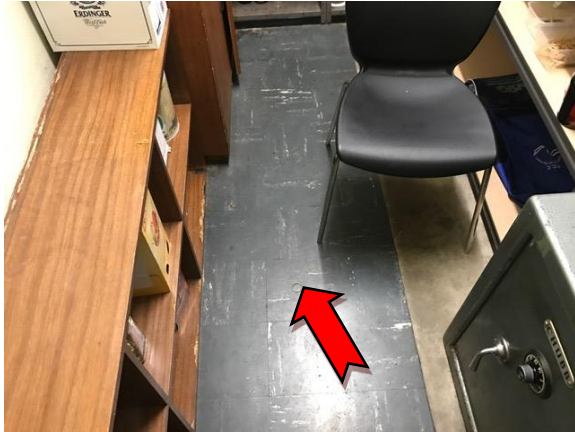
Photo 1. Interior, ground level, strong room, green floor covering – asbestos-containing vinyl floor tile.

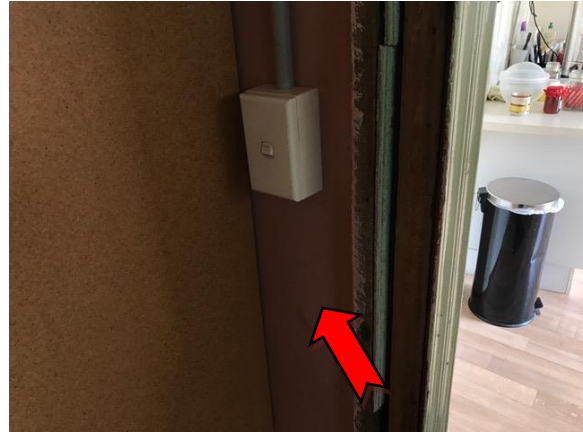
Photo 2. Interior, ground level, club room, wall lining – assumed asbestos-containing fibre cement sheeting

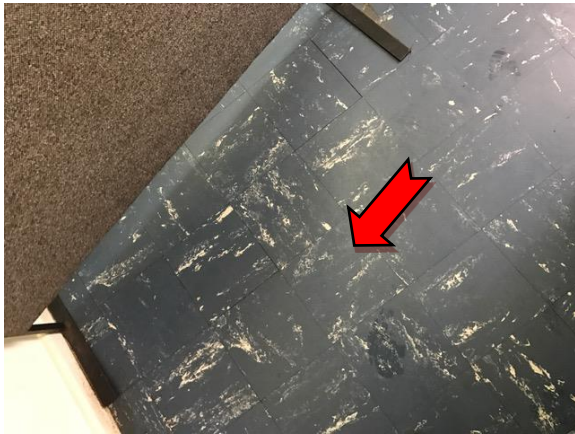
Photo 3. Interior, ground level, family room, blue floor covering – asbestos-containing vinyl floor tile.

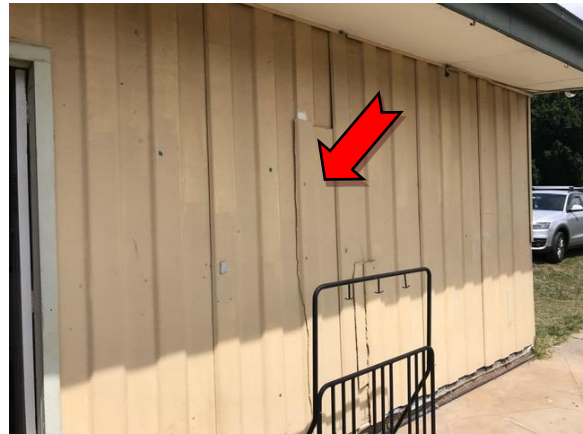
Photo 4. Exterior, croquet club, wall cladding – asbestos-containing fibre cement sheeting.

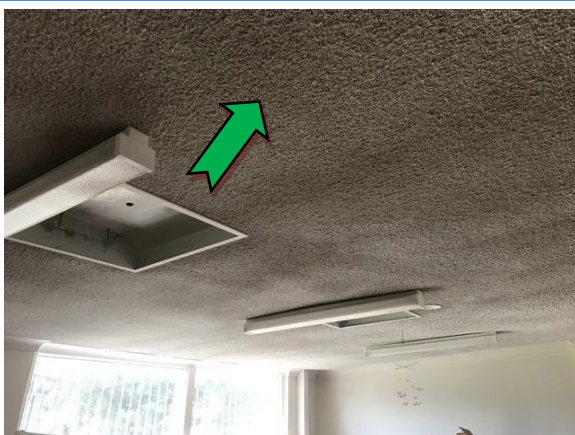
Photo 5. Interior, ground level, office and service area, ceiling – non asbestos-containing vermiculite.
