Hazardous Building Materials Assessment

Henson Park - Electrical Room

Sydenham Road,
Marrickville NSW 2204

Inner West Council
April 2018

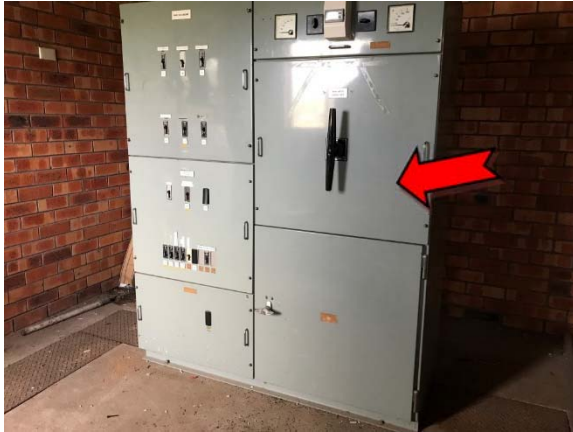
Photo 1. Interior, south-east elevation, electrical backing boards – suspected asbestos-containing bituminous backing board.

- Non-friable asbestos was suspected in the form of bituminous backing boards located south-east inside the room.

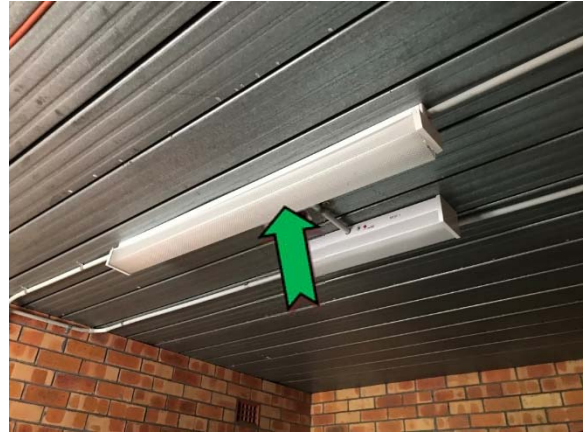
Photo 2. Interior, throughout, single tube fluorescent light fitting – suspected non PCB-containing capacitors.

- No PCBs were identified or suspected during the Assessment.

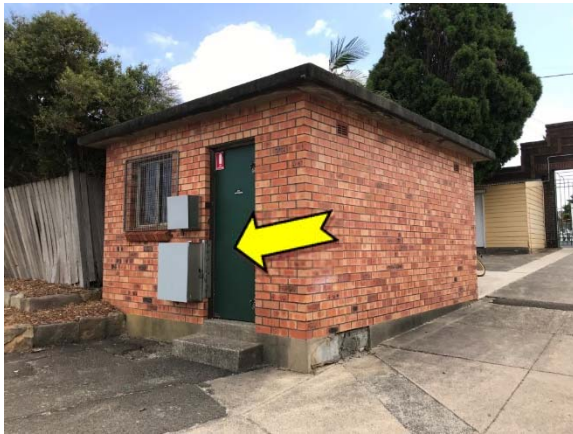
Exterior	Throughout	Door	Green - upper coloured paint system	Lead Paint - Swab	-	Suspected Positive	-	Low	Good	Low	1 unit	Confirm status by quantitative test method, maintain in current condition, over paint with a lead-free paint as part of ongoing maintenance. Remove under controlled conditions in accordance with AS 4361.2:2017 Guide to hazardous paint management prior to renovation or demolition works.	-	-	3
Throughout	-	-	-	Ozone Depleting Substances	-	-	-	-	-	-	-	No suspect ODS's identified at the time of the assessment.	-	-	-

Photo 3. Exterior, door – suspected lead-containing green upper paint system.

- LCP was suspected in the form of green upper paint systems to the door of the electrical room.
