Hazardous Building Materials Assessment Henson Park Grandstand and Change Rooms Sydenham Road Marrickville NSW 2204

Inner West Council
April 2018

Job No.: 57722-138

Count ID: CID: 164

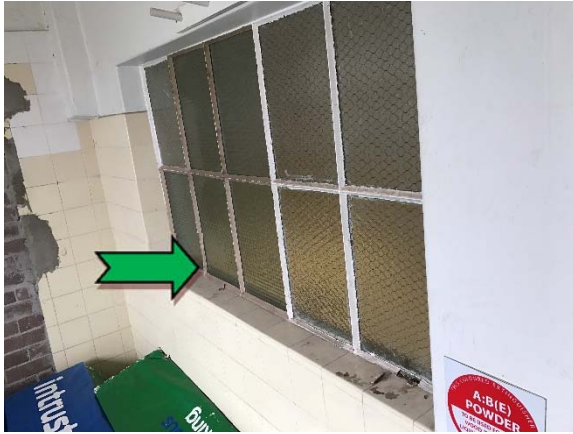
Photo 1. Exterior, ground level, throughout – non asbestos-containing window caulking.

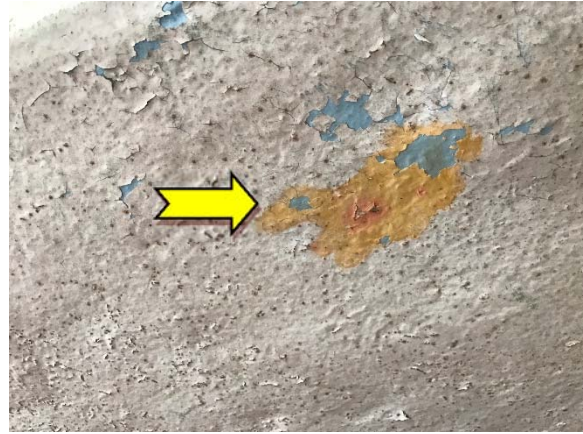
Interior	Throughout	Ceiling	Blue - lower coloured paint system	Lead Paint - Swab	-	Suspected Positive	-	Low	Good	Low	100 m ²	Confirm status by quantitative test method, maintain in current condition, over paint with a lead-free paint as part of ongoing maintenance. Remove under controlled conditions in accordance with AS 4361.2:2017 Guide to hazardous paint management prior to renovation or demolition works.	-	-	-
Throughout	-	-	-	Ozone Depleting Substances	-	-	-	-	-	-	-	No suspect ODS's identified at the time of the assessment.	-	-	-

Photo 2. Interior, ceiling, throughout – suspected lead-containing white upper and blue lower paint systems.

- LCP was identified in white and blue paints to the ceiling throughout the site.

- The *LeadCheck* paint swab method can detect lead in paint at concentrations of 0.5% and above, and may indicate lead in some paint films as low as 0.2%. As paint with a lead content greater than 0.1% by dry weight is now considered to be lead-containing, Prensa recommends confirming status of suspected LCP identified during the Assessment by quantitative test method.

- The safest method of dealing with LCP is to replace or remove the items in their entirety that have LCP on them and replace them with new items that do not contain lead. This allows the items to be disposed of as regular building or demolition unsegregated waste in accordance with the NSW Environment Protection Authority (EPA) *Waste Classification Guidelines 2014 Part 1 – Classifying Waste*. The advantage of this method is the reduction in labour requirements to remove the lead paint and also this reduces the risk to workers from exposure to lead dust or fumes. If the removal of the LCP or coatings is the preferred or required option this may generate significant amounts of potential hazardous waste. This waste must be removed, collected and disposed of by an appropriately licensed contractor under controlled conditions that minimises the release to air, water and soil. Disposal of lead waste must be disposed of as hazardous waste at an approved waste facility.
