Hazardous Building Materials Assessment

Henson Park Male Toilets on Hill

Inner West Council

April 2018

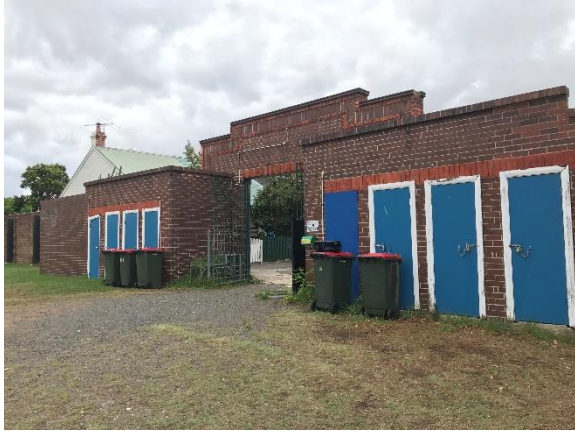
Photo 1. No access to interior of the building at the time of assessment. No hazardous building materials suspected at the time of assessment.

No access to interior of the building at time of Assessment due to keys not working.

- A destructive hazardous building material survey should be carried out prior to any demolition or refurbishment works. Any hazardous building materials identified within this survey should be removed prior to the commencement of any works that may cause disturbance.
- During demolition/refurbishment works, if any materials that are not referenced in this report and are suspected of containing asbestos are encountered, then works must cease and an asbestos hygienist should be notified to determine whether the material contains asbestos.
