Hazardous Building Materials Assessment Henson Park Media Building, Kiosk and Toilets Sydenham Road Marrickville NSW 2204

Inner West Council
April 2018

Executive Summary

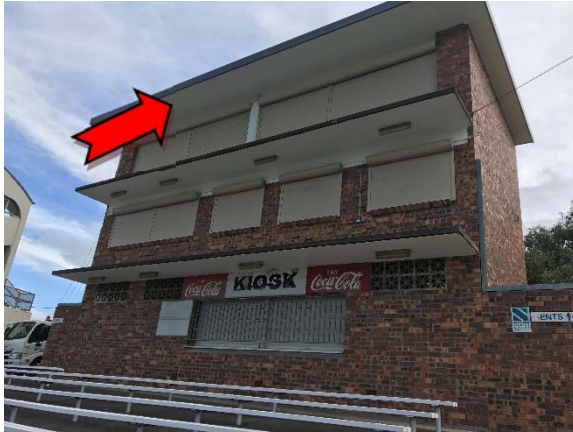
Photo 1. Exterior kiosk, all levels, eaves/awnings – identified/assumed asbestos-containing fibre cement sheeting.

- Non-friable asbestos was identified/assumed in the form of fibre cement sheeting to the eaves and awnings to the exterior of the site.

Area / Level	Room & Location	Feature	Item Description	Hazard Type	Sample No.	Sample Status	Friability	Disturb. Potential	Condition	Risk Status	Approx. Quantity	Recommendations & Comments	Control Priority	Reinspect Date	Photo No.
Exterior	Throughout	Eaves	Fibre cement sheeting	Asbestos	57722-139-001	Positive	Non-friable	Low	Good	Low	30 m ²	Maintain in current condition if to remain in-situ. Remove under controlled non-friable asbestos removal conditions prior to refurbishment or demolition works by a Class B (non-friable) licensed asbestos removal contractor.	P4	Mar-23	1
Exterior, all levels	Throughout	Awnings	Fibre cement sheeting	Asbestos	Same as: 57722-139-001	Assumed Positive	Non-friable	Low	Good	Low	60 m ²	Maintain in current condition if to remain in-situ. Remove under controlled non-friable asbestos removal conditions prior to refurbishment or demolition works by a Class B (non-friable) licensed asbestos removal contractor.	P4	Mar-23	1

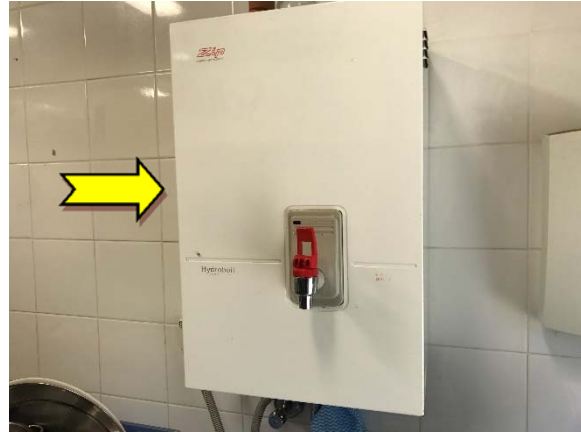
Interior, level two	Store three	Wall panelling	Fibre cement sheeting	Asbestos	57722-139-002	Negative	-	-	-	-	-	-	-	-	-
Interior, ground level	Kiosk	Hot water heater	Insulation material - internal	SMF	-	Suspected Positive	Bonded	Low	Good	Low	1 units	Maintain in current condition if to remain in-situ. Remove under controlled SMF conditions as per the Code of Practice for the Safe Use of Synthetic Mineral Fibres [NOHSC: 2006 (1990)].	-	-	2
Throughout	-	-	-	PCBs	-	-	-	-	-	-	-	No suspect PCB-containing capacitors identified at the time of the assessment.	-	-	-
Exterior	South elevation	Shutters	Beige - upper coloured paint system	Lead Paint - Swab	-	Suspected Positive	-	Low	Good	Low	20 m ²	Confirm status by quantitative test method, maintain in current condition, over paint with a lead-free paint as part of ongoing maintenance. Remove under controlled conditions in accordance with AS 4361.2:2017 Guide to hazardous paint management prior to renovation or demolition works.	-	-	-

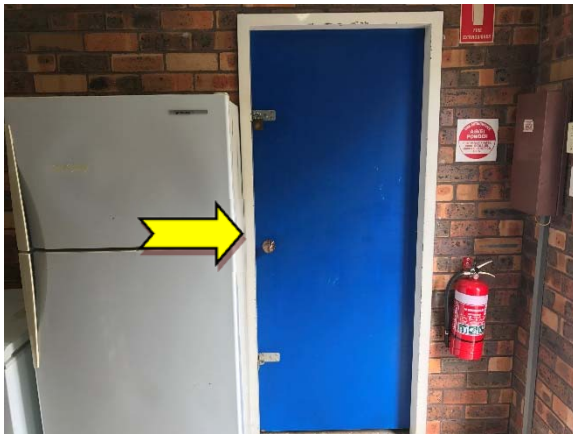
Exterior	North elevation	Doors	Blue - upper coloured paint system	Lead Paint - Swab	-	Suspected Positive	-	Low	Good	Low	10 m ²	Confirm status by quantitative test method, maintain in current condition, over paint with a lead-free paint as part of ongoing maintenance. Remove under controlled conditions in accordance with AS 4361.2:2017 Guide to hazardous paint management prior to renovation or demolition works.	-	-	3
Exterior	North elevation	Door frames	White - upper coloured paint system	Lead Paint - Swab	-	Suspected Positive	-	Low	Good	Low	6 m ²	Confirm status by quantitative test method, maintain in current condition, over paint with a lead-free paint as part of ongoing maintenance. Remove under controlled conditions in accordance with AS 4361.2:2017 Guide to hazardous paint management prior to renovation or demolition works.	-	-	3
Interior	Throughout	Ceiling	White - upper coloured paint system	Lead Paint - Swab	-	Suspected Positive	-	Low	Good	Low	20 m ²	Confirm status by quantitative test method, maintain in current condition, over paint with a lead-free paint as part of ongoing maintenance. Remove under controlled conditions in accordance with AS 4361.2:2017 Guide to hazardous paint management prior to renovation or demolition works.	-	-	-

Photo 3. Interior, throughout, doors – suspected lead-containing blue & white paint systems.

- The safest method of dealing with LCP is to replace or remove the items in their entirety that have LCP on them and replace them with new items that do not contain lead. This allows the items to be disposed of as regular building or demolition unsegregated waste in accordance with the NSW Environment Protection Authority (EPA) *Waste Classification Guidelines 2014 Part 1 – Classifying Waste*. The advantage of this method is the reduction in labour requirements to remove the lead paint and also this reduces the risk to workers from exposure to lead dust or fumes. If the removal of the LCP or coatings is the preferred or required option this may generate significant amounts of potential hazardous waste. This waste must be removed, collected and disposed of by an appropriately licensed contractor under controlled conditions that minimises the release to air, water and soil. Disposal of lead waste must be disposed of as hazardous waste at an approved waste facility.
