Hazardous Building Materials Assessment Henson Park Turnstyle & Female Toilets Sydenham Road Marrickville NSW 2204

Inner West Council
April 2018

Job No.: 57722-161

Count ID: CID: 172

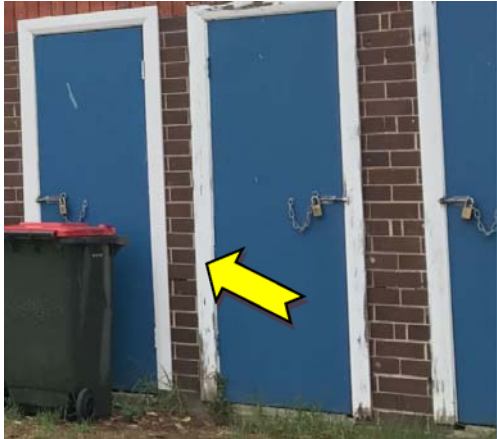
Photo 1. Exterior, throughout, door frames - suspected lead-containing white upper paint system.

- LCP was suspected in the white and blue upper coloured paint systems throughout the doors and door frames to the building.

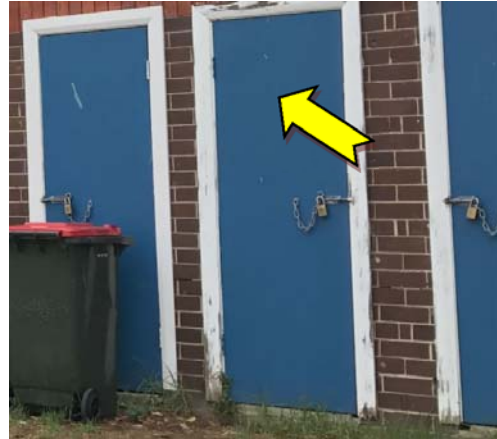
Exterior	Throughout	Doors	Blue (dark) - upper coloured paint system	Lead Paint - Swab	-	Suspected Positive	-	Low	Good	Low	28 m ²	Confirm status by quantitative test method, maintain in current condition, over paint with a lead-free paint as part of ongoing maintenance. Remove under controlled conditions in accordance with AS 4361.2:2017 Guide to hazardous paint management prior to renovation or demolition works.	-	-	2
Throughout	-	-	-	Ozone Depleting Substances	-	-	-	-	-	-	-	No suspect ODS's identified at the time of the assessment.	-	-	-

Photo 2. Exterior, throughout, doors - suspected lead-containing blue upper paint system.
