Hazardous Building Materials Assessment Marrickville Golf Course Garage Wharf Street Marrickville NSW 2204

Inner West Council
April 2018

Job No.: 57722-166

Count ID: CID: 255

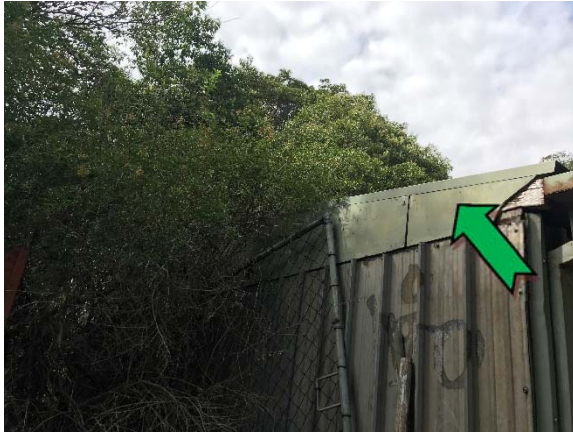
Photo 1. Exterior, garage throughout, wall lining – non asbestos-containing fibre cement sheeting.

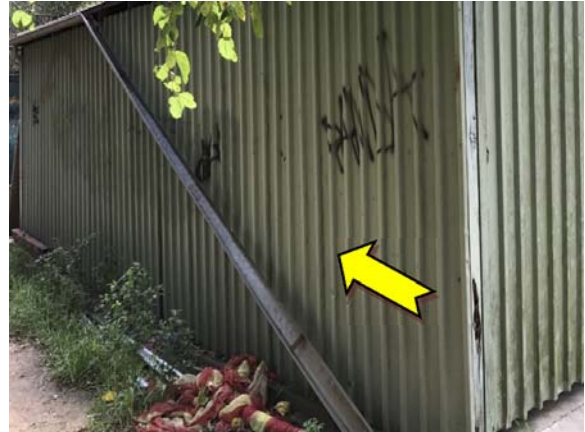
Photo 2. Exterior, throughout. walls – suspected lead-containing green upper paint system.

- LCP was suspected in the form of green upper coloured paint systems throughout the exterior of the garage.

- The *LeadCheck* paint swab method can detect lead in paint at concentrations of 0.5% and above, and may indicate lead in some paint films as low as 0.2%. As paint with a lead content greater than 0.1% by dry weight is now considered to be lead-containing, Prensa recommends confirming status of suspected LCP identified during the Assessment by quantitative test method.

- The safest method of dealing with LCP is to replace or remove the items in their entirety that have LCP on them and replace them with new items that do not contain lead. This allows the items to be disposed of as regular building or demolition unsegregated waste in accordance with the NSW Environment Protection Authority (EPA) *Waste Classification Guidelines 2014 Part 1 – Classifying Waste*. The advantage of this method is the reduction in labour requirements to remove the lead paint and also this reduces the risk to workers from exposure to lead dust or fumes. If the removal of the LCP or coatings is the preferred or required option this may generate significant amounts of potential hazardous waste. This waste must be removed, collected and disposed of by an appropriately licensed contractor under controlled conditions that minimises the release to air, water and soil. Disposal of lead waste must be disposed of as hazardous waste at an approved waste facility.

- Advise all relevant site personnel and site contractors of the results of the LCP and the safe work procedures required and/or work practices to be avoided in the areas of confirmed LCP.

- Any remediation works that may generate dust or fumes (i.e. sanding, burning) must be performed under controlled conditions by a suitably resourced and experienced hazardous material/waste abatement contractor (e.g. a Class A licensed asbestos removal contractor).
