Hazardous Building Materials Assessment Marrickville Golf Course Maintenance Shed Wharf Street Marrickville NSW 2204

Inner West Council
April 2018

Job No.: 57722-165

Count ID: CID: 256

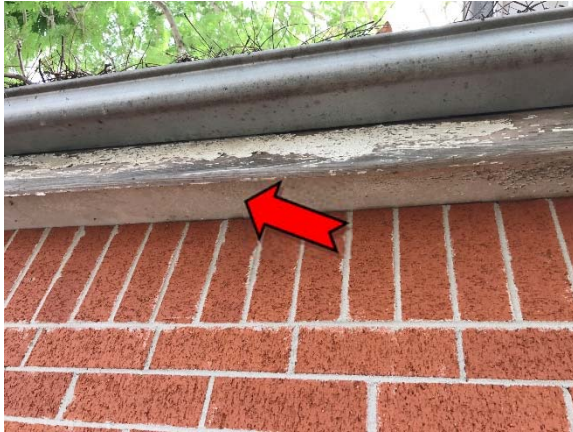
Photo 1. Exterior, south elevation, eaves – asbestos-containing fibre cement sheeting.

- Non-friable asbestos was identified in the form of fibre cement sheeting eaves to the exterior south elevation of the garage.

- When asbestos removal works are required, the person that commissions the works must ensure that this is undertaken by an appropriately licensed asbestos contractor. The asbestos removal works must be conducted under controlled asbestos removal working conditions.

- Most ACM were found not to be appropriately labelled. ACM on-site should be labelled in accordance with the relevant state / territory Legislation and AS 1319-1994 *Safety signs for the occupational environment* to warn of the dangers of disturbing these materials.

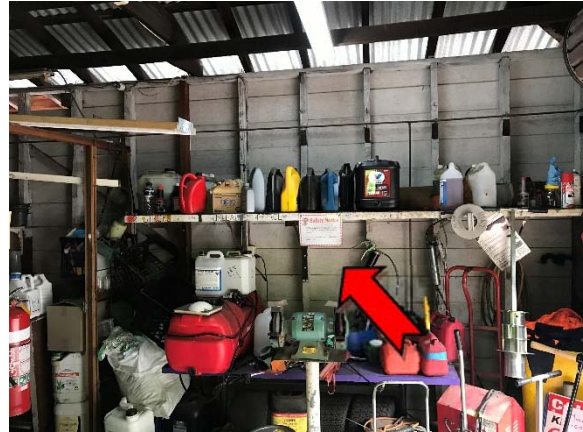
Photo 2. Interior, garage, walls – non asbestos-containing fibre cement sheeting.

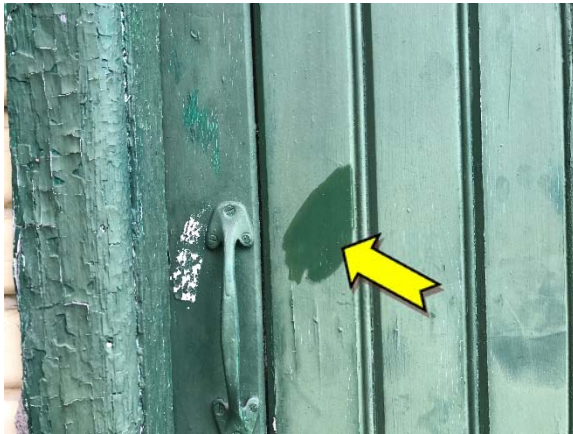
Interior	Office	Door	Green - upper coloured paint system	Lead Paint - Swab	-	Suspected Positive	-	-	-	-	5 m ²	Confirm status by quantitative test method, maintain in current condition, over paint with a lead-free paint as part of ongoing maintenance. Remove under controlled conditions in accordance with AS 4361.2:2017 Guide to hazardous paint management prior to renovation or demolition works.	-	-	3
Exterior	Office	Walls	Yellow - upper coloured paint system	Lead Paint - Swab	-	Suspected Positive	-	-	-	-	25 m ²	Confirm status by quantitative test method, maintain in current condition, over paint with a lead-free paint as part of ongoing maintenance. Remove under controlled conditions in accordance with AS 4361.2:2017 Guide to hazardous paint management prior to renovation or demolition works.	-	-	4
Throughout	-	-	-	Ozone Depleting Substances	-	-	-	-	-	-	-	No suspect ODS's identified at the time of the assessment.	-	-	-

Photo 3. Exterior, office, door - suspected lead-containing green upper paint system.

- LCP was suspected in the form of green and yellow upper coloured paint systems to the exterior of office.

- Advise all relevant site personnel and site contractors of the results of the LCP and the safe work procedures required and/or work practices to be avoided in the areas of confirmed LCP.
- Any remediation works that may generate dust or fumes (i.e. sanding, burning) must be performed under controlled conditions by a suitably resourced and experienced hazardous material/waste abatement contractor (e.g. a Class A licensed asbestos removal contractor).

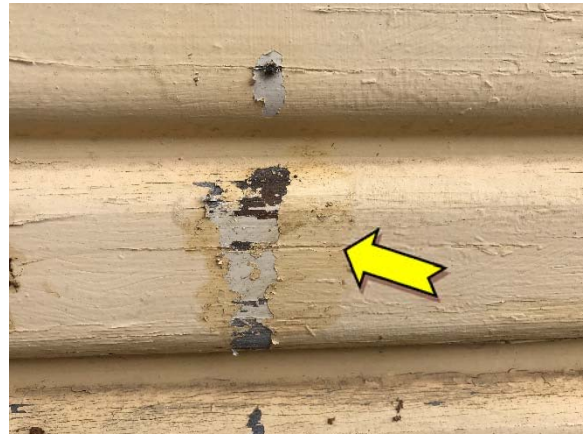
Photo 4. Exterior, office, walls - suspected lead-containing yellow upper paint system.
