Hazardous Building Materials Assessment Marrickville Golf Course Pro Shop Wharf Street Marrickville NSW 2204

Inner West Council
April 2018

Job No.: 57722-163

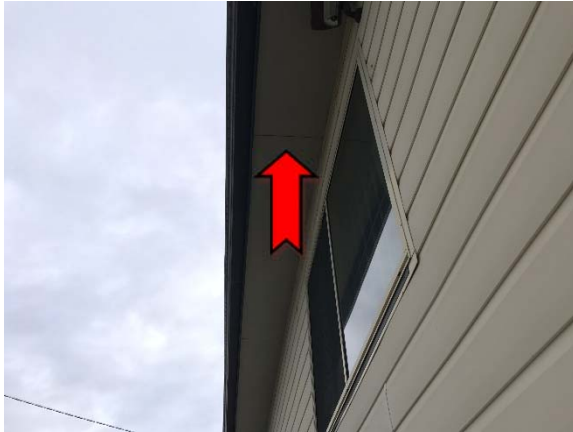
Photo 1. Exterior, throughout, eaves – suspected asbestos-containing fibre cement sheeting.

- Non-friable asbestos was suspected in the form of fibre cement sheeting eaves throughout the exterior of the building.

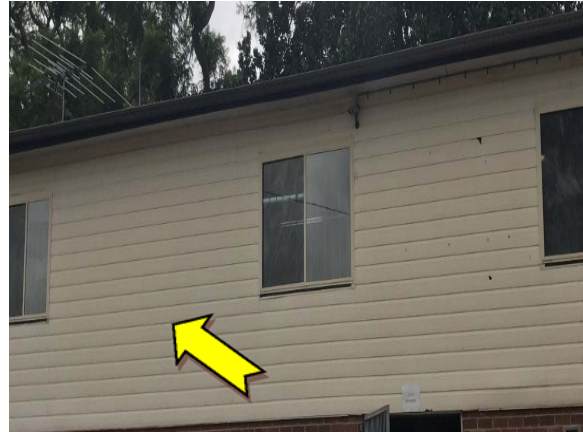
Photo 2. Exterior, throughout, high level, walls - suspected lead-containing cream upper paint system.

- LCP was suspected in the form of cream upper coloured paint systems to the high level exterior wall clad.

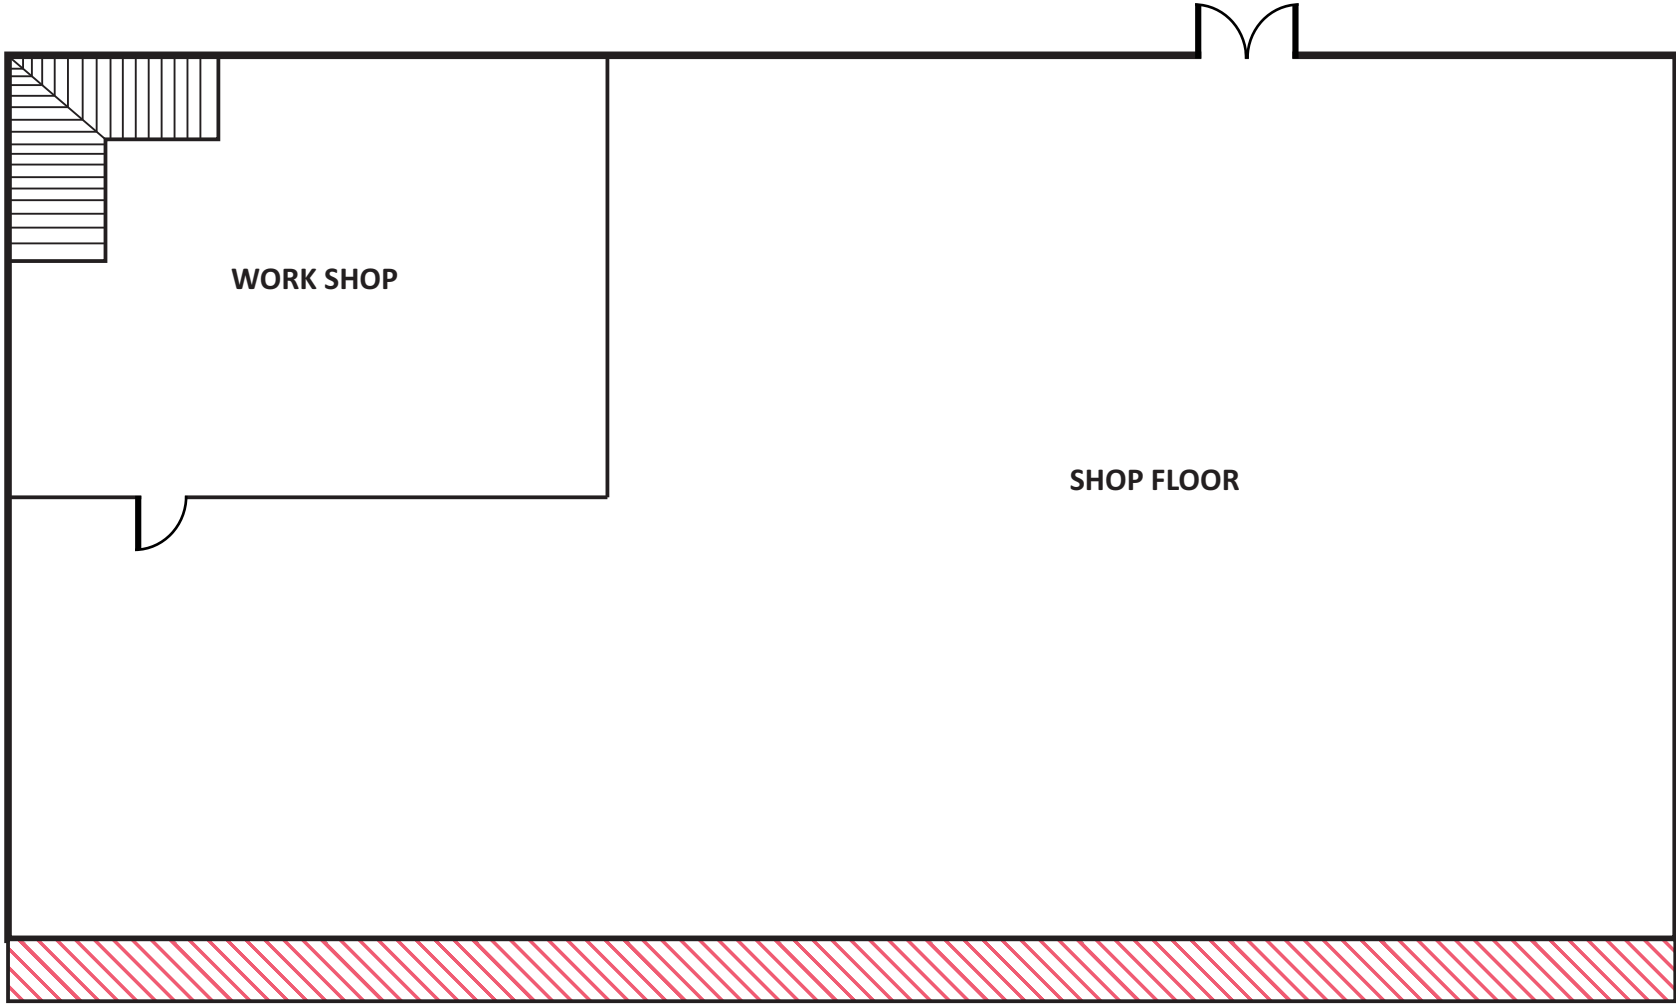
Marrickville Golf Course Pro Shop, Marrickville - Level 1

Eaves
