Hazardous Building Materials Assessment Marrickville Golf Course Rear Toilet Wharf Street Marrickville NSW 2204

Inner West Council
April 2018

Job No.: 57722-164

Count ID: CID: 257

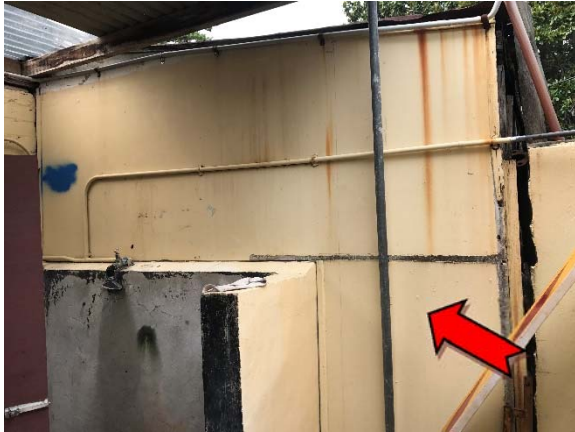
Photo 1. Interior, throughout south elevation, wall – asbestos-containing fibre cement sheeting.

- Non-friable asbestos was identified in the form of fibre cement sheeting to southern elevation walls.

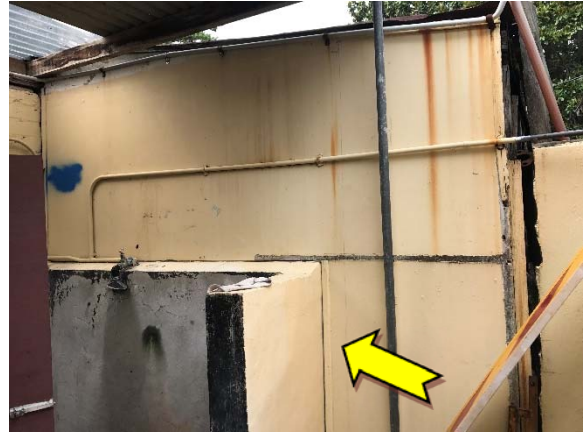
Photo 2. Interior, throughout, walls - suspected lead-containing cream upper paint system.

- LCP was suspected in the form of cream upper coloured paint systems to the walls throughout the toilets.
