# Hazardous Building Materials Assessment Marrickville Park Materials Store Wharf Street Marrickville NSW 2204

Inner West Council  
April 2018

Job No.: 57722-168

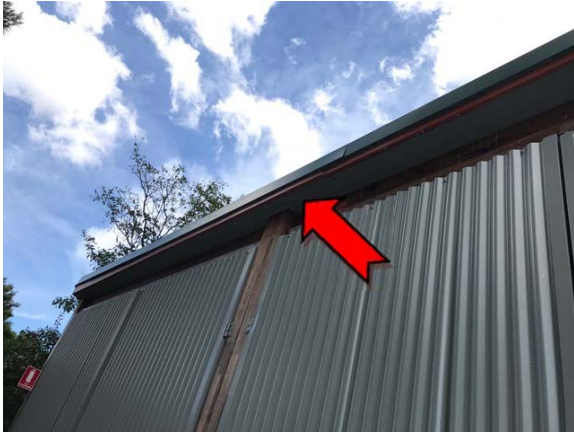
**Photo** Exterior, throughout, eaves – suspected  
**1.** asbestos-containing fibre cement sheeting.

- Non-friable asbestos was suspected in the form of fibre cement sheeting eaves throughout the exterior of the building.

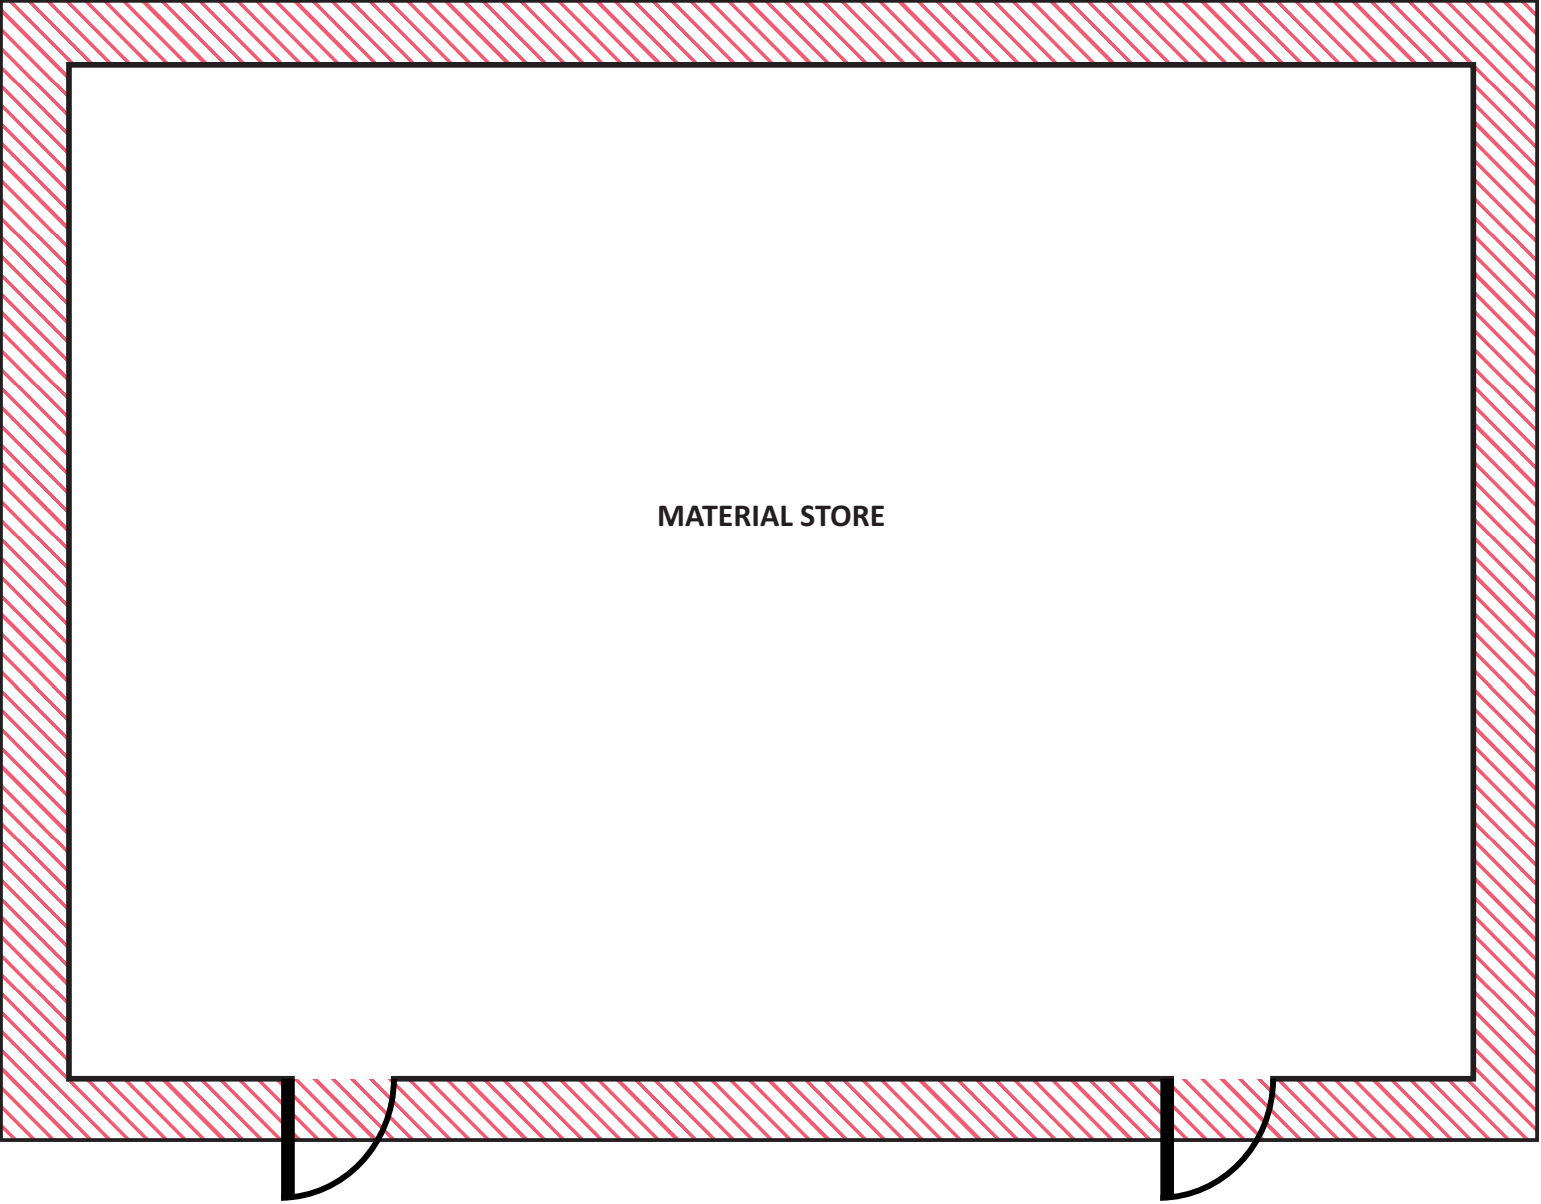
Drawing Title:  
Marrickville Park Materials Store

Eaves
