Hazardous Building Materials Assessment Newtown Town Hall Australia & Bedford Streets, Newtown NSW 2042

Inner West Council
April 2018

Job No.: 57722-145

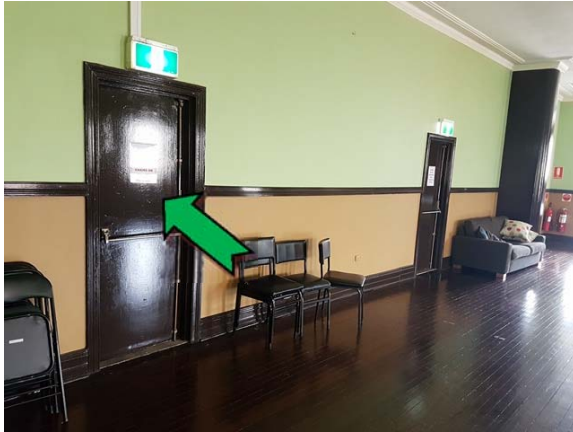
Photo 1. Interior, throughout, fire doors – suspected non asbestos-containing fire door core.

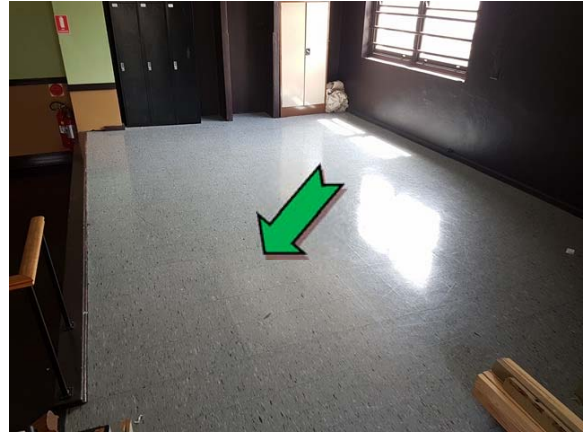
Photo 2. Interior, level one, hall, floor – non asbestos-containing vinyl floor tiles.

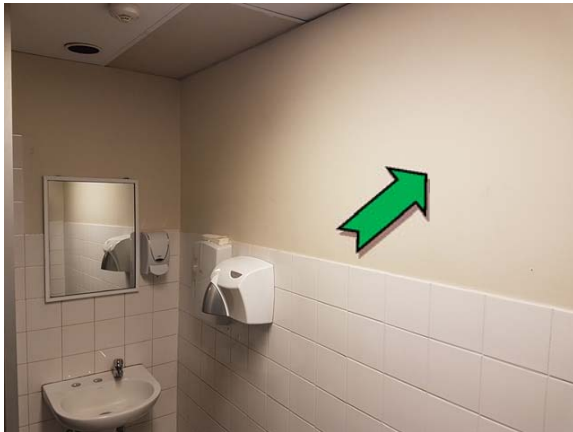
Photo 3. Interior, level one, toilet, walls – assumed non asbestos-containing fibre cement sheeting.

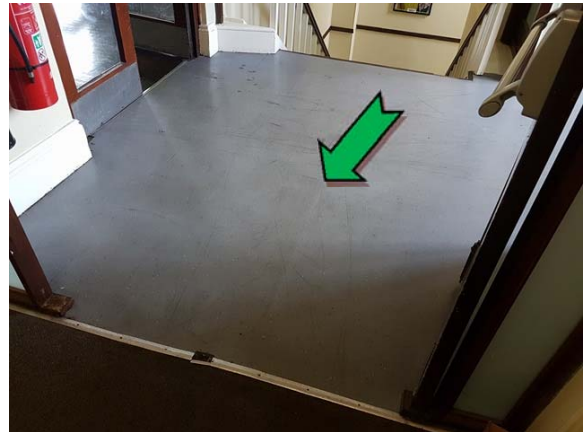
Photo 4. Interior, level one, south stairs, floor – assumed non asbestos-containing sheet vinyl.

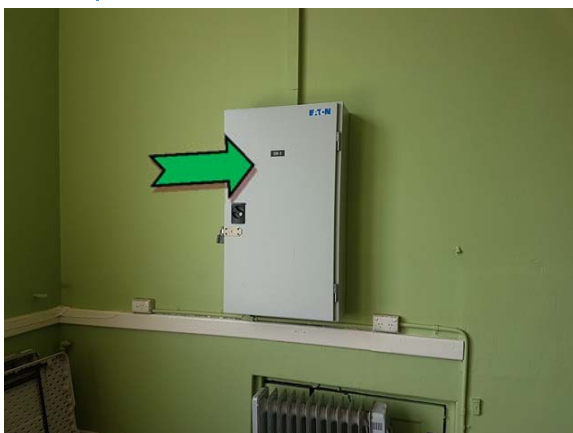
Photo 5. Interior, level one, electrical backing board – suspected non asbestos-containing bituminous backing board.

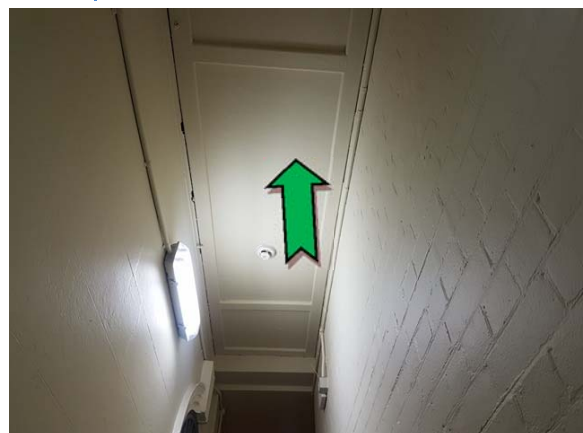
Photo 6. Interior, level one, north stairs, ceiling – suspected asbestos-containing fibre cement sheeting.

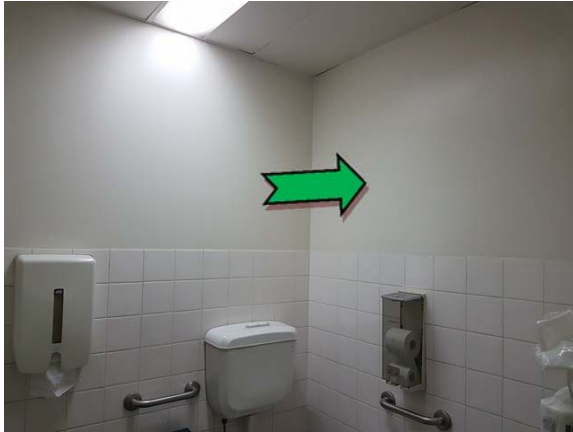
Photo 7. Interior, ground level, staff toilet, wall – non asbestos-containing fibre cement sheeting.

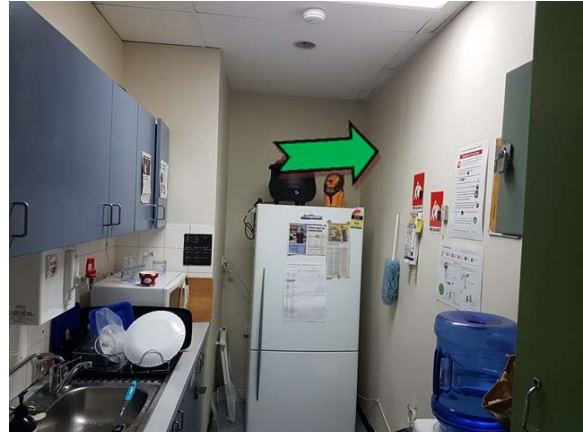
Photo 8. Interior, ground level, kitchen, wall – assumed non asbestos-containing fibre cement sheeting.

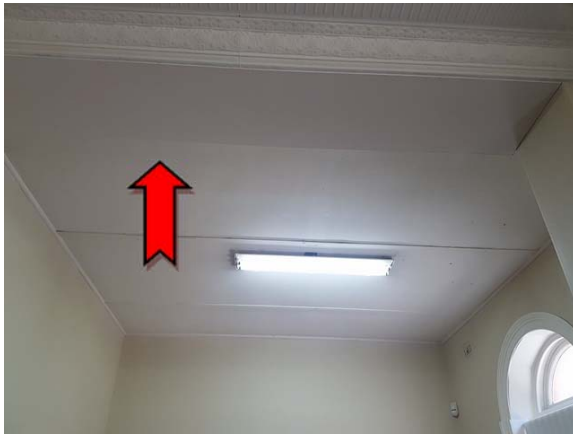
Photo 9. Interior, ground level, reception office, ceiling – suspected asbestos-containing fibre cement sheeting.

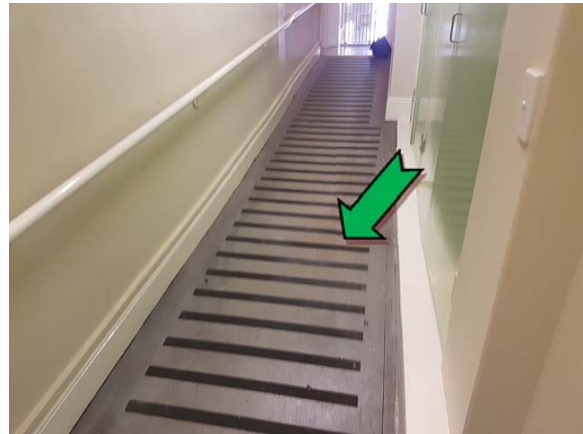
Photo 10. Interior, ground level, central ramp, grey floor coverings – non asbestos-containing vinyl sheeting.

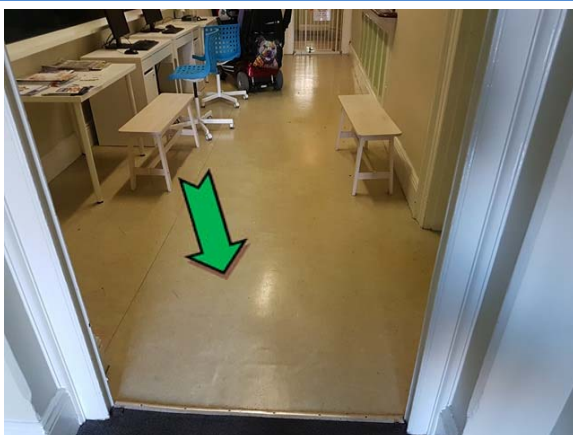
Photo 11. Interior, ground level, reception office, beige floor coverings – non asbestos-containing sheet vinyl.

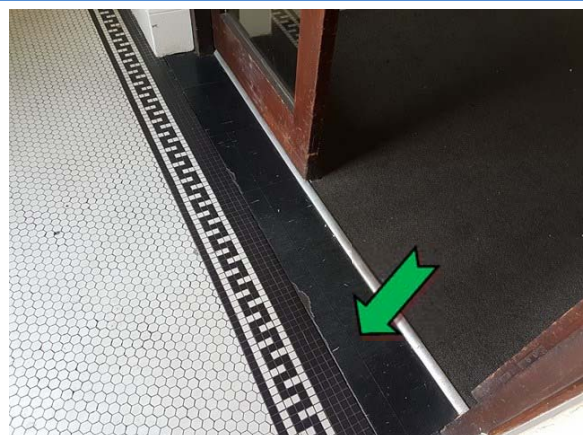
Photo 12. Interior, ground level, entrance, black floor coverings – non asbestos-containing vinyl floor tiles.

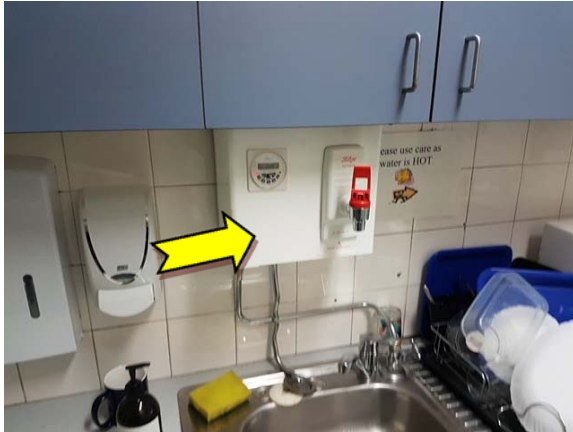
Area / Level	Room & Location	Feature	Item Description	Hazard Type	Sample No.	Sample Status	Friability	Disturb. Potential	Condition	Risk Status	Approx. Quantity	Recommendations & Comments	Control Priority	Reinspect Date	Photo No.
Interior, ground level	North-west elevation, hall	Floor coverings - grey	Sheet vinyl	Asbestos	Same as 57722-145-003A	Assumed Negative	-	-	-	-	-	-	-	-	-
Interior, ground level	North-west elevation, hall, to floor tiles	Floor coverings - grey	Adhesive	Asbestos	Same as 57722-145-003B	Assumed Negative	-	-	-	-	-	-	-	-	-
Interior, ground level	Reception office	Floor coverings - beige	Sheet vinyl	Asbestos	57722-145-002	Negative	-	-	-	-	-	-	-	-	11
Interior, ground level	Entrance	Floor coverings - black	Vinyl floor tiles	Asbestos	57722-145-001	Negative	-	-	-	-	-	-	-	-	12
Interior, ground level	North-west elevation, staff kitchen	Hot water heater	Insulation material - internal	SMF	-	Suspected Positive	Bonded	Low	Good	Low	1 unit	Maintain in current condition if to remain in-situ. Remove under controlled SMF conditions as per the Code of Practice for the Safe Use of Synthetic Mineral Fibres [NOHSC: 2006 (1990)].	-	-	13

Photo 13. Interior, ground level, north-west elevation, kitchen, hot water heater – suspected SMF internal insulation material.

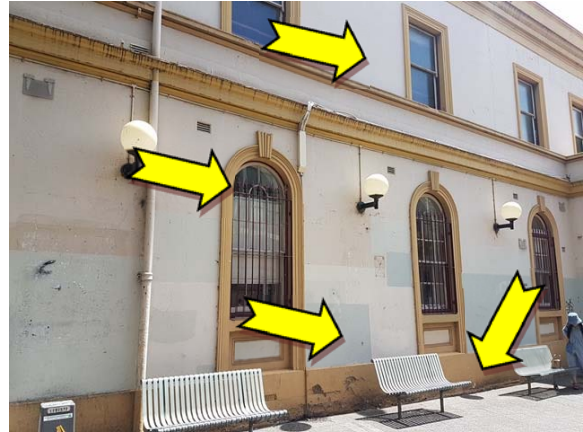
Photo 14. Exterior, throughout, walls and window frames – suspected lead-containing beige, yellow, red and white upper coloured paint systems.

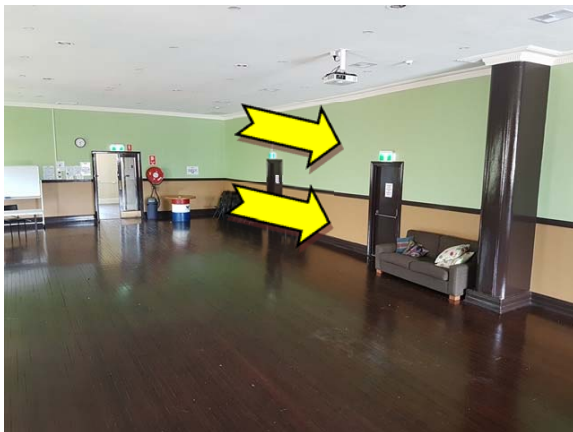
Exterior	Throughout	Walls	Red - upper coloured paint system	Lead Paint - Swab	-	Suspected Positive	-	Low	Good	Low	-	Confirm status by quantitative test method, maintain in current condition, over paint with a lead-free paint as part of ongoing maintenance. Remove under controlled conditions in accordance with AS 4361.2:2017 Guide to hazardous paint management prior to renovation or demolition works.	-	-	14
Exterior and interior	Throughout	Windows & door frames	White - upper coloured paint system	Lead Paint - Swab	-	Suspected Positive	-	Low	Good	Low	-	Confirm status by quantitative test method, maintain in current condition, over paint with a lead-free paint as part of ongoing maintenance. Remove under controlled conditions in accordance with AS 4361.2:2017 Guide to hazardous paint management prior to renovation or demolition works.	-	-	14
Interior, level one	Hall, throughout	Walls	Green - upper coloured paint system	Lead Paint - Swab	-	Suspected Positive	-	Low	Good	Low	-	Confirm status by quantitative test method, maintain in current condition, over paint with a lead-free paint as part of ongoing maintenance. Remove under controlled conditions in accordance with AS 4361.2:2017 Guide to hazardous paint management prior to renovation or demolition works.	-	-	15

Photo 15. Interior, level one, hall, walls – suspected lead-containing green, beige and brown upper coloured paint systems.

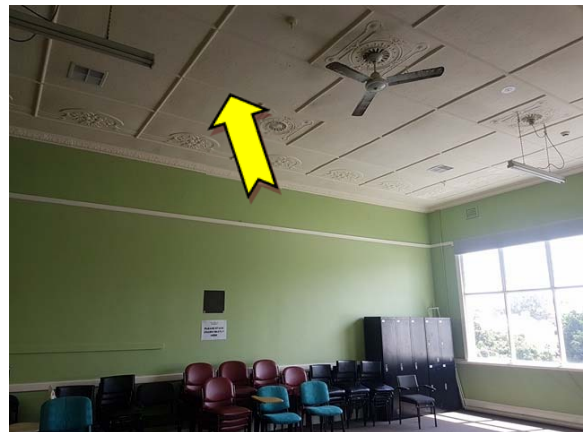
Area / Level	Room & Location	Feature	Item Description	Hazard Type	Sample No.	Sample Status	Friability	Disturb. Potential	Condition	Risk Status	Approx. Quantity	Recommendations & Comments	Control Priority	Reinspect Date	Photo No.
Interior, level one	Throughout	Walls	Green - upper coloured paint system	Lead Paint - Swab	-	Suspected Positive	-	Low	Good	Low	-	Confirm status by quantitative test method, maintain in current condition, over paint with a lead-free paint as part of ongoing maintenance. Remove under controlled conditions in accordance with AS 4361.2:2017 Guide to hazardous paint management prior to renovation or demolition works.	-	-	-
Interior, level one	Throughout	Ceiling	White - upper coloured paint system	Lead Paint - Swab	-	Suspected Positive	-	Low	Good	Low	-	Confirm status by quantitative test method, maintain in current condition, over paint with a lead-free paint as part of ongoing maintenance. Remove under controlled conditions in accordance with AS 4361.2:2017 Guide to hazardous paint management prior to renovation or demolition works.	-	-	16

Photo 16. Interior, level one, throughout, ceiling – suspected lead-containing white upper paint systems.

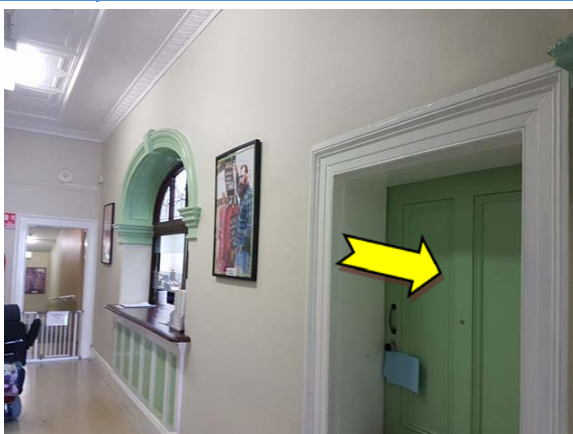
Photo 17. Interior, throughout, door – suspected lead-containing green upper paint system.

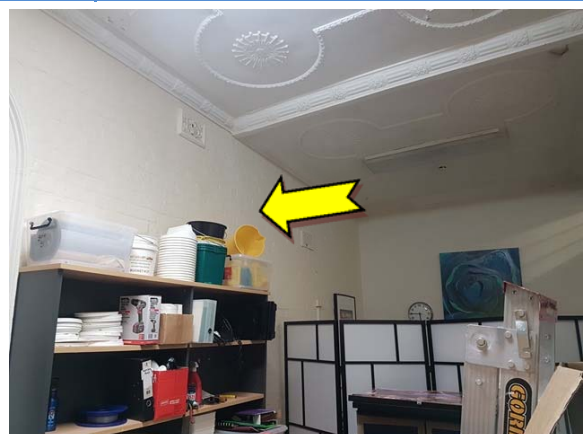
Photo 18. Interior, throughout, walls – suspected lead-containing white upper paint systems.
