Hazardous Building Materials Assessment Newtown Town Hall - Beach Burrito 1a Bedford Street, Newtown NSW 2042

Inner West Council
April 2018

Job No.: 57722-114

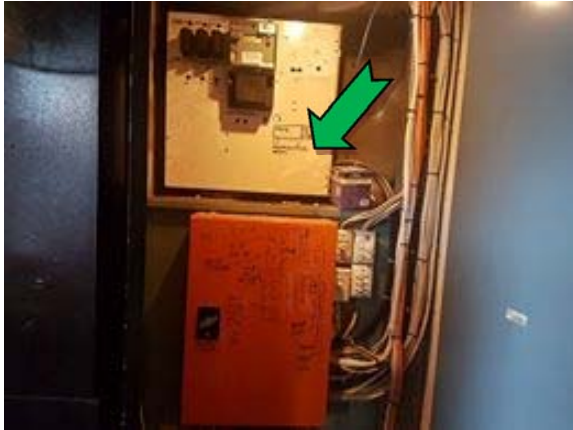
Photo 1. Interior, south-west elevation, electrical distribution cupboard, electrical backing board – suspected non asbestos-containing bituminous backing board.

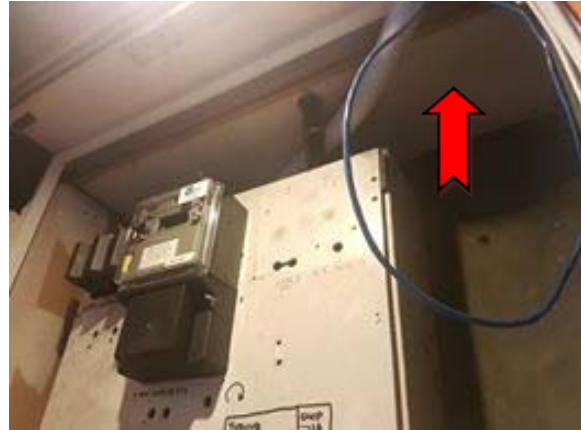
Photo 2. Interior, electrical distribution cupboard, lining – asbestos-containing fibre cement sheeting.

- Non-friable asbestos was identified in the form of fibre cement sheeting to the lining within the electrical distribution cupboard at the time of the Assessment.

- ACM that may be disturbed should be removed prior to the commencement of any works.
- When asbestos removal works are required, the person that commissions the works must ensure that this is undertaken by an appropriately licensed asbestos contractor. The asbestos removal works must be conducted under controlled asbestos removal working conditions.

- Most ACM were found not to be appropriately labelled. ACM on-site should be labelled in accordance with the relevant state / territory Legislation and AS 1319-1994 *Safety signs for the occupational environment* to warn of the dangers of disturbing these materials.

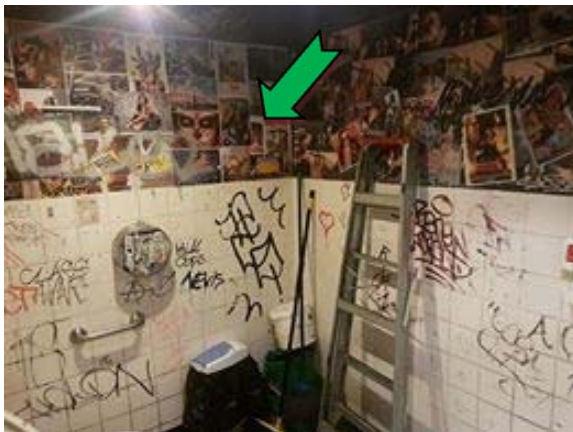
Photo 3. Interior, bathrooms, walls – non asbestos-containing fibre cement sheeting.

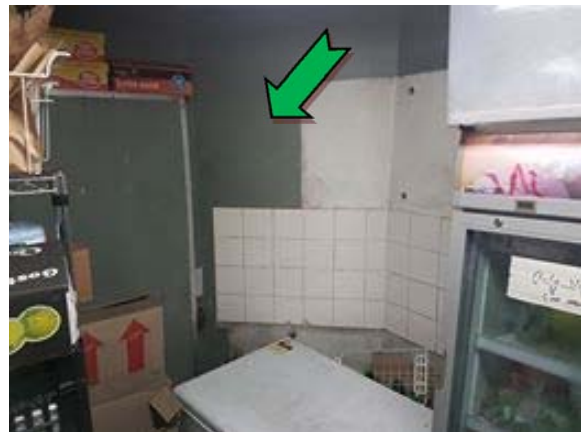
Photo 4. Interior, storage room, walls – non asbestos-containing fibre cement sheeting and suspected lead-containing green upper paint systems.

- The *LeadCheck* paint swab method can detect lead in paint at concentrations of 0.5% and above, and may indicate lead in some paint films as low as 0.2%. As paint with a lead content greater than 0.1% by dry weight is now considered to be lead-containing, Prensa recommends confirming status of suspected LCP identified during the Assessment by quantitative test method.

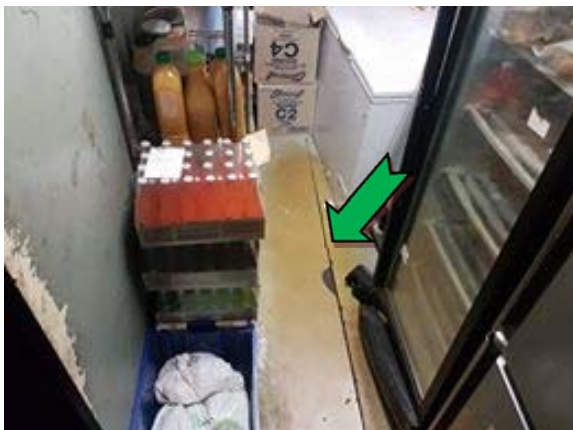
Photo 5. Interior, storage room, floor coverings – non asbestos-containing sheet vinyl.

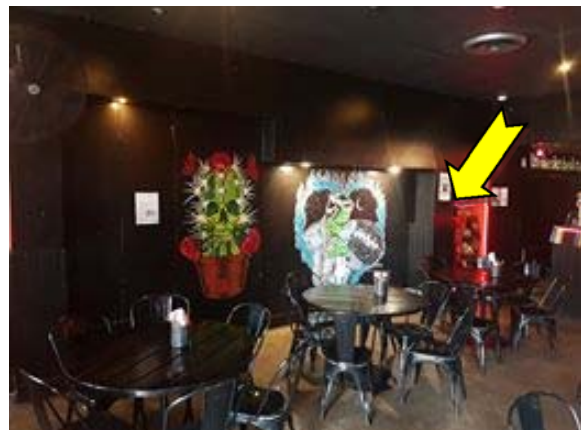
Photo 6. Interior, throughout, walls – suspected lead-containing black upper paint systems.

- LCP was suspected in the form of black, green and grey upper coloured paint systems throughout the interior of the building during the time of the Assessment.
- LCP was suspected in the form of white and red lower coloured paint systems to the floor in the back of house area during the time of the Assessment.
