Hazardous Building Materials Assessment

Tom Foster Community Centre

1-13 Darley Street
Newtown NSW 2042

Inner West Council
April 2018

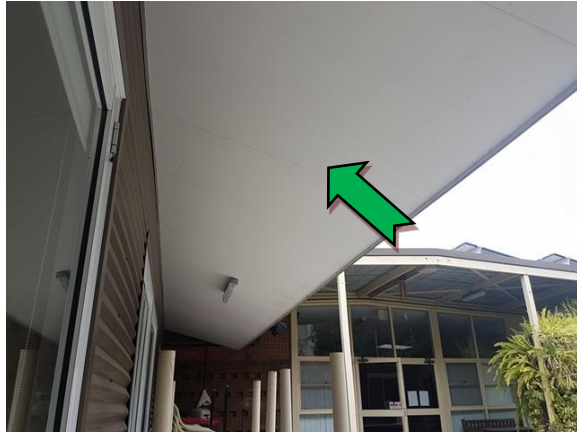
Photo 1. Exterior, north-east elevation, awning – non asbestos containing fibre cement sheeting.

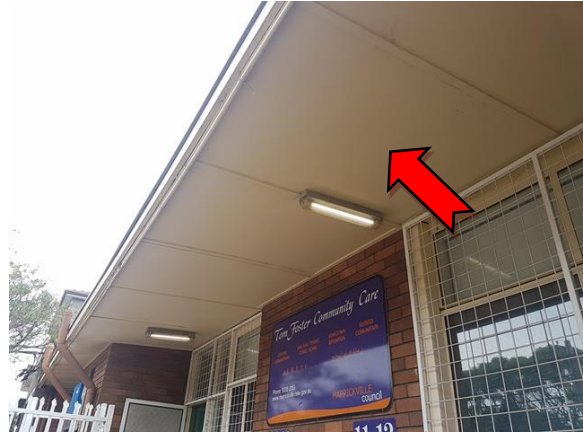
Photo 2. Exterior, south-west elevation, awning – suspected asbestos-containing fibre cement sheeting.

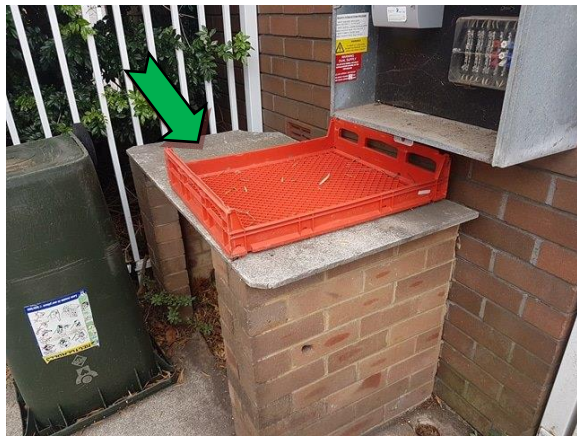
Photo 3. Exterior, south-west elevation, water main cover – non asbestos-containing fibre cement sheeting.

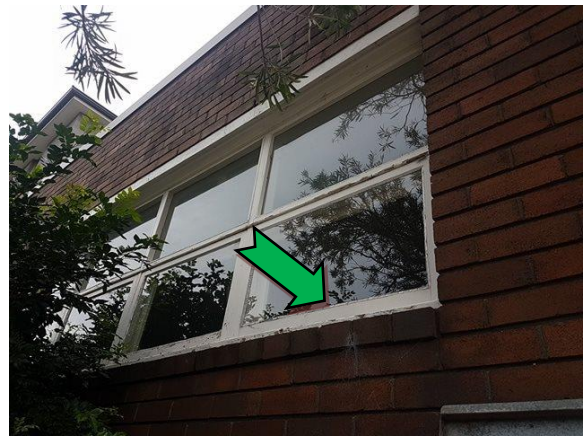
Photo 4. Exterior, south-west elevation, window frames – non asbestos-containing caulking.

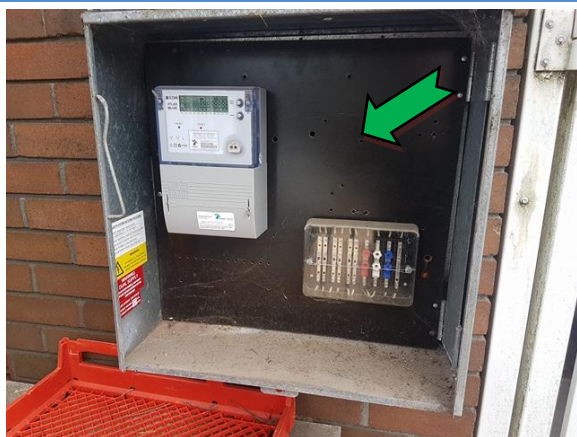
Photo 5. Exterior, south-west elevation, electrical backing board – suspected non asbestos-containing bituminous backing board.

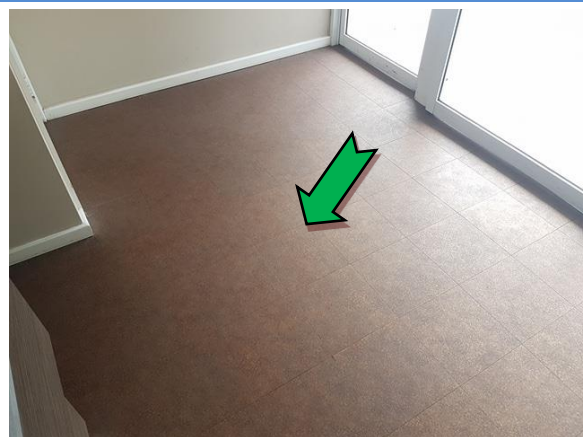
Photo 6. Interior, reception, floor – suspected non asbestos-containing vinyl floor tiles.

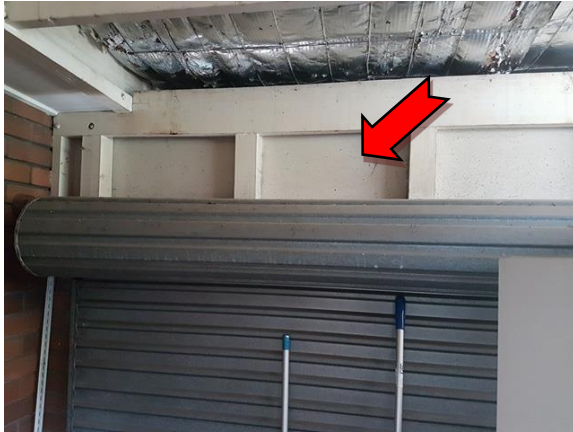
Photo 7. Interior, store room/garage, infill panels – suspected asbestos containing fibre cement sheeting.

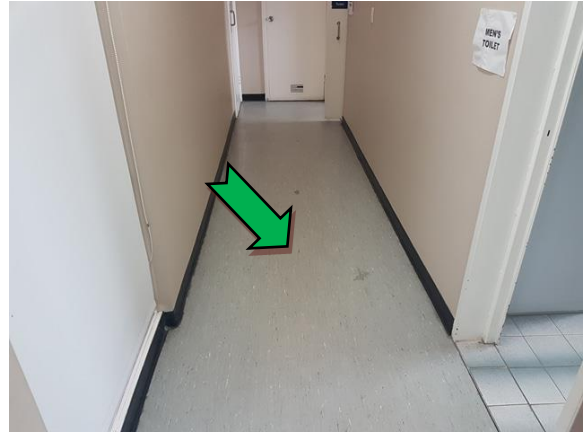
Photo 8. Interior, northern elevation, hallway, floor – non asbestos-containing sheet vinyl.

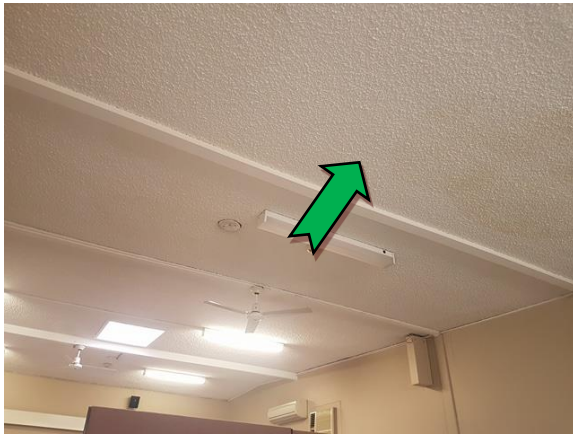
Photo 9. Interior, north-west elevation, dining hall, ceiling – non asbestos-containing sprayed vermiculite.

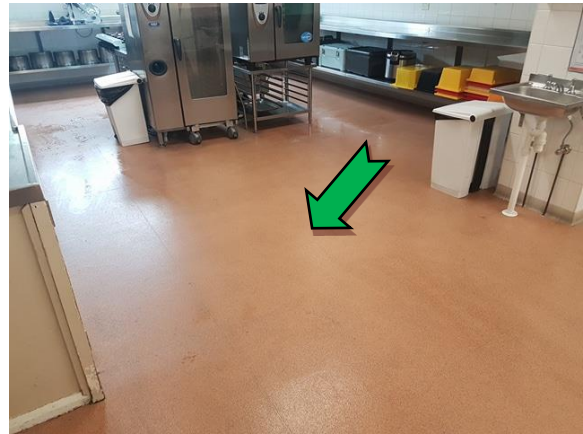
Photo 10. Interior, west elevation, kitchen, floor – suspected non asbestos-containing vinyl sheeting.

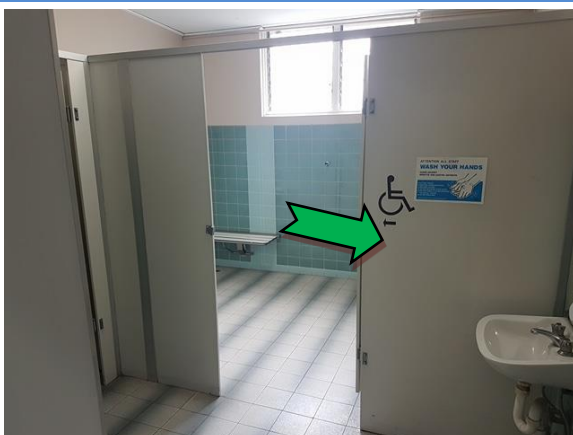
Photo 11. Interior, toilets, partition walls – non asbestos-containing fibre cement sheeting.

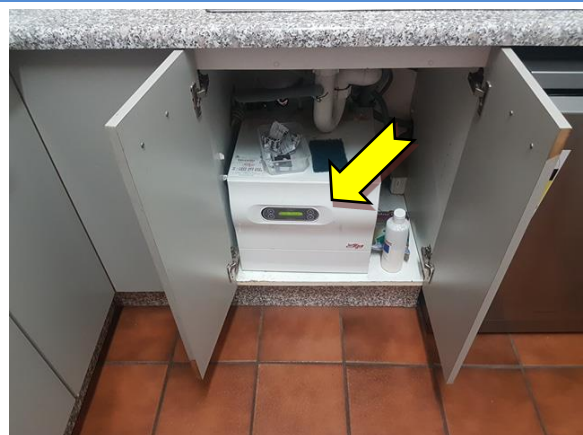
Photo 12. Interior, kitchen, under sink, hot water heater – suspected SMF internal insulation.

- Suspected SMF was observed in the form of internal insulation to hot water heater located under the sink within the kitchen; and
- Suspected SMF was observed in the form of sarking insulation within the ceiling void throughout the building.

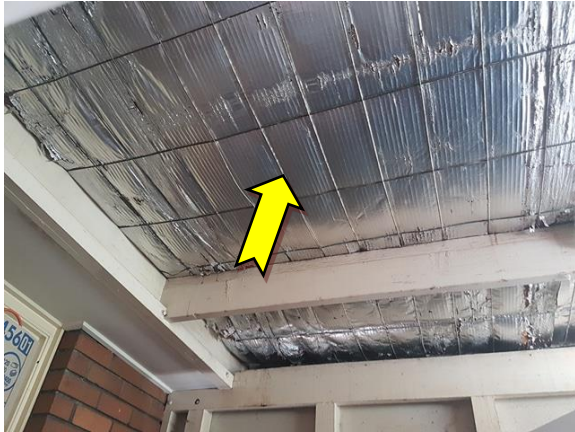
Photo 13. Interior, throughout ceiling void, sarking – suspected SMF insulation.

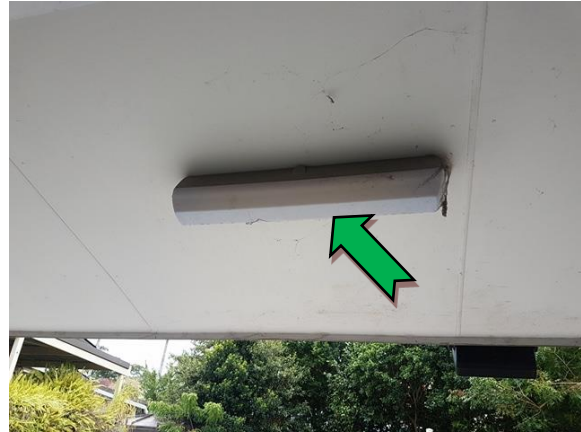
Exterior	Throughout	Fluorescent light fitting - single tube	Capacitor	PCBs	Not Sampled: Electrical Hazard	Suspected Negative	-	-	-	-	-	PCB-containing capacitors are unlikely to be present due to age and appearance of light fittings. Confirm PCB status prior to refurbishment or demolition works.	-	-	14
Interior	Throughout	Fluorescent light fitting - double tube	Capacitor	PCBs	Not Sampled: Electrical Hazard	Suspected Negative	-	-	-	-	-	PCB-containing capacitors are unlikely to be present due to age and appearance of light fittings. Confirm PCB status prior to refurbishment or demolition works.	-	-	15
Interior	Throughout	Walls	Beige - upper coloured paint system	Lead Paint - Swab	-	Suspected Positive	-	Low	Good	Low	800m ²	Confirm status by quantitative test method, maintain in current condition, over paint with a lead-free paint as part of ongoing maintenance. Remove under controlled conditions in accordance with AS 4361.2:2017 Guide to hazardous paint management prior to renovation or demolition works.	-	-	-

Photo 14. Exterior, throughout, single tube fluorescent light fittings – suspected non PCB-containing capacitors.

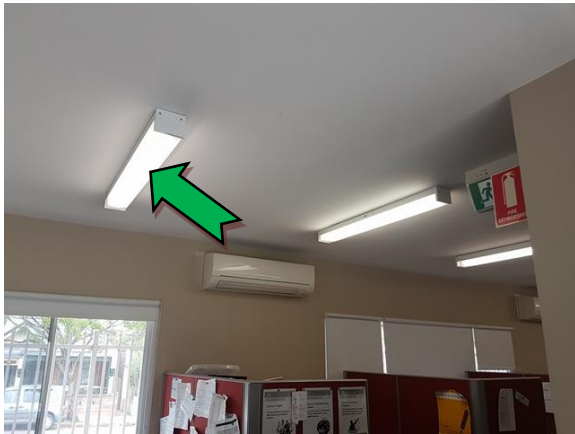
Photo 15. Interior, throughout, double tube fluorescent light fittings – suspected non PCB-containing capacitors.

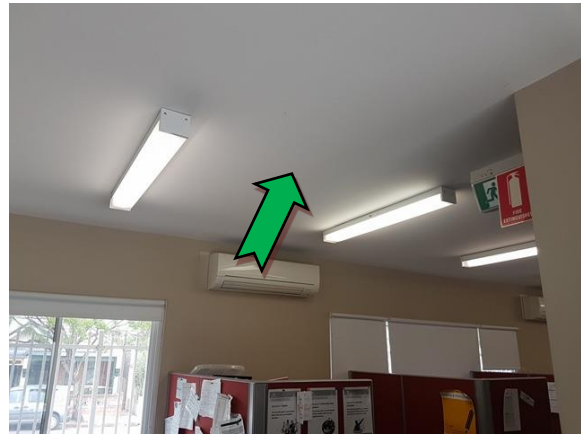
Interior	Throughout	Ceiling	White - upper coloured paint system	Lead Paint - Swab	-	Suspected Positive	-	Low	Good	Low	500m ²	Confirm status by quantitative test method, maintain in current condition, over paint with a lead-free paint as part of ongoing maintenance. Remove under controlled conditions in accordance with AS 4361.2:2017 Guide to hazardous paint management prior to renovation or demolition works.	-	-	16
Exterior	North-east elevation	Air conditioning unit	Unknown refrigerant	Ozone Depleting Substances	-	Suspected Positive	-	-	-	-	1 unit	No data was visible at the time of the assessment. Confirm status of suspected ozone depleting substances identified in the assessment.	-	-	17
Exterior	North-west elevation	Air conditioning unit	Unknown refrigerant	Ozone Depleting Substances	-	Suspected Positive	-	-	-	-	1 unit	No data was visible at the time of the assessment. Confirm status of suspected ozone depleting substances identified in the assessment.	-	-	-

Photo 16. Interior, throughout, ceiling – white upper coloured paint system.

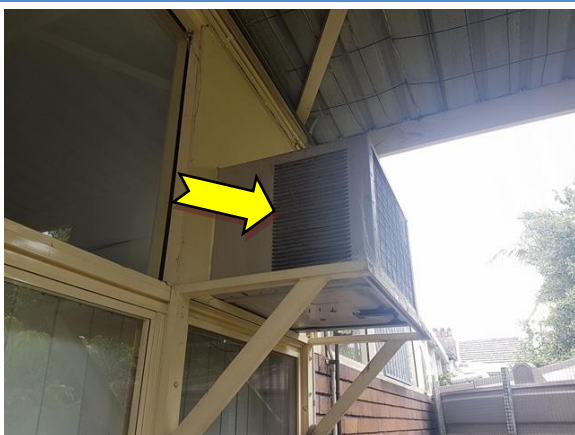
Photo 17. Exterior, north-east elevation, air conditioning unit, unknown refrigerant – suspected ozone depleting substance.

- Two suspected ODS-containing air conditioning units were identified at the exterior north-east and north-west elevations of the building.

- In accordance with the Commonwealth Ozone Protection Legislation, Prensa recommends, in line with Australia's commitment to phase out ODS-containing substances that units which are required to be replaced due to their age, damage or functionality, have their ODS-containing refrigerants replaced with a non-ODS alternative such as R410A.

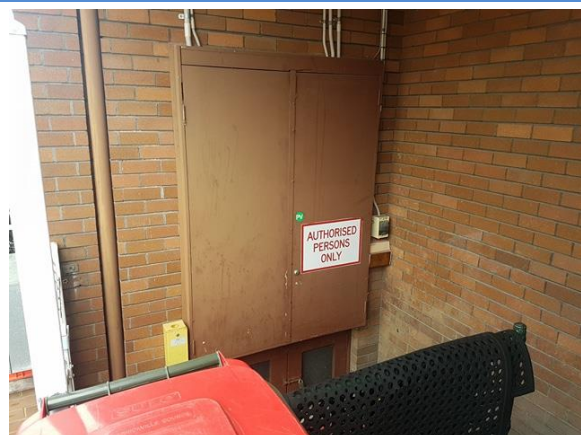
Photo 18. Exterior south-west elevation, electrical distribution board – no access at the time of assessment.
