Hazardous Building Materials Assessment Petersham Park Kindergarten 92A Brighton Street, Petersham NSW 2049

Inner West Council
April 2018

Job No.: 57722-024

Count ID: CID: 297

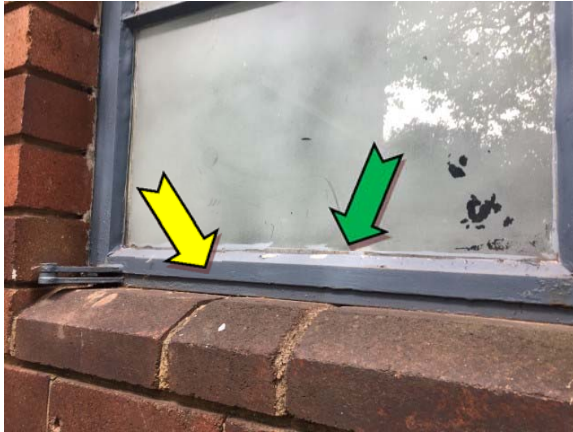
Photo 1. Exterior, north-eastern elevation, window frames – non asbestos-containing window caulking and suspected lead-containing blue upper paint system.

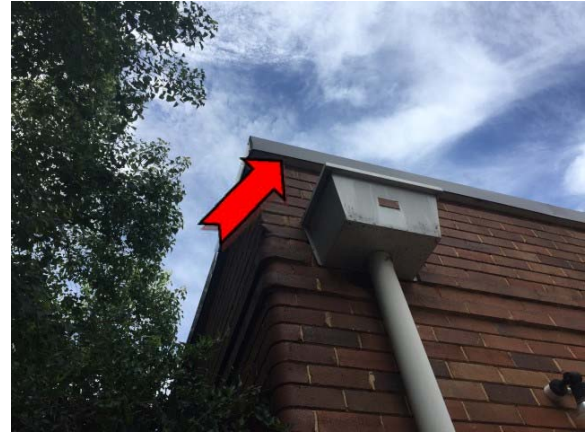
Photo 2. Exterior, throughout, eaves – suspected asbestos-containing fibre cement sheeting.

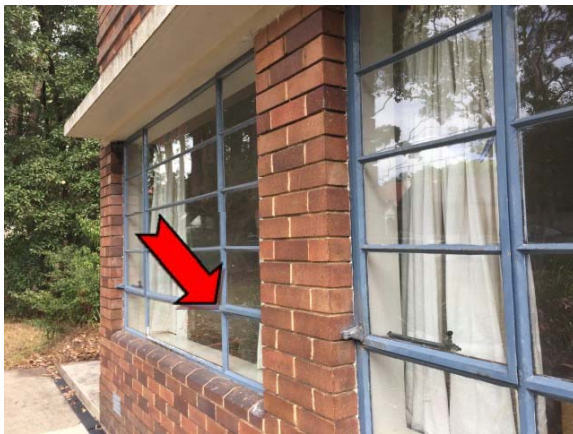
Photo 3. Exterior, southern elevation, window frames – asbestos-containing mastic sealant.

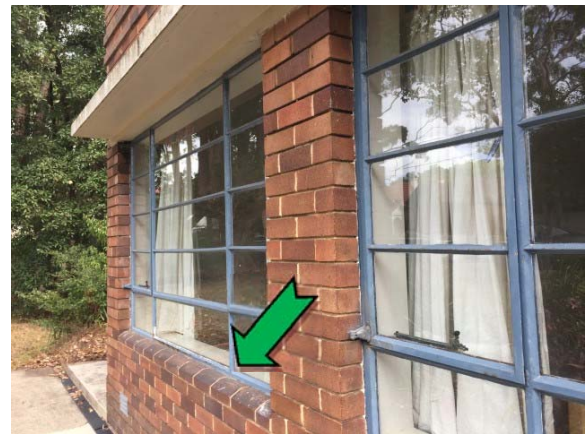
Photo 4. Exterior, southern elevation, window frames – assumed non asbestos containing window caulking.

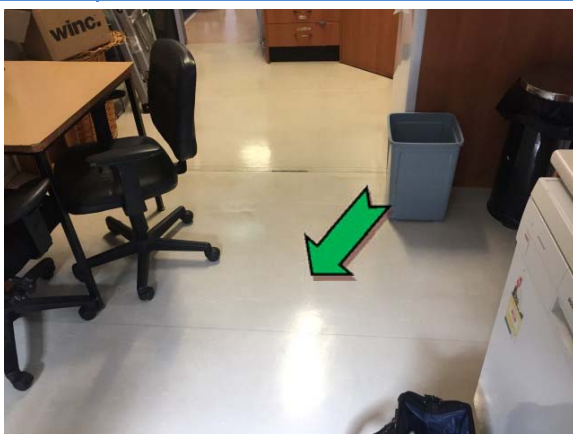
Photo 5. Interior, kitchen, cream floor coverings – non asbestos-containing vinyl sheeting.

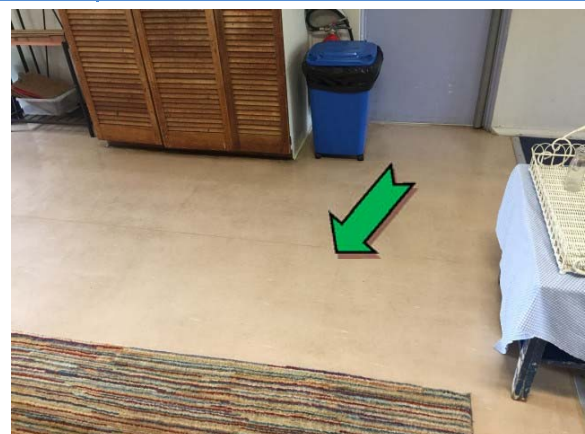
Photo 6. Interior, playroom two, pink floor coverings – non asbestos-containing vinyl sheeting.

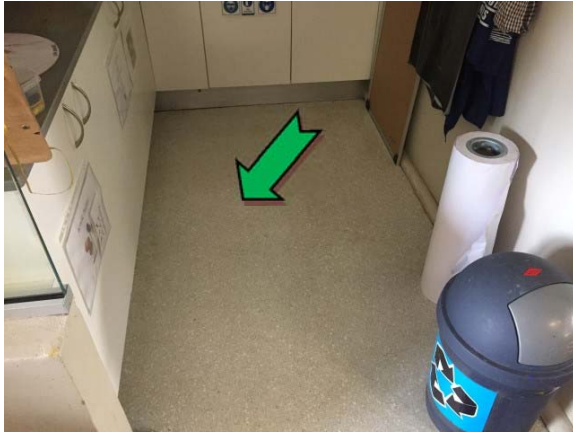
Photo 7. Interior, laundry, white floor coverings – non asbestos-containing vinyl sheeting.

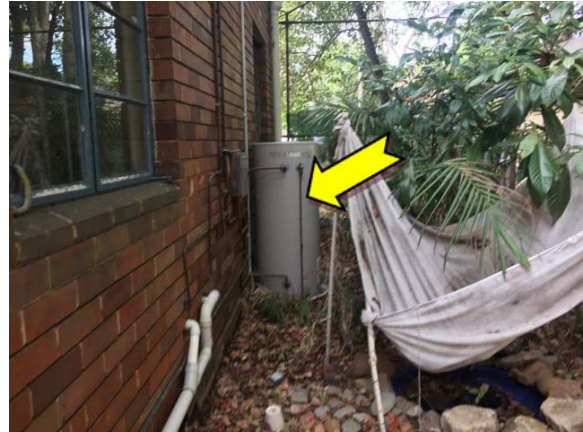
Photo 8. Exterior, south-west elevation, hot water heater – suspected internal SMF insulation.

- SMF materials that are likely to be disturbed during any proposed demolition/refurbishment works should be handled in accordance with the *Code of Practice for the Safe Use of Synthetic Mineral Fibres* [NOHSC:2006(1990)]. If these materials are impacted upon by accident or by pre-planned works, the Inner West Council must be informed via the contact detailed within Section 7: *Accidental Disturbance of Known or Suspected Hazardous Building Materials*. Following disturbance, inspection by a competent person should be undertaken.

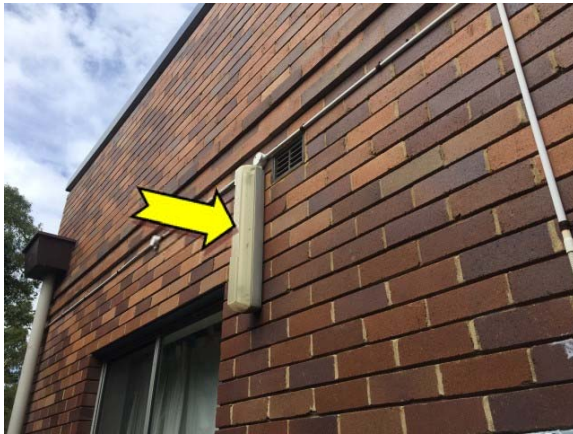
Photo 9. Exterior, single tube fluorescent light fittings – suspected PCB-containing capacitor.

- Electrical fittings that contain or suspected to contain PCB oil-containing capacitors should be removed as hazardous/regulated waste under controlled working conditions prior to the demolition or refurbishment works in accordance with the *Polychlorinated Biphenyls Management Plan, Revised Edition April 2003*.

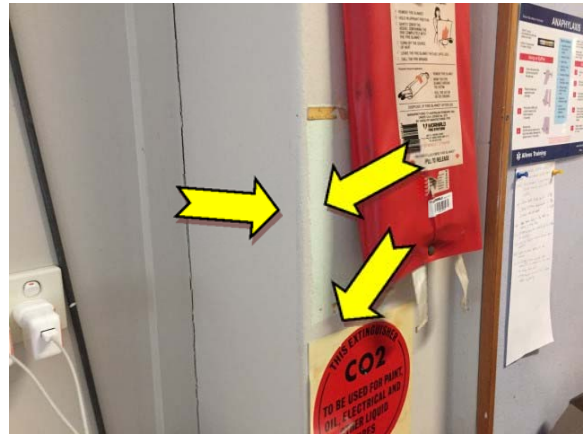
Photo 10. Interior, kitchen, walls – suspected lead-containing grey upper paint systems and green lower paint systems.

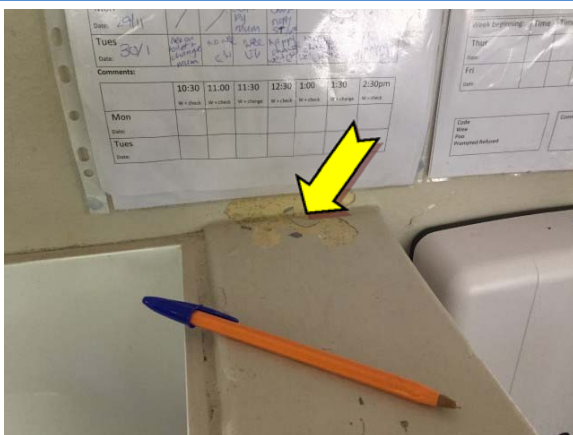
Photo 11. Interior, throughout, walls – lead-containing yellow lower paint systems.

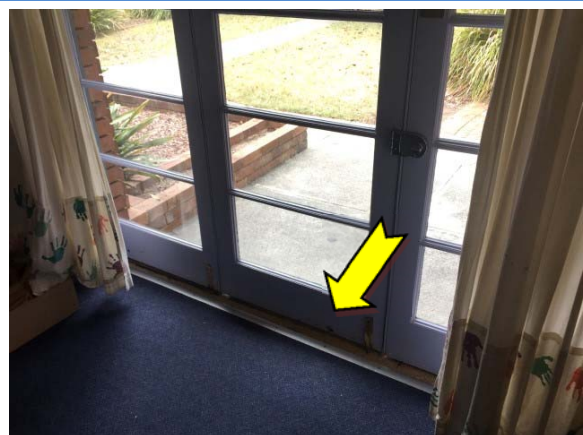
Interior	Throughout	Doors & frames	Yellow (light) - lower coloured paint system	Lead Paint - Swab	-	Positive	-	Low	Fair	Low	20 m ²		-	-	12
Throughout	-	-	-	Ozone Depleting Substances	-	-	-	-	-	-	-	No suspect ODS's identified at the time of the assessment.	-	-	-
Exterior, rear of property	-	-	-	-	-	-	-	-	-	-	-	No access to rear garden at time of inspection. Staff instructed consultants to not enter this area as children were occupying this space.	-	-	-
Throughout, ceiling space	-	-	-	-	-	-	-	-	-	-	-	No access into ceiling space due to no access hatch.	-	-	-

Photo 12. Interior, door and door frames – lead-containing yellow lower paint systems.

- Remove flaking lead containing paint to window surrounds, doors and door frames throughout the property in accordance with AS4361.2-2017 Guide to Hazardous Paint Management and relevant legislation.
