Hazardous Building Materials Assessment Petersham Park Bandstand Rotunda Brighton Street Petersham NSW 2049

Inner West Council
April 2018

Job No.: 57722-085

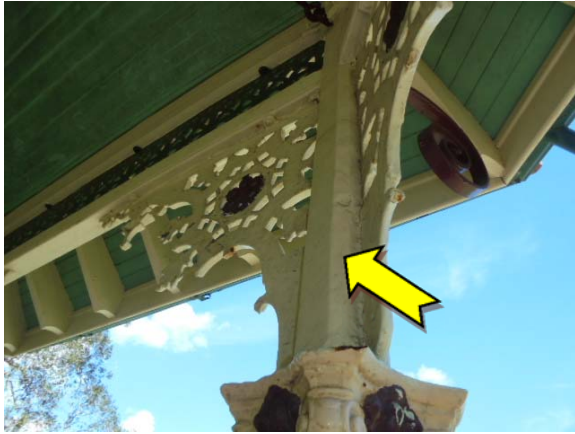
Photo 1. Exterior, throughout, railing – suspected lead-containing white upper paint system.

- LCP was suspected in the form of white and green coloured upper paint systems throughout the rotunda.

- The *LeadCheck* paint swab method can detect lead in paint at concentrations of 0.5% and above, and may indicate lead in some paint films as low as 0.2%. As paint with a lead content greater than 0.1% by dry weight is now considered to be lead-containing, Prensa recommends confirming status of suspected LCP identified during the Assessment by quantitative test method.

- The safest method of dealing with LCP is to replace or remove the items in their entirety that have LCP on them and replace them with new items that do not contain lead. This allows the items to be disposed of as regular building or demolition unsegregated waste in accordance with the NSW Environment Protection Authority (EPA) *Waste Classification Guidelines 2014 Part 1 – Classifying Waste*. The advantage of this method is the reduction in labour requirements to remove the lead paint and also this reduces the risk to workers from exposure to lead dust or fumes. If the removal of the LCP or coatings is the preferred or required option this may generate significant amounts of potential hazardous waste. This waste must be removed, collected and disposed of by an appropriately licensed contractor under controlled conditions that minimises the release to air, water and soil. Disposal of lead waste must be disposed of as hazardous waste at an approved waste facility.

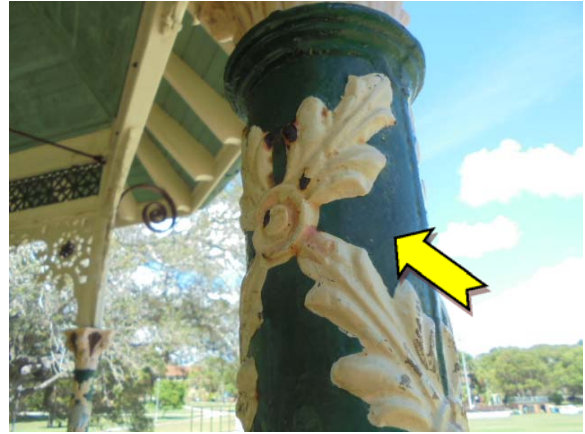
Photo 2. Exterior, throughout, support rails – suspected lead-containing green upper paint system.
