# Hazardous Building Materials Assessment Petersham Park - Grandstand Brighton and West Streets Petersham NSW 2049

Inner West Council

April 2018

Job No.: 57722-022

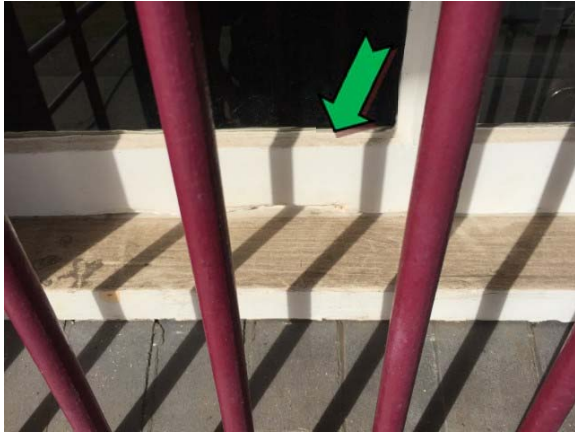
**Photo 1.** Exterior, ground level, north-east elevation, window frames – non asbestos-containing window caulking.

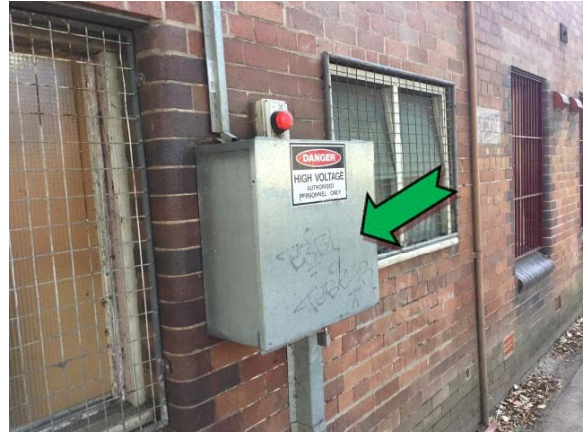
**Photo 2.** Exterior, ground level, north-west elevation, to wall, electrical switchboard – suspected non asbestos-containing bituminous material.

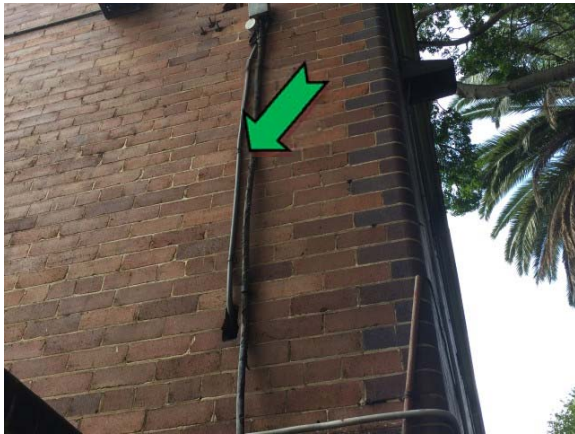
**Photo 3.** Exterior, north elevation, adjacent male toilets, insulation – non asbestos containing woven material.

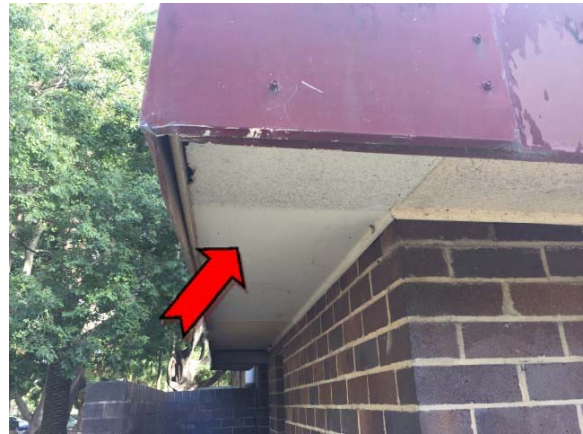
**Photo 4.** Exterior, south-west corner to female toilets, eaves – asbestos-containing fibre cement sheeting.

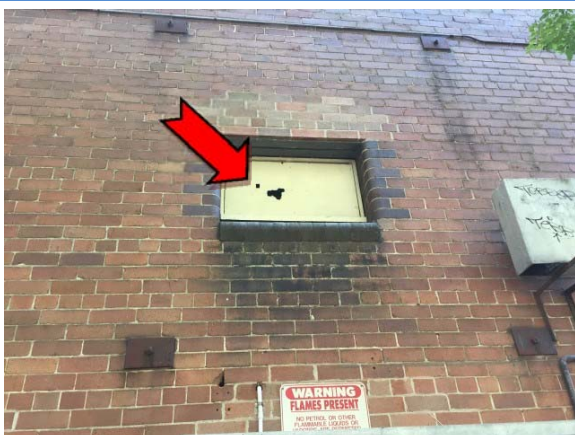
Exterior, ground level	West elevation at height	Infill panels	Fibre cement sheeting	Asbestos	Not sampled: height restrictions	Suspected Positive	Non-friable	Low	Fair	Low	1 m <sup>2</sup>	Confirm status, label as containing asbestos and maintain in current condition if to remain in-situ. Remove under controlled non-friable asbestos removal conditions prior to refurbishment or demolition works by a Class B (non-friable) licensed asbestos removal contractor.	P4	Jan-23	5
Interior, ground level	Canteen, throughout ceiling void	Ceiling space	Fibre cement sheeting	Asbestos	57722-022-004	Negative	-	-	-	-	-	-	-	-	-
Interior, ground level	Club room	Ceiling	Fibre cement sheeting	Asbestos	57722-022-005	Negative	-	-	-	-	-	-	-	-	6
Interior, ground level	Canteen, throughout ceiling	Ceiling	Fibre cement sheeting	Asbestos	Same as 57722-022-005	Assumed Negative	-	-	-	-	-	-	-	-	7
Interior, ground level	Office room, west wall	Switchboard	Bituminous backing board	Asbestos	Not sampled: electrical hazard	Suspected Negative	-	-	-	-	-	Suspected negative due to age and appearance.	-	-	8

**Photo 5.** Exterior, west elevation, infill panels at height – suspected asbestos-containing fibre cement sheeting.

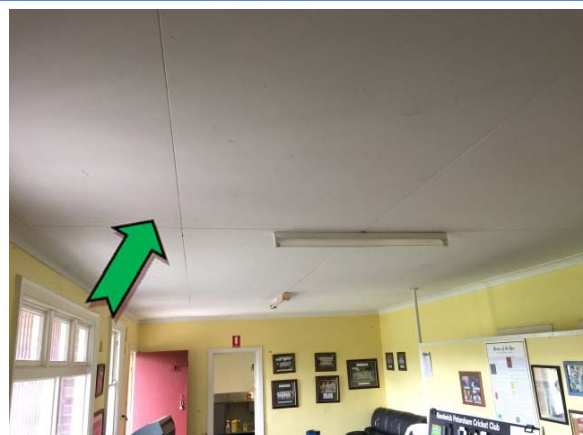
**Photo 6.** Interior, clubroom, ceiling – non asbestos-containing fibre cement sheeting.

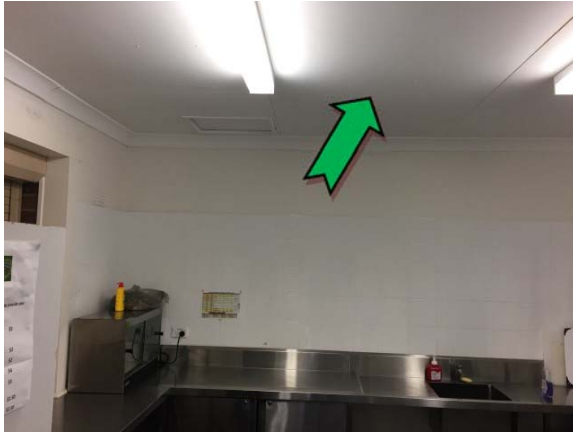
**Photo 7.** Interior, canteen, ceiling – assumed non asbestos-containing fibre cement sheeting.

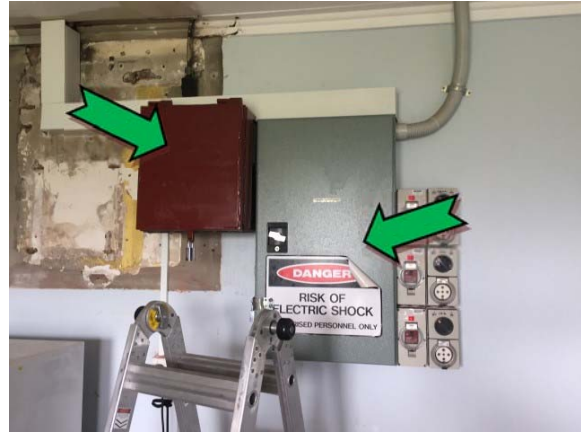
Interior, ground level	Office room, west wall	Electrical backing board	Bituminous backing board	Asbestos	Not sampled: electrical hazard	Suspected Negative	-	-	-	-	-	Suspected negative due to age and appearance.	-	-	8
Interior, ground level	North bathroom, throughout ceiling	Ceiling	Fibre cement sheeting	Asbestos	57722-022-006	Negative	-	-	-	-	-	-	-	-	9
Interior, ground level	South bathroom, throughout ceiling	Ceiling	Fibre cement sheeting	Asbestos	Same as 57722-022-006	Assumed Negative	-	-	-	-	-	-	-	-	-
Interior, ground level	Change room 1	Ceiling	Fibre cement sheeting	Asbestos	Same as 57722-022-005	Assumed Negative	-	-	-	-	-	-	-	-	10

**Photo 8.** Interior, office, west wall, electrical boards – suspected non asbestos-containing electrical backing boards.

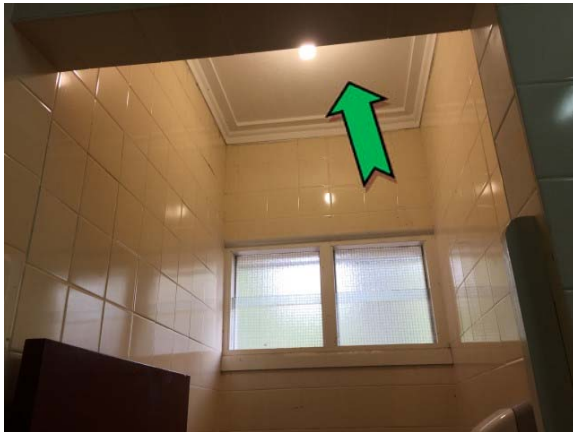
**Photo 9.** Interior, north bathroom, ceiling – non asbestos-containing fibre cement sheeting.

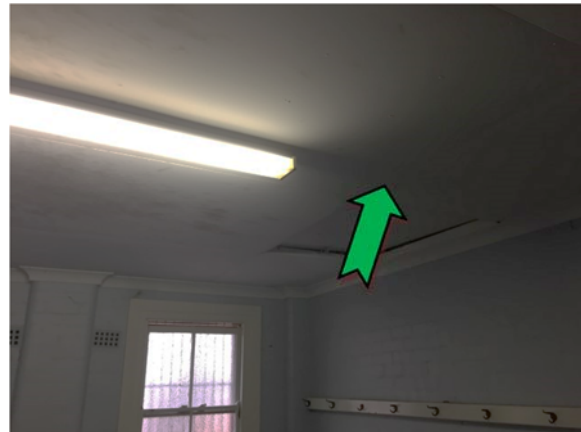
**Photo 10.** Interior change room one and two, ceiling – assumed non asbestos-containing fibre cement sheeting.

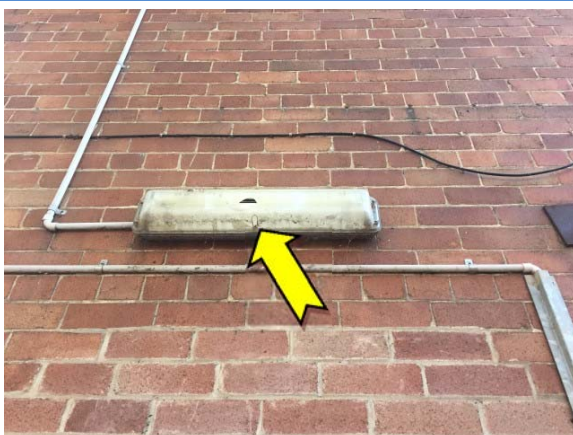
**Photo 11.** Exterior, single tube fluorescent light fitting – suspected PCB-containing capacitor.

- Electrical fittings suspected of containing PCB oil capacitors should be treated as containing PCB oils until such time as evidence suggest otherwise e.g. further assessed.
- Electrical fittings that contain or suspected to contain PCB oil-containing capacitors should be removed as hazardous/regulated waste under controlled working conditions prior to the demolition or refurbishment works in accordance with the *Polychlorinated Biphenyls Management Plan, Revised Edition April 2003*.

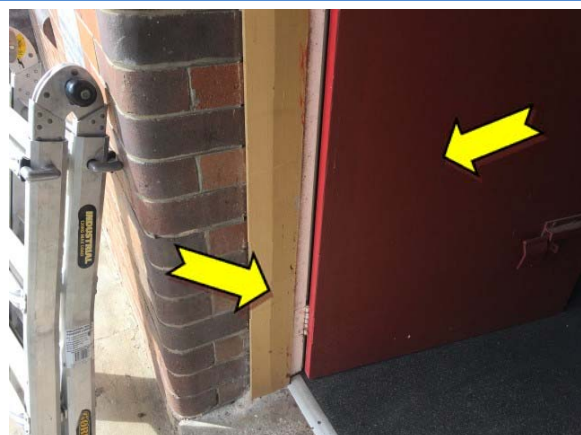
**Photo 12.** Exterior, door and door frames – suspected lead-containing red and yellow coloured upper paint systems.

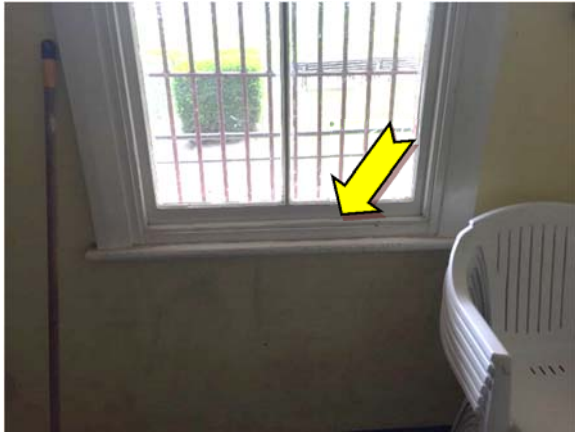
Exterior, ground level	Throughout, window frames	Window frames	White - lower coloured paint system	Lead Paint - Swab	-	Positive	-	Low	Fair	Low	20 m <sup>2</sup>	Maintain in current condition, over paint with a lead-free paint as part of ongoing maintenance. Remove under controlled conditions in accordance with AS 4361.2:2017 Guide to hazardous paint management prior to renovation or demolition works.	-	-	-
Exterior, ground level	Throughout, window frames	Window frames	Cream - upper coloured paint system	Lead Paint - Swab	-	Suspected Positive	-	Low	Good	Low	20 m <sup>2</sup>	Confirm status by quantitative test method, maintain in current condition, over paint with a lead-free paint as part of ongoing maintenance. Remove under controlled conditions in accordance with AS 4361.2:2017 Guide to hazardous paint management prior to renovation or demolition works.	-	-	-
Interior, ground level	Throughout, window frames	Window frames	White - lower coloured paint system	Lead Paint - Swab	-	Positive	-	Low	Good	Low	20 m <sup>2</sup>	Maintain in current condition, over paint with a lead-free paint as part of ongoing maintenance. Remove under controlled conditions in accordance with AS 4361.2:2017 Guide to hazardous paint management prior to renovation or demolition works.	-	-	13

**Photo 13.** Interior, window frames – lead-containing white upper paint system.

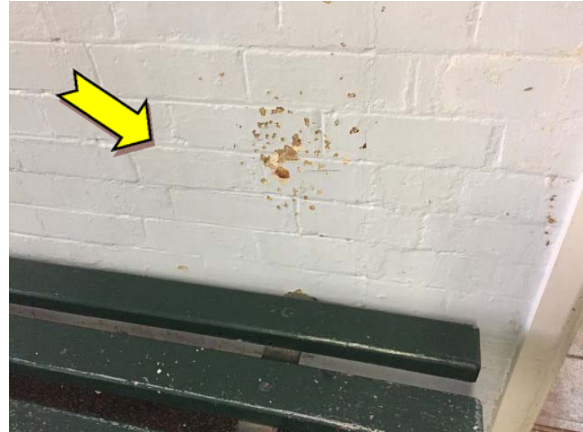
**Photo 14.** Interior, walls – suspected lead-containing white upper paint system.
