Hazardous Building Materials Assessment

Petersham Town Hall

107 Crystal Street
Petersham NSW 2049

Inner West Council
April 2018

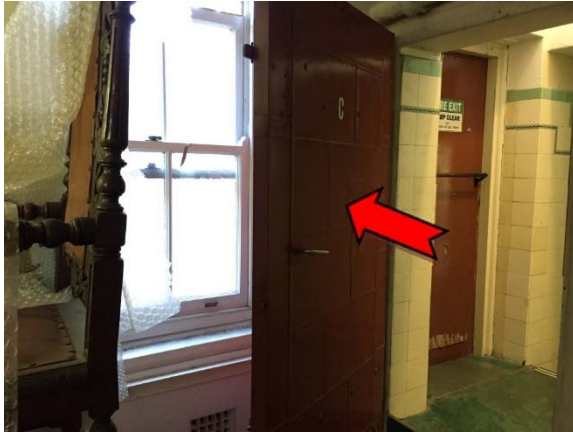
Photo 1. Interior, basement level, fireproof storage room, door core – suspected friable asbestos-containing fire door core.

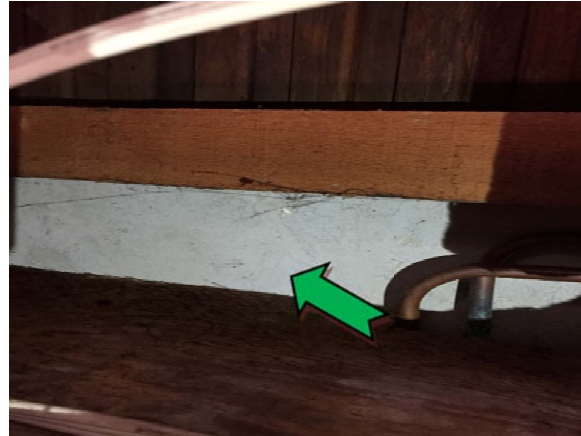
Photo 2. Interior, basement level, multi-function hall, ceiling – non asbestos-containing fibre cement sheeting.

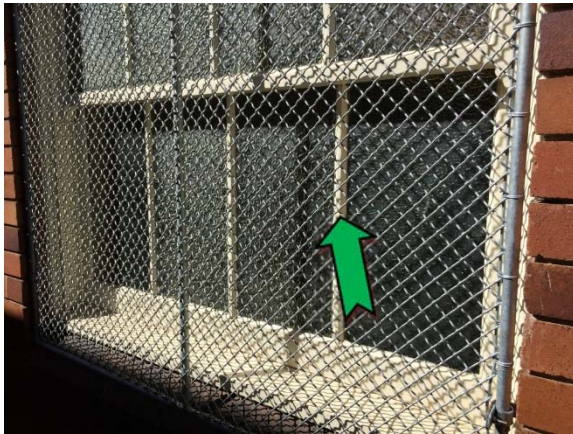
Photo 3. Exterior, throughout, window frames – non asbestos-containing window caulking.

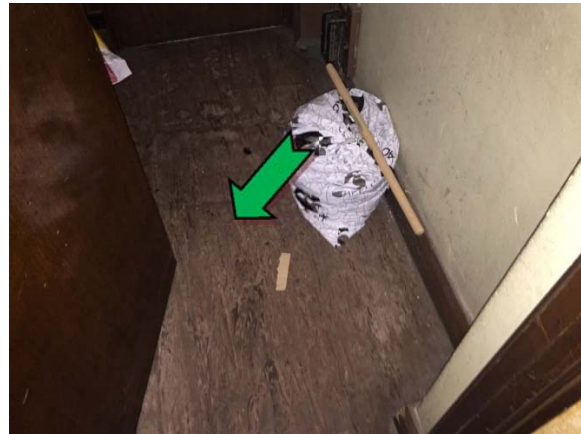
Photo 4. Interior, ground level, store room adjacent amenities room, brown floor covering – non asbestos-containing vinyl floor tiles.

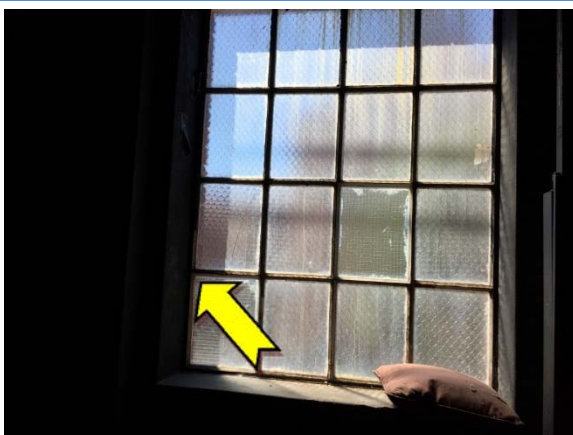
Photo 5. Interior ground level, main hall stage, window frames – non asbestos-containing window caulking.

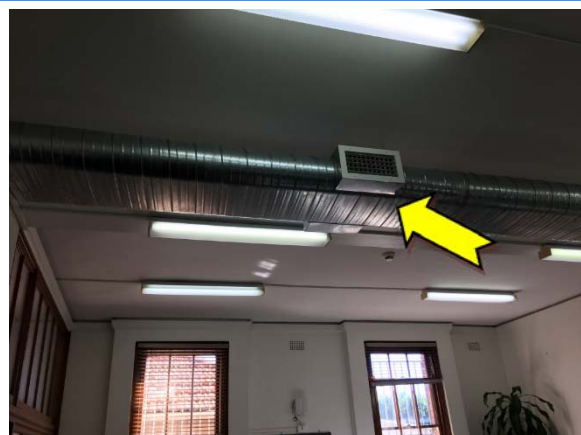
Interior, ground floor	Throughout	Duct	Insulation material - internal	SMF	-	Suspected Positive	Bonded	Low	Good	Low	100 m	Maintain in current condition if to remain in-situ. Remove under controlled SMF conditions as per the Code of Practice for the Safe Use of Synthetic Mineral Fibres [NOHSC: 2006 (1990)].	-	-	6
Interior, ground floor	Kitchen	Hot water heater	insulation material - internal	SMF	-	Suspected Positive	Bonded	Low	Good	Low	1 unit	Maintain in current condition if to remain in-situ. Remove under controlled SMF conditions as per the Code of Practice for the Safe Use of Synthetic Mineral Fibres [NOHSC: 2006 (1990)].	-	-	5
Interior, basement	Throughout	Fluorescent light fitting - double tube	Capacitor	PCBs	-	Suspected Negative	-	-	-	-	-	PCB-containing capacitors are unlikely to be present due to age and appearance of light fittings. Confirm PCB status prior to refurbishment or demolition works.	-	-	-

Photo 6. Interior, ground level, throughout, ductwork – suspected SMF internal insulation.

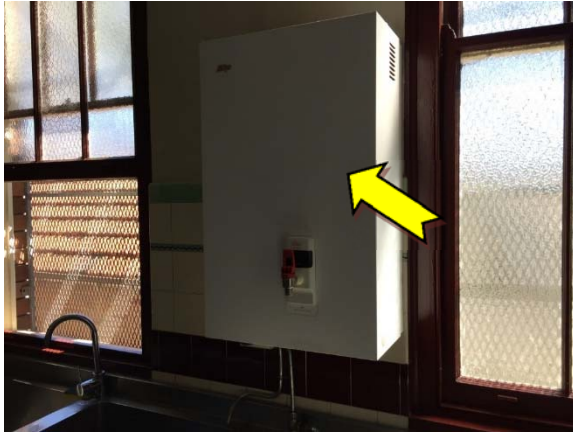
Photo 7. Interior, ground level, kitchen, hot water heater – suspected SMF internal insulation.

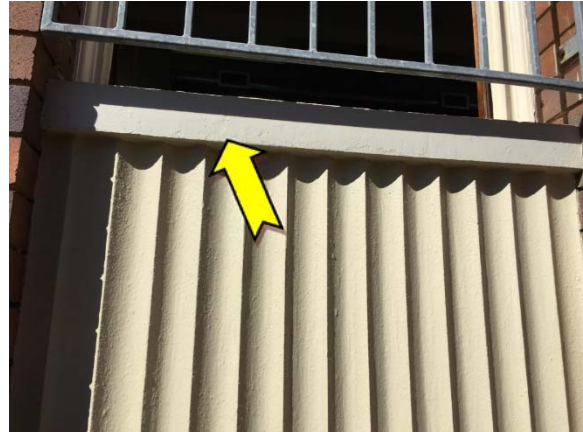
Exterior	Throughout	Window frames	Cream - upper coloured paint system	Lead Paint - Swab	-	Suspected Positive	-	Low	Good	Low	100 m ²	Maintain in current condition, over paint with a lead-free paint as part of ongoing maintenance. Remove under controlled conditions in accordance with AS 4361.2:2017 Guide to hazardous paint management prior to renovation or demolition works.	-	-	8
Exterior	Southern extent of building (entrance)	walls	Cream - upper coloured paint system	Lead Paint - Swab	-	Suspected Positive	-	Low	Good	Low	50 m ²	Maintain in current condition, over paint with a lead-free paint as part of ongoing maintenance. Remove under controlled conditions in accordance with AS 4361.2:2017 Guide to hazardous paint management prior to renovation or demolition works.	-	-	9
Interior, level 1	Waiting room	Walls	White - upper coloured paint system	Lead Paint - Swab	-	Suspected Positive	-	Low	Good	Low	20 m ²	Maintain in current condition, over paint with a lead-free paint as part of ongoing maintenance. Remove under controlled conditions in accordance with AS 4361.2:2017 Guide to hazardous paint management prior to renovation or demolition works.	-	-	-

Photo 8. Exterior, throughout, window frames – suspected lead-containing cream upper paint system.

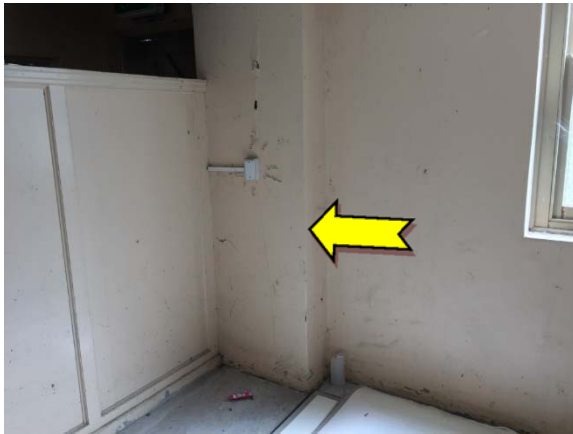
Photo 9. Interior, throughout, walls – suspected lead-containing cream upper paint system.

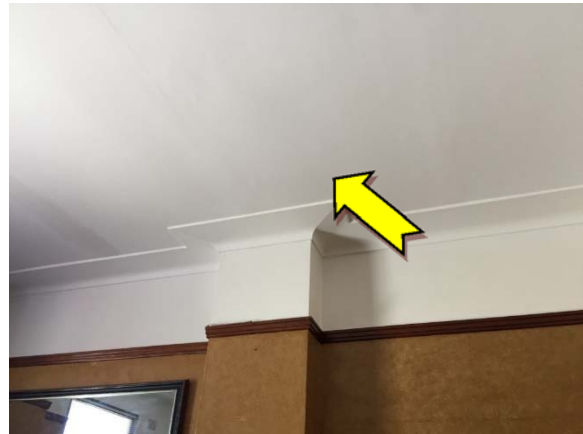
Interior, Ground floor	Throughout	Ceiling	White - upper coloured paint system	Lead Paint - Swab	-	Suspected Positive	-	Low	Good	Low	100 m ²	Maintain in current condition, over paint with a lead-free paint as part of ongoing maintenance. Remove under controlled conditions in accordance with AS 4361.2:2017 Guide to hazardous paint management prior to renovation or demolition works.	-	-	10
Interior, Ground floor	Bathroom & stairs	Floor	Green (dark) - upper coloured paint system	Lead Paint - Swab	-	Suspected Positive	-	Low	Good	Low	20 m ²	Maintain in current condition, over paint with a lead-free paint as part of ongoing maintenance. Remove under controlled conditions in accordance with AS 4361.2:2017 Guide to hazardous paint management prior to renovation or demolition works.	-	-	-
Interior, Ground floor	Main hall, stage	Walls	Black - upper coloured paint system	Lead Paint - Swab	-	Suspected Positive	-	Low	Good	Low	100 m ²	Maintain in current condition, over paint with a lead-free paint as part of ongoing maintenance. Remove under controlled conditions in accordance with AS 4361.2:2017 Guide to hazardous paint management prior to renovation or demolition works.	-	-	11

Photo 10. Interior, throughout, ceilings– suspected lead-containing white upper paint system.

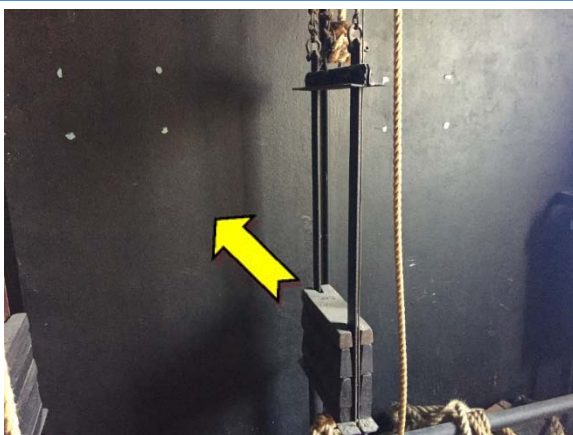
Photo 11. Interior, ground level, main hall stage, walls – suspected lead-containing black upper paint system.

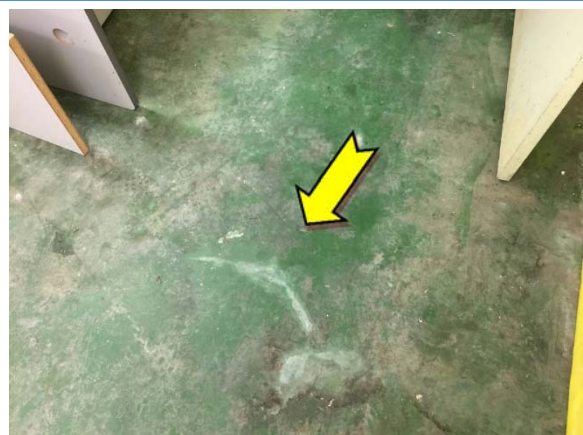
Photo 12. Interior, basement, fire-proof storage room, bathrooms & corridor, floor – suspected lead-containing green upper paint system.
