Hazardous Building Materials Assessment Petersham Service Centre 2-14 Fisher Street, Petersham NSW 2049

Inner West Council
April 2018

Job No.: 57722-078

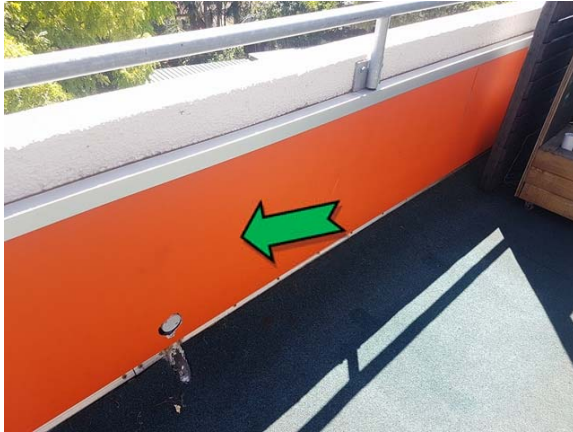
Photo 1. Exterior, level 1, terrace, wall lining – non asbestos-containing fibre cement sheeting.

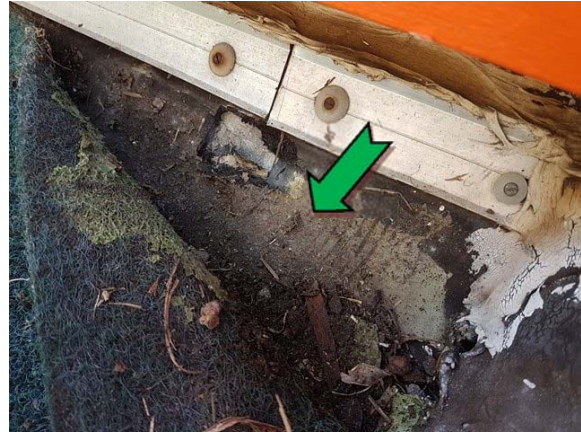
Photo 2. Exterior, level 1, terrace, waterproof membrane – non asbestos-containing bituminous material.

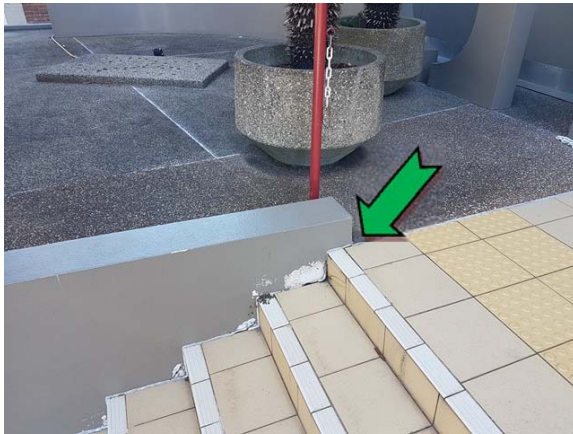
Photo 3. Exterior, throughout, entrance stairs, expansion joint – non asbestos-containing mastic sealant.

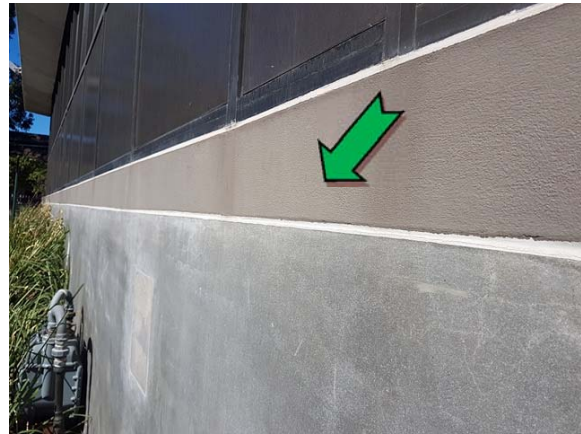
Photo 4. Exterior, throughout, walls – non asbestos-containing mastic sealant.

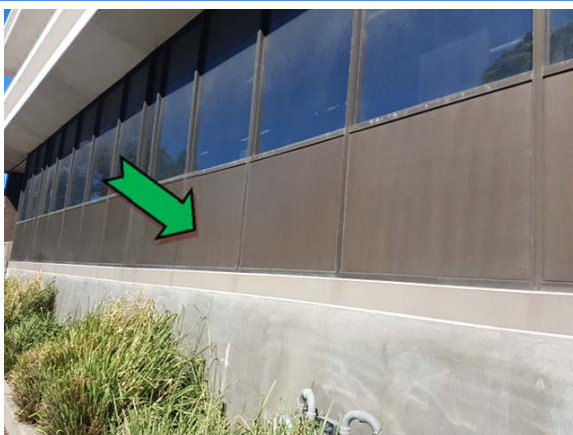
Photo 5. Exterior, throughout, infill panels – non asbestos-containing fibre cement sheeting and suspected lead-containing brown upper paint systems.

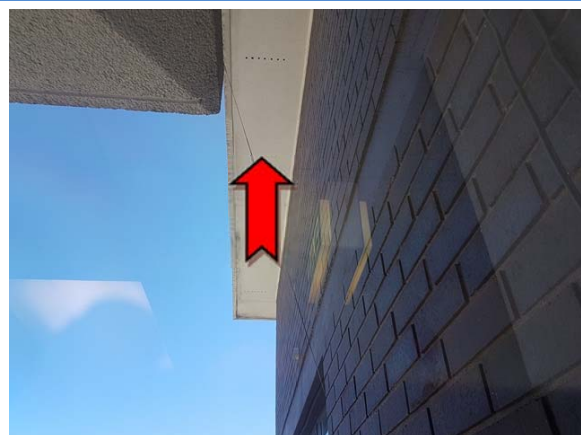
Photo 6. Exterior, throughout, eaves – suspected asbestos-containing fibre cement sheeting.

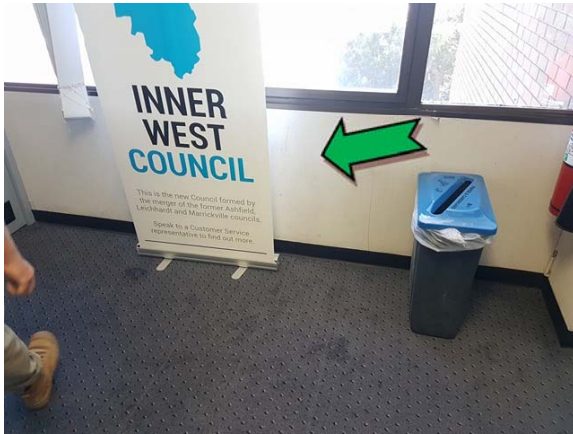
Photo 7. Interior, throughout, beneath windows, walls – non asbestos-containing fibre cement sheeting.

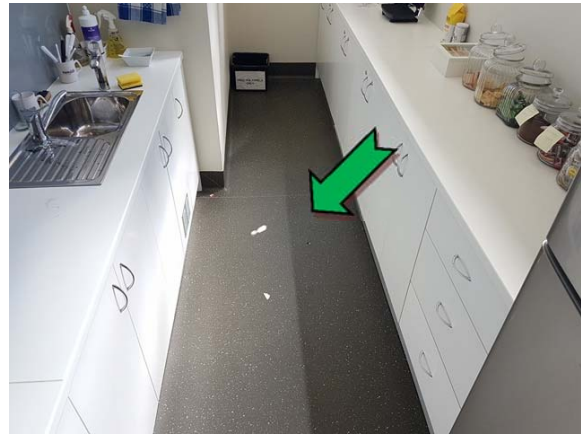
Photo 8. Interior, all levels, kitchens, floor coverings – suspected non asbestos-containing dark grey sheet vinyl.

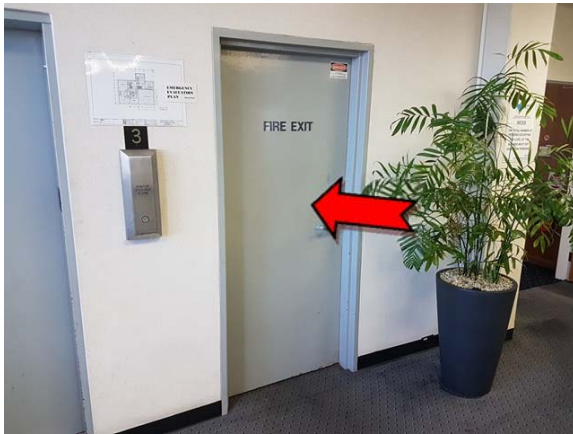
Photo 9. Interior, all levels, fire doors – suspected asbestos-containing fire door cores.

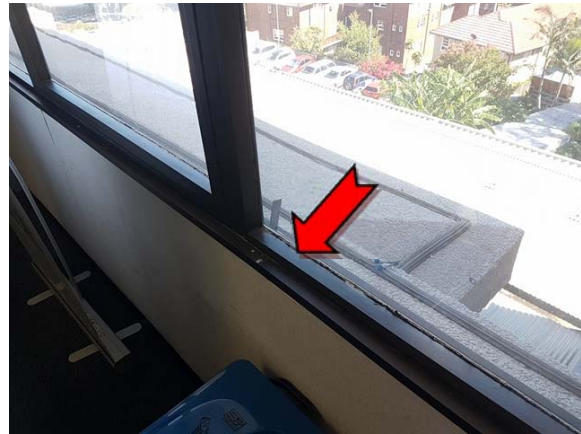
Photo 10. Interior, level 3, lift lobby, window frames – asbestos-containing window caulking.

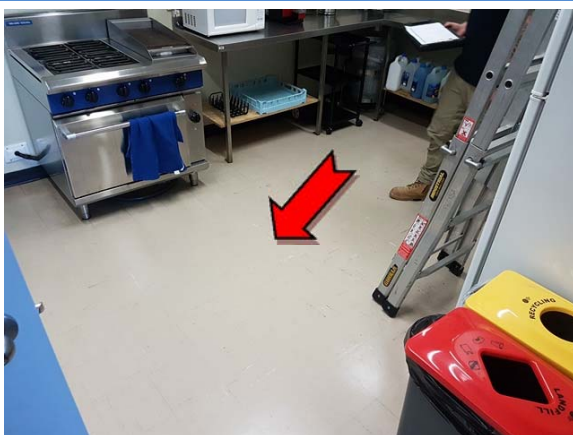
Photo 11. Interior, level 3, kitchen, floor coverings – assumed asbestos-containing beige vinyl floor tiles.

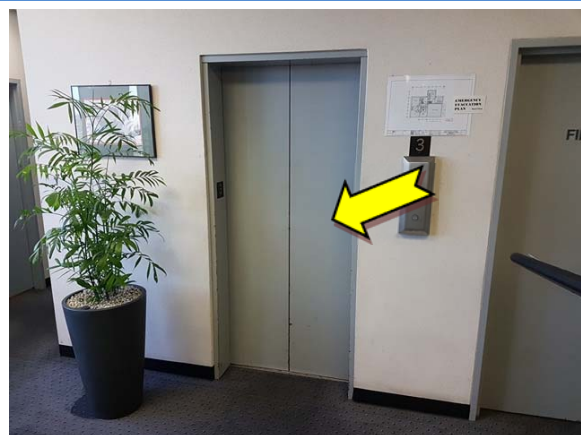
Interior, level 3	Kitchen	Floor coverings (Beige)	Vinyl floor tiles	Asbestos	57722-078-006A	Positive	Non-friable	Low	Good	Low	25 m ²	Maintain in current condition if to remain in-situ. Remove under controlled non-friable asbestos removal conditions prior to refurbishment or demolition works by a Class B (non-friable) licensed asbestos removal contractor.	P4	Mar-23	11
Interior, level 3	Kitchen	Floor coverings (Beige)	Adhesive	Asbestos	57722-078-006B	Negative	-	-	-	-	-	-	-	-	-
Interior, level 3	Throughout	Lift doors	Door core	Asbestos	-	Suspected Positive	Friable	Low	Good	Low	5 units	Label as containing asbestos and maintain in current condition if to remain in-situ. Remove under controlled friable asbestos removal conditions prior to refurbishment or demolition works by a Class A (friable) licensed asbestos removal contractor.	P4	Mar-23	12

Photo 12. Interior, level 3, lift doors – suspected asbestos-containing insulation door core.

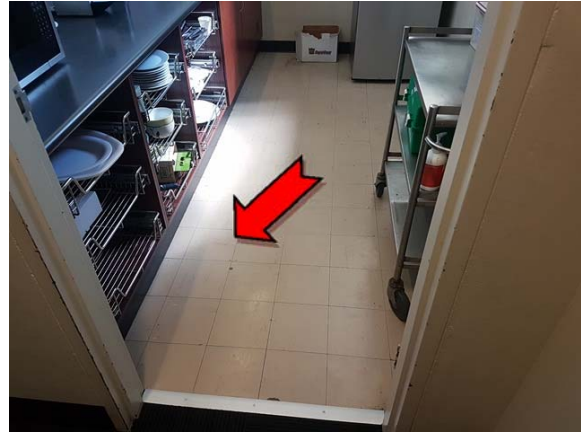
Photo 14. Interior, level 1, kitchen, north-east, beige floor coverings – assumed asbestos-containing vinyl floor tiles.

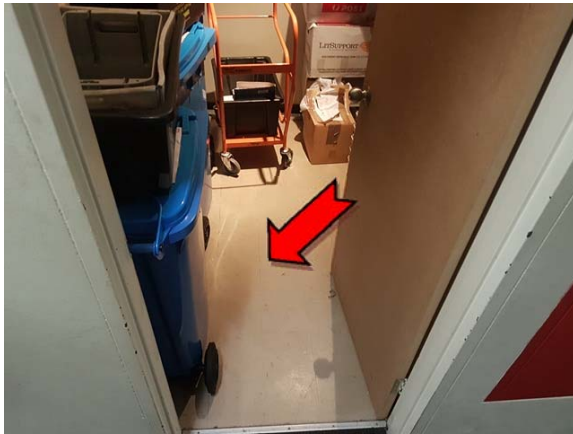
Interior, level 1	Kitchen, north-east	Floor coverings (Beige)	Vinyl floor tiles	Asbestos	Same as: 57722-078-006A	Assumed Positive	Non-friable	Low	Good	Low	8 m ²	Label as containing asbestos and maintain in current condition if to remain in-situ. Remove under controlled non-friable asbestos removal conditions prior to refurbishment or demolition works by a Class B (non-friable) licensed asbestos removal contractor.	P4	Mar-23	14
Interior, level 1	Kitchen, north-east	Floor coverings (Beige)	Adhesive	Asbestos	Same as: 57722-078-006B	Assumed Negative	-	-	-	-	-	-	-	-	-
Interior, ground level	Central storeroom	Floor coverings (Beige)	Vinyl floor tiles	Asbestos	Same as: 57722-078-006A	Assumed Positive	Non-friable	Low	Good	Low	5 m ²	Label as containing asbestos and maintain in current condition if to remain in-situ. Remove under controlled non-friable asbestos removal conditions prior to refurbishment or demolition works by a Class B (non-friable) licensed asbestos removal contractor.	P4	Mar-23	15

Photo 15. Interior, ground level, central store room, beige floor coverings – assumed asbestos-containing vinyl floor tiles.

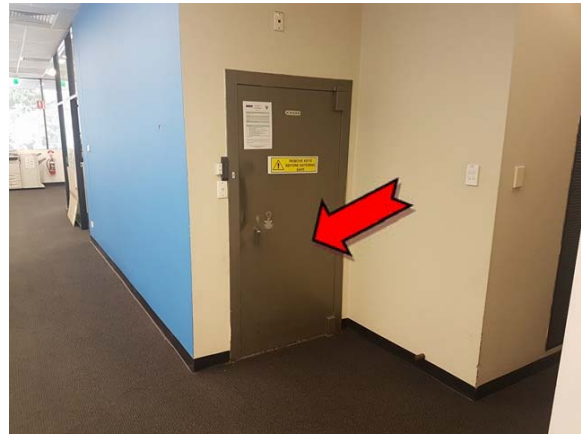
Photo 16. Interior, ground level, strong room, door – suspected asbestos-containing insulating door core.

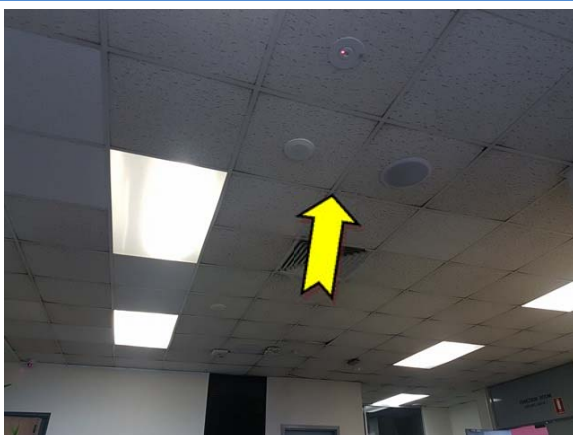
Interior, ground level	Central storeroom	Floor coverings (Beige)	Adhesive	Asbestos	Same as: 57722-078-006B	Assumed Negative	-	-	-	-	-	-	-	-	-
Interior, ground level	Strongroom	Door core	Insulation material - internal	Asbestos	Not sampled: Sealed unit	Suspected Positive	Friable	Low	Good	Low	1 unit	Confirm status, label as containing asbestos and maintain in current condition if to remain in-situ. Remove under controlled friable asbestos removal conditions prior to refurbishment or demolition works by a Class A (friable) licensed asbestos removal contractor.	P4	-	16
Interior	Lift cart	Floor covering	Grey vinyl floor tiles	Asbestos	Not sampled age and appearance	Suspected Negative	-	-	-	-	-	-	-	-	-
Interior, all levels	Throughout	Ceiling	Compressed ceiling tiles	SMF	-	Suspected Positive	Non-friable	Low	Good	Low	150 m ²	Maintain in current condition if to remain in-situ. Remove under controlled SMF conditions as per the Code of Practice for the Safe Use of Synthetic Mineral Fibres [NOHSC: 2006 (1990)].	-	-	17

Photo 17. Interior, throughout, ceiling – suspected SMF compressed ceiling tiles.

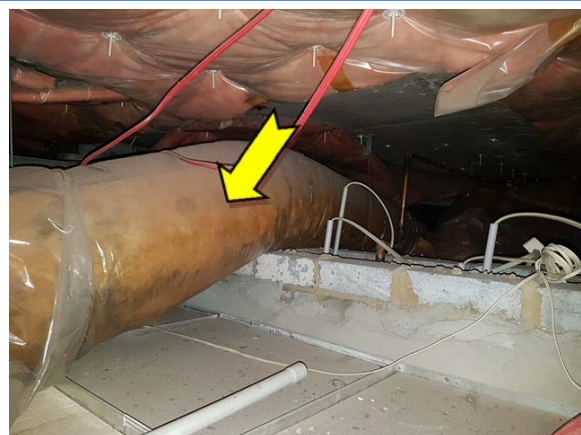
Photo 18. Interior, throughout, ceiling space, flexible ductwork – suspected SMF internal insulation material.

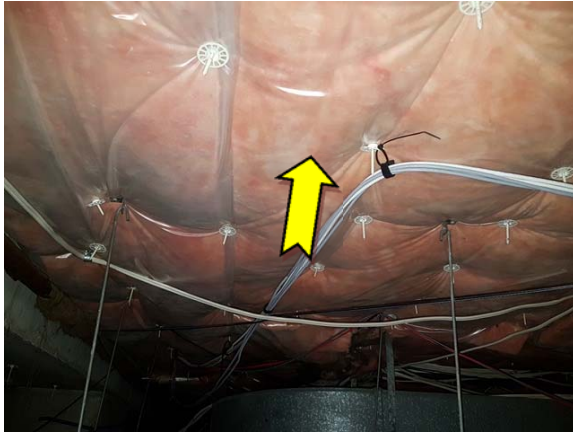
Photo 19. Interior, level 3, ceiling space – suspected SMF insulation material.

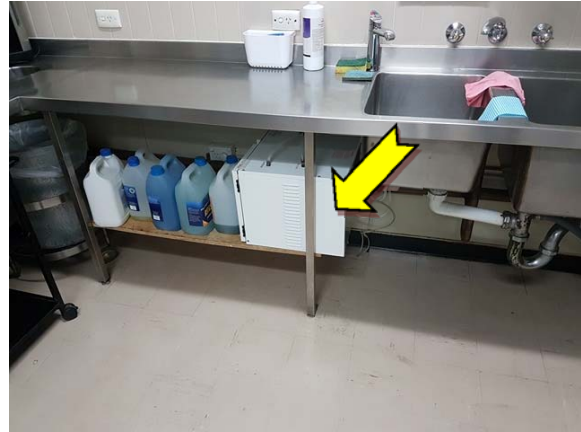
Interior, all levels	Throughout, ceiling space	Flexible ductwork	Insulation material - internal	SMF	-	Suspected Positive	Non-friable	Low	Good	Low	160 m	Maintain in current condition if to remain in-situ. Remove under controlled SMF conditions as per the Code of Practice for the Safe Use of Synthetic Mineral Fibres [NOHSC: 2006 (1990)].	-	-	18
Interior, level 3	Lobby, throughout	Ceiling space	Insulation	SMF	-	Suspected Positive	Non-friable	Low	Good	Low	150 m ²	Maintain in current condition if to remain in-situ. Remove under controlled SMF conditions as per the Code of Practice for the Safe Use of Synthetic Mineral Fibres [NOHSC: 2006 (1990)].	-	-	19
Interior, level 3	Kitchen	Hot water boiler	Insulation material - internal	SMF	-	Suspected Positive	Non-friable	Low	Good	Low	1 unit	Maintain in current condition if to remain in-situ. Remove under controlled SMF conditions as per the Code of Practice for the Safe Use of Synthetic Mineral Fibres [NOHSC: 2006 (1990)].	-	-	20

Photo 20. Interior, level 3, kitchen, hot water boiler – suspected SMF internal insulation material.

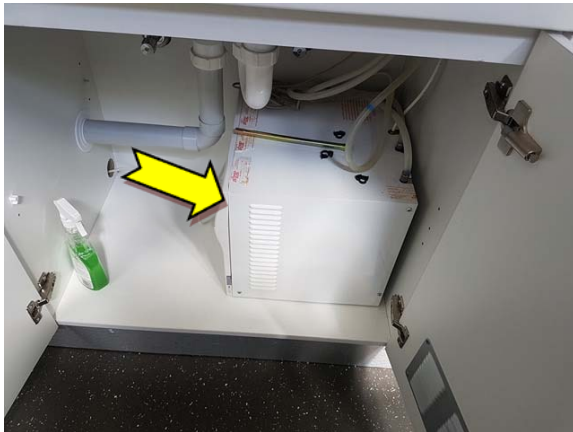
Interior, level 2	Kitchen, north-west	Hot water boiler	Insulation material - internal	SMF	-	Suspected Positive	Non-friable	Low	Good	Low	1 unit	Maintain in current condition if to remain in-situ. Remove under controlled SMF conditions as per the Code of Practice for the Safe Use of Synthetic Mineral Fibres [NOHSC: 2006 (1990)].	-	-	21
Interior, level 1	Kitchen, north-east	Hot water boiler	Insulation material - internal	SMF	-	Suspected Positive	Non-friable	Low	Good	Low	1 unit	Maintain in current condition if to remain in-situ. Remove under controlled SMF conditions as per the Code of Practice for the Safe Use of Synthetic Mineral Fibres [NOHSC: 2006 (1990)].	-	-	-

Photo 21. Interior, level 2, north-west, kitchen, hot water boiler – suspected SMF internal insulation material.

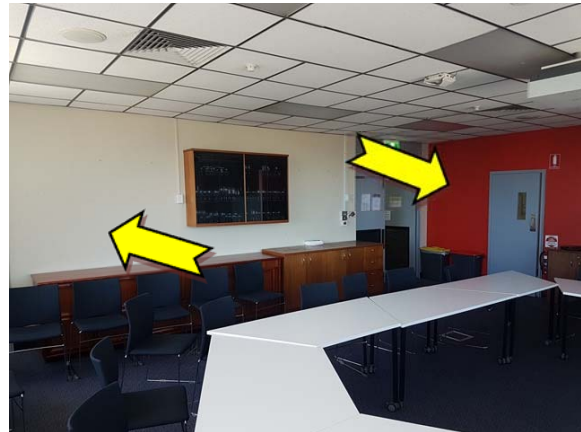
Photo 22. Interior, throughout, wall – suspected lead-containing red and cream upper coloured paint system.

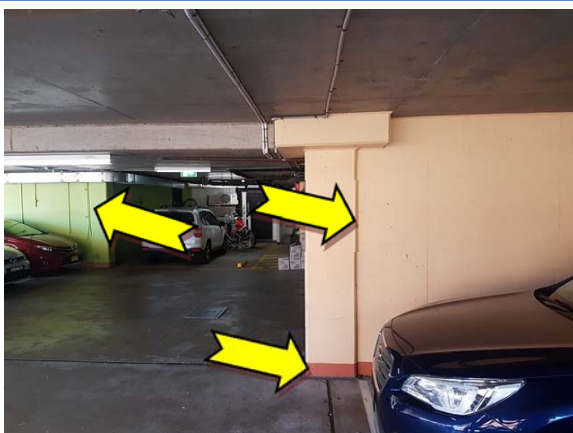
Interior, all levels	Throughout	Walls	Cream - upper coloured paint system	Lead Paint - Swab	-	Suspected Positive	-	Low	Good	Low	150 m ²	Confirm status by quantitative test method, maintain in current condition, over paint with a lead-free paint as part of ongoing maintenance. Remove under controlled conditions in accordance with AS 4361.2:2017 Guide to hazardous paint management prior to renovation or demolition works.	-	-	22
Interior, basement level	Car park	Walls - internal	Orange (light) - upper coloured paint system	Lead Paint - Swab	-	Suspected Positive	-	Low	Good	Low	50 m ²	Confirm status by quantitative test method, maintain in current condition, over paint with a lead-free paint as part of ongoing maintenance. Remove under controlled conditions in accordance with AS 4361.2:2017 Guide to hazardous paint management prior to renovation or demolition works.	-	-	23
Interior, basement level	Car park	Walls - internal	Orange (dark) - upper coloured paint system	Lead Paint - Swab	-	Suspected Positive	-	Low	Good	Low	50 m ²	Confirm status by quantitative test method, maintain in current condition, over paint with a lead-free paint as part of ongoing maintenance. Remove under controlled conditions in accordance with AS 4361.2:2017 Guide to hazardous paint management prior to renovation or demolition works.	-	-	23

Photo 23. Interior, basement level, car park, walls – suspected green, light orange and dark orange upper coloured paint systems.
