# Hazardous Building Materials Assessment

## Balmain Early Childhood Centre

530A Darling Street  
Rozelle NSW 2041

Inner West Council  
April 2018

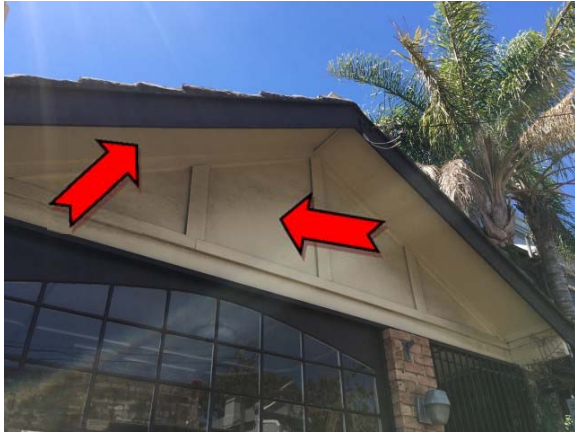
**Photo 1.** Exterior, ground level, western elevation, eaves and gable – suspected asbestos-containing fibre cement sheeting.

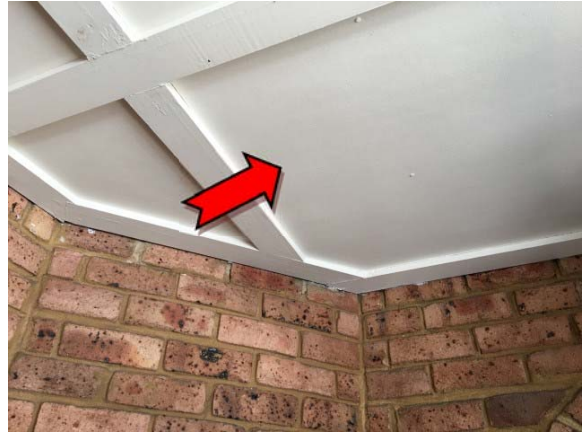
**Photo 2.** Exterior, ground level, entrance lobby, ceiling – asbestos-containing fibre cement sheeting.

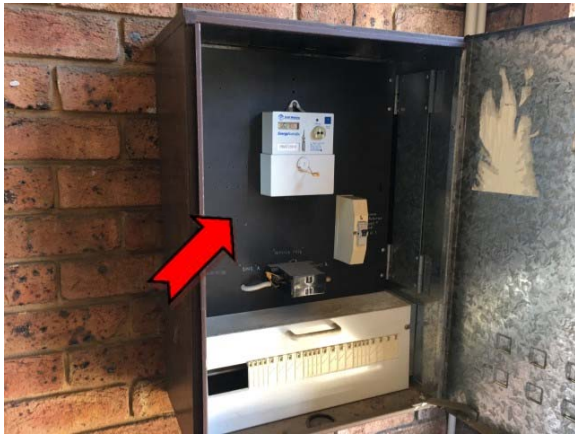
**Photo 3.** Exterior, ground level, western elevation, switchboard – suspected asbestos-containing bituminous backing board.

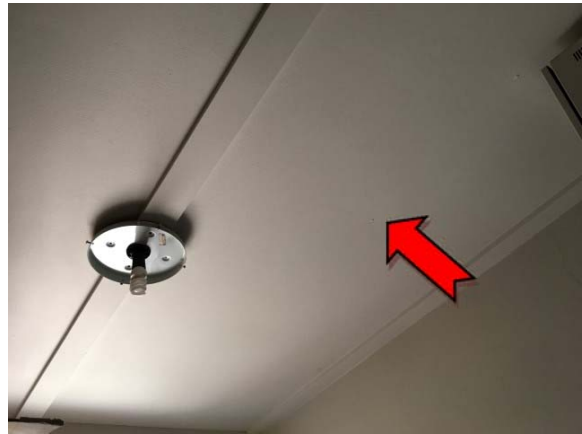
**Photo 4.** Interior, ground level, eastern elevation, toilet 2, ceiling – asbestos-containing fibre cement sheeting.

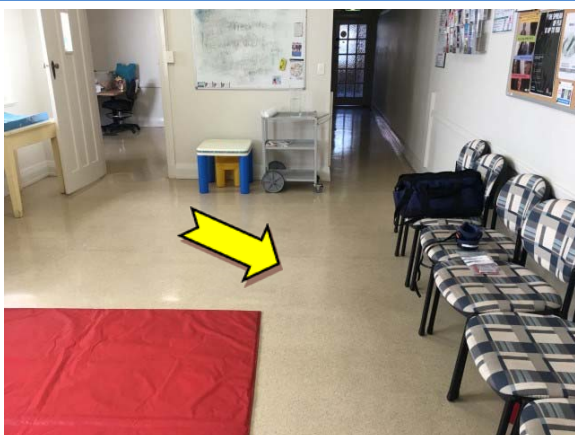
**Photo 5.** Interior, ground level, throughout, floor – suspected non asbestos-containing vinyl sheeting.

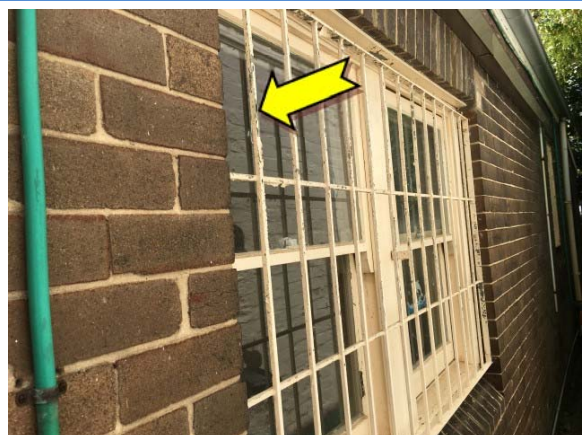
**Photo 6.** Exterior, ground level, throughout, window frames – lead-containing beige upper coloured paint system.

- Remove flaking lead containing paint to window surrounds throughout the property in accordance with AS4361.2-2017 Guide to Hazardous Paint Management and relevant legislation.

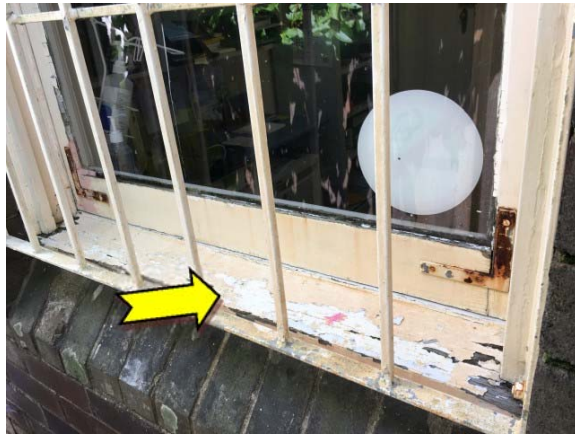
**Photo 7.** Exterior, ground level, throughout, window frames – lead-containing white lower coloured paint system.

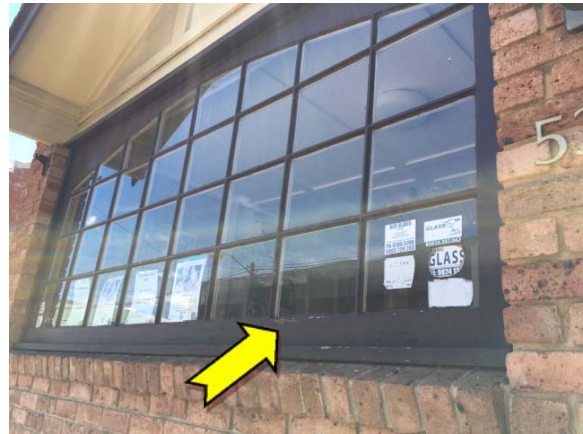
**Photo 8.** Exterior, ground level, throughout, window frames – suspected lead-containing brown upper coloured paint system.

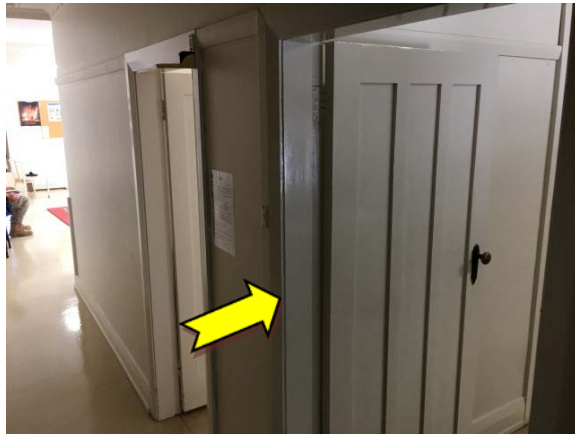
**Photo 9.** Interior, ground level, throughout, doors and door frames – suspected lead-containing white upper coloured paint system.

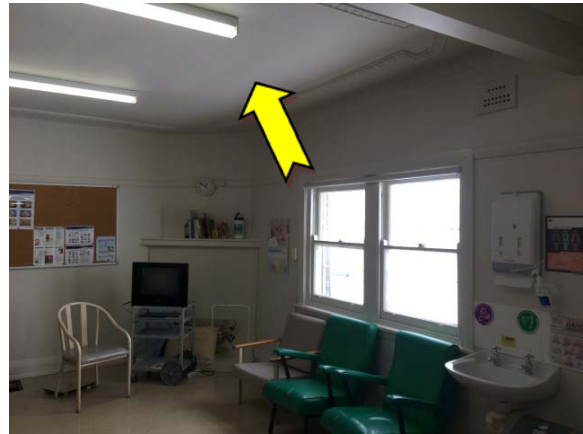
**Photo 10.** Interior, ground level, throughout, walls and ceiling – suspected lead-containing white upper coloured paint system.
