# Hazardous Building Materials Assessment Hannaford Community Centre 608 Darling Street Rozelle NSW 2039

Inner West Council  
April 2018

Job No.: 57722-046

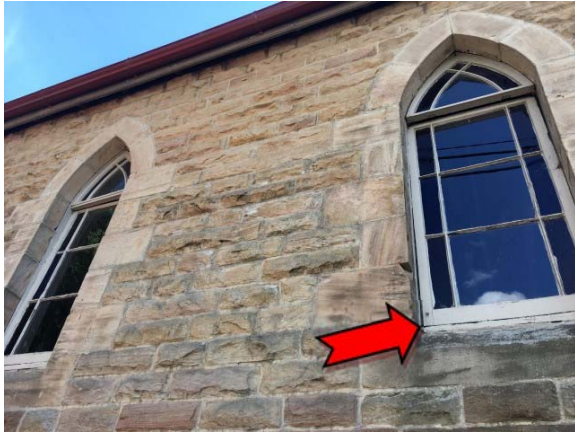
**Photo 1.** Exterior, ground level, throughout, window frames – suspected asbestos-containing window caulking.

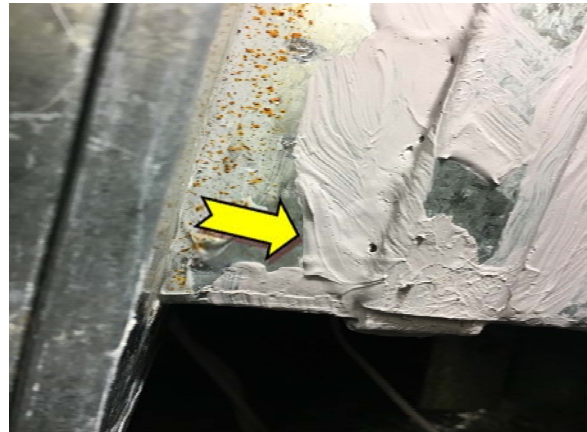
**Photo 2.** Interior, ground level, toilet, ceiling space, duct – suspected non asbestos-containing mastic sealant.

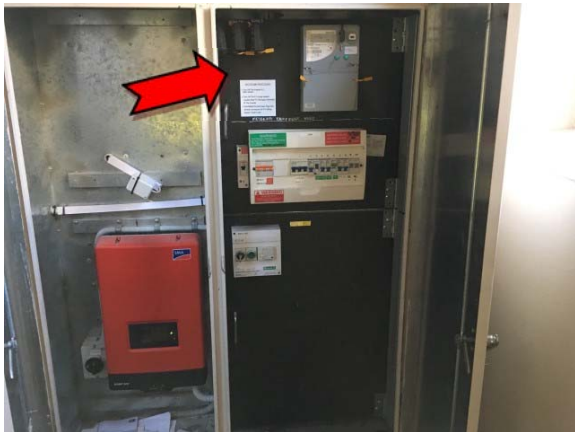
**Photo 3.** Interior, ground level, main hall, electrical cupboard, electric backing board – suspected asbestos-containing bituminous backing board.

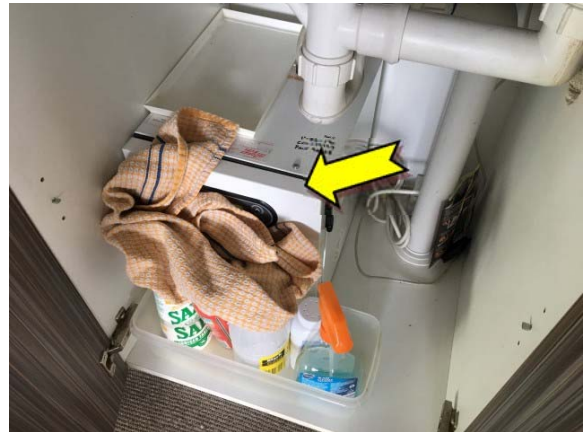
**Photo 4.** Interior, upper level, meeting room, under sink, hot water heater – suspected SMF-containing internal insulation material.

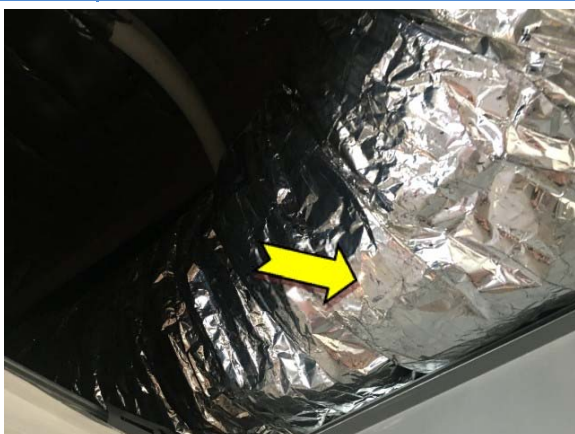
**Photo 5.** Interior, upper level, eastern end of meeting room, ceiling space, ductwork – suspected SMF-containing internal insulation material.

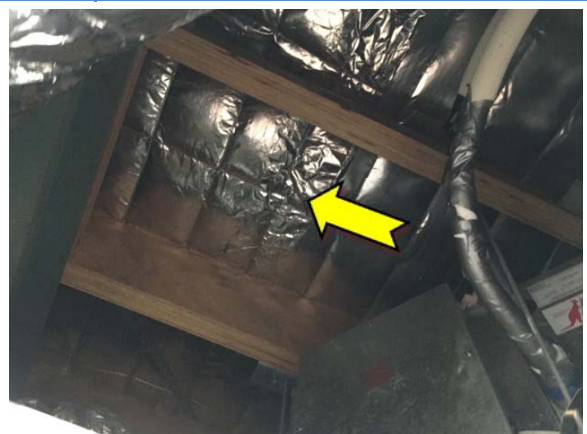
**Photo 6.** Interior, upper level, eastern end of meeting room, ceiling space – suspected SMF-containing sarking insulation material.

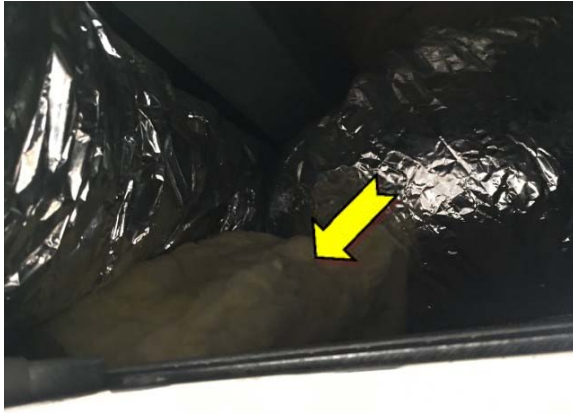
**Photo 7.** Interior, upper level, eastern end of meeting room, ceiling space – suspected SMF-containing insulation batts material.

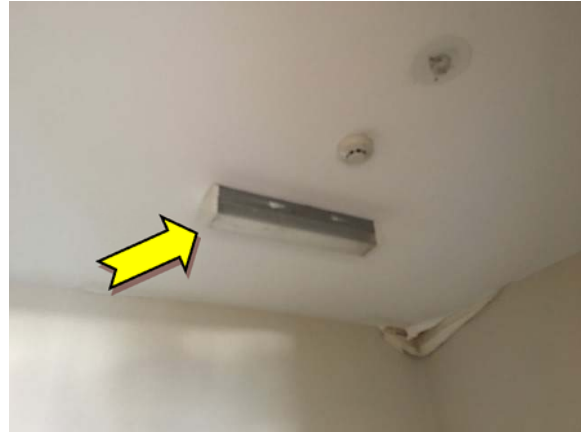
**Photo 8.** Interior, ground level, storage cupboard, single tube fluorescent light fitting – suspected PCB-containing capacitor.

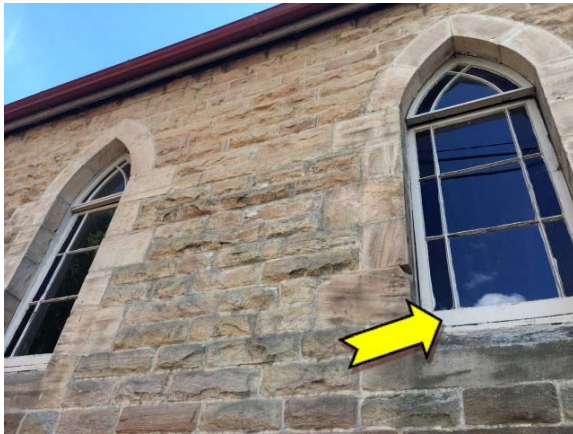
**Photo 9.** Exterior, throughout, window frames – suspected lead-containing cream upper coloured paint system.

- Remove flaking lead containing paint to window surrounds throughout the property in accordance with AS4361.2-2017 Guide to Hazardous Paint Management and relevant legislation.

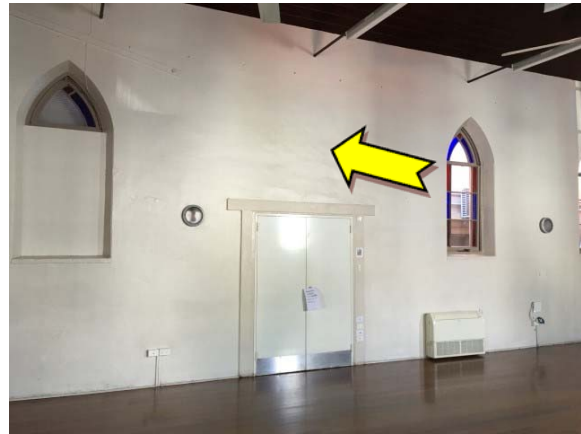
**Photo 10.** Interior, ground level, hall, throughout, walls – suspected lead-containing cream upper coloured paint system.

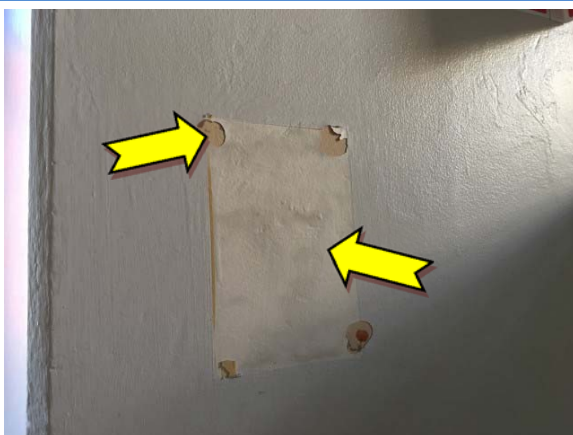
**Photo 11.** Interior, ground level, hall, throughout, walls – suspected lead-containing yellow and white lower coloured paint systems.
