Hazardous Building Materials Assessment Easton Park – Amenities/Dressing Sheds/ Toilets Lilyfield Road, Rozelle NSW 2039

Inner West Council
April 2018

Job No.: 57722-067

Count ID: CID: 130

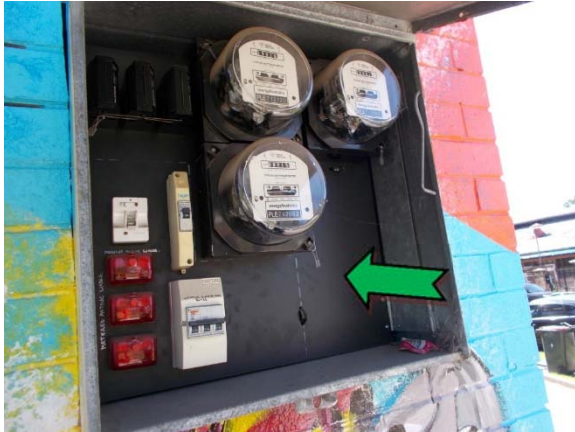
Photo 1. Exterior, south elevation, to wall, electrical board – suspected non asbestos-containing bituminous backing board

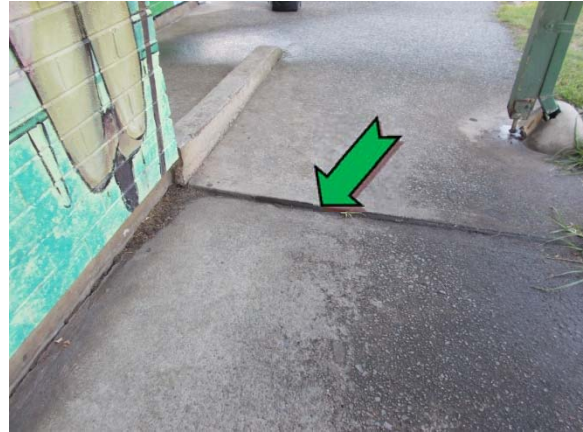
Photo 2. Exterior, throughout, ground, expansion joint – non asbestos-containing construction joint mastic.

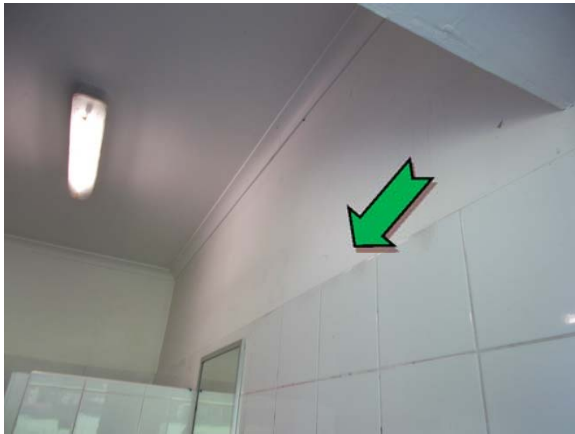
Photo 3. Interior, unisex toilet, walls – non asbestos-containing fibre cement sheeting.

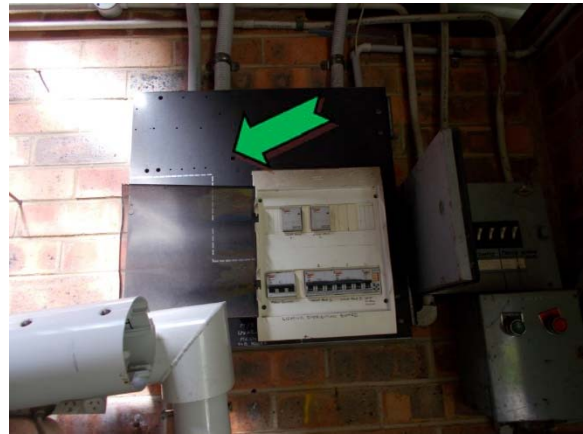
Photo 4. Interior, store room, switchboard - non asbestos-containing bituminous backing board.

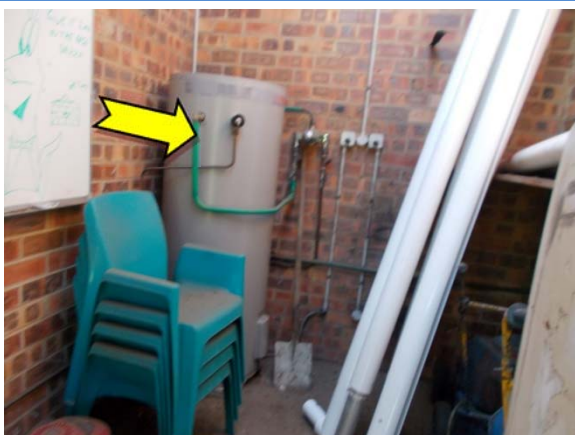
Photo 5. Interior, store room, hot water heater – suspected SMF internal insulation material.

- SMF internal insulation was suspected within the hot water heater located in the store room.

- SMF materials that are likely to be disturbed during any proposed demolition/refurbishment works should be handled in accordance with the *Code of Practice for the Safe Use of Synthetic Mineral Fibres* [NOHSC:2006(1990)]. If these materials are impacted upon by accident or by pre-planned works, the Inner West Council must be informed via the contact detailed within Section 7: *Accidental Disturbance of Known or Suspected Hazardous Building Materials*. Following disturbance, inspection by a competent person should be undertaken.

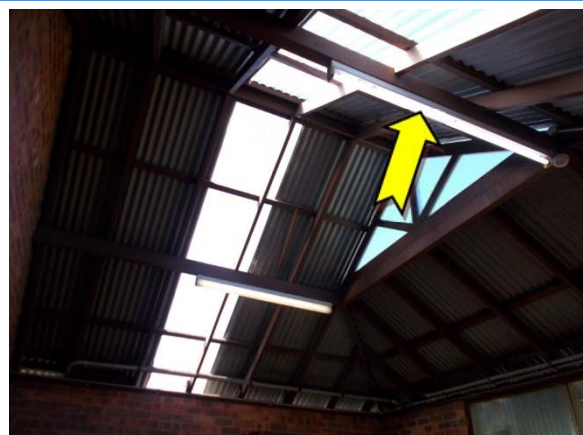
Interior, ground level	Throughout	Fluorescent light fitting - single tube	Capacitor	PCBs	Not sampled: electrical hazard	Suspected Positive	-	-	-	-	10 units	PCB-containing capacitors are suspected due to age & appearance of electrical fittings. Remove and dispose of in accordance with the Polychlorinated Biphenyls Management Plan, Revised Edition April 2003.	-	-	6
Exterior, ground level	Walls, throughout	Walls	Various colours - upper coloured paint system	Lead Paint - Swab	-	Suspected Positive	-	Low	Good	Low	90 m ²	Confirm status by quantitative test method, maintain in current condition, over paint with a lead-free paint as part of ongoing maintenance. Remove under controlled conditions in accordance with AS 4361.2:2017 Guide to hazardous paint management prior to renovation or demolition works.	-	-	7
Interior, ground level	Toilet cubicles, throughout	Walls - internal	Green (dark) - upper coloured paint system	Lead Paint - Swab	-	Suspected Positive	-	Low	Good	Low	10 m ²	Confirm status by quantitative test method, maintain in current condition, over paint with a lead-free paint as part of ongoing maintenance. Remove under controlled conditions in accordance with AS 4361.2:2017 Guide to hazardous paint management prior to renovation or demolition works.	-	-	8

Photo 6. Interior, throughout, single tubed fluorescent light fitting – suspected PCB-containing capacitors.

- PCBs were suspected within the capacitors of the single tubed fluorescent light fittings located in throughout the building.

- Electrical fittings suspected of containing PCB oil capacitors should be treated as containing PCB oils until such time as evidence suggest otherwise e.g. further assessed.
- Electrical fittings that contain or suspected to contain PCB oil-containing capacitors should be removed as hazardous/regulated waste under controlled working conditions prior to the demolition or refurbishment works in accordance with the *Polychlorinated Biphenyls Management Plan, Revised Edition April 2003*.

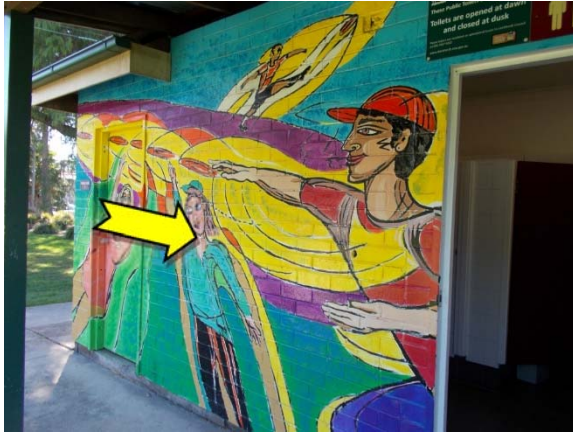
Photo 7. Exterior, throughout, graffiti walls – suspected lead-containing various upper coloured paint systems.

- LCP was suspected in the form of various upper coloured paint systems to the exterior of the building.
- LCP was suspected in the form of dark green upper paint systems to the toilet cubicles throughout.

- The *LeadCheck* paint swab method can detect lead in paint at concentrations of 0.5% and above, and may indicate lead in some paint films as low as 0.2%. As paint with a lead content greater than 0.1% by dry weight is now considered to be lead-containing, Prensa recommends confirming status of suspected LCP identified during the Assessment by quantitative test method.

- The safest method of dealing with LCP is to replace or remove the items in their entirety that have LCP on them and replace them with new items that do not contain lead. This allows the items to be disposed of as regular building or demolition unsegregated waste in accordance with the NSW Environment Protection Authority (EPA) *Waste Classification Guidelines 2014 Part 1 – Classifying Waste*. The advantage of this method is the reduction in labour requirements to remove the lead paint and also this reduces the risk to workers from exposure to lead dust or fumes. If the removal of the LCP or coatings is the preferred or required option this may generate significant amounts of potential hazardous waste. This waste must be removed, collected and disposed of by an appropriately licensed contractor under controlled conditions that minimises the release to air,

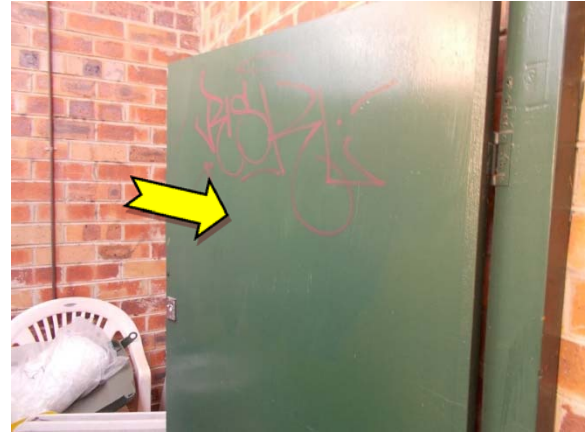
Photo 8. Interior, toilet cubicles – suspected lead-containing dark green upper paint system.
