Hazardous Building Materials Assessment Bridgewater Park Pump House Margaret Street, Rozelle NSW 2039

Inner West Council
April 2018

Job No.: 57722-066

Count ID: CID: 77

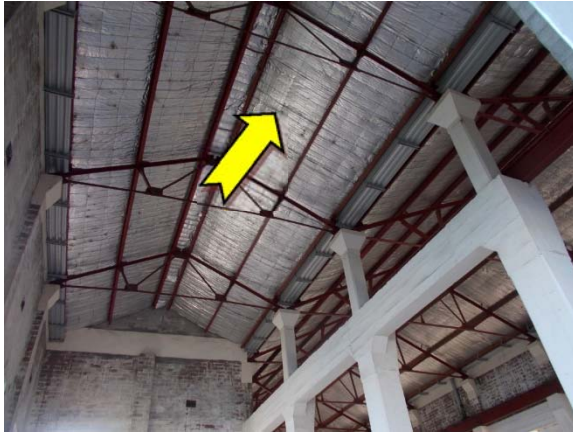
Photo 1. Interior, throughout, roof, insulation – suspected SMF sarking insulation material.

- SMF sarking insulation was suspected to the roof at the time of Assessment.

- SMF materials that are likely to be disturbed during any proposed demolition/refurbishment works should be handled in accordance with the *Code of Practice for the Safe Use of Synthetic Mineral Fibres* [NOHSC:2006(1990)]. If these materials are impacted upon by accident or by pre-planned works, the Inner West Council must be informed via the contact detailed within Section 7: *Accidental Disturbance of Known or Suspected Hazardous Building Materials*. Following disturbance, inspection by a competent person should be undertaken.

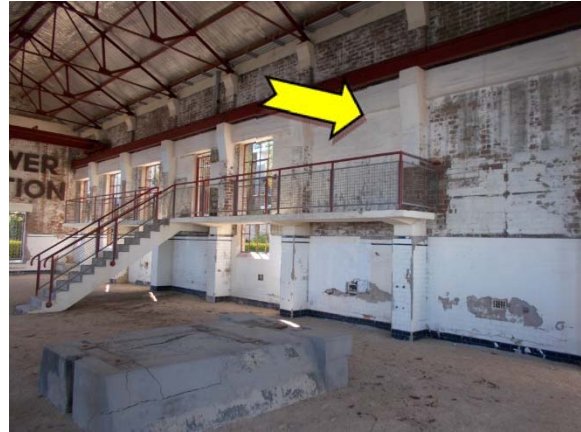
Photo 2. Interior, throughout, walls – suspected lead-containing white upper paint systems.

- LCP was suspected in the form of white upper paint systems to the interior walls of the building.

- The *LeadCheck* paint swab method can detect lead in paint at concentrations of 0.5% and above, and may indicate lead in some paint films as low as 0.2%. As paint with a lead content greater than 0.1% by dry weight is now considered to be lead-containing, Prensa recommends confirming status of suspected LCP identified during the Assessment by quantitative test method.

- Remove flaking lead-containing paint to walls throughout the property in accordance with AS4361.2-2017 Guide to Hazardous Paint Management and relevant legislation.
