Hazardous Building Materials Assessment Victoria Road – Toilet Block Victoria Road Rozelle NSW 2039

Inner West Council
April 2018

Executive Summary

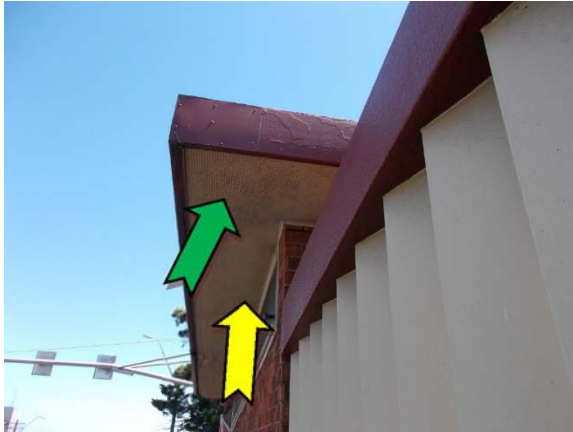
Exterior, ground level	Throughout	Eaves	Cream - upper coloured paint system	Lead Paint - Swab	-	Suspected Positive	-	Low	Fair	Low	2 m ²	Confirm status by quantitative test method, maintain in current condition, over paint with a lead-free paint as part of ongoing maintenance. Remove under controlled conditions in accordance with AS 4361.2:2017 Guide to hazardous paint management prior to renovation or demolition works.	-	-	1
Exterior, ground level	Throughout	Eaves	Cream - lower coloured paint system	Lead Paint - Swab	-	Positive	-	Low	Fair	Low	2 m ²	Remove flaking sections and over paint with a lead-free paint. Remove under controlled conditions in accordance with AS 4361.2:2017 Guide to hazardous paint management prior to renovation or demolition works.	-	-	1
Exterior, ground level	Throughout	Features	Red - upper coloured paint system	Lead Paint - Swab	-	Suspected Positive	-	Low	Good	Low	12 m ²	Confirm status by quantitative test method, maintain in current condition, over paint with a lead-free paint as part of ongoing maintenance. Remove under controlled conditions in accordance with AS 4361.2:2017 Guide to hazardous paint management prior to renovation or demolition works.	-	-	3

Photo 1. Exterior, throughout, eaves – assumed non asbestos-containing textured coatings; suspected lead-containing cream upper paints; and lead-containing cream lower paint systems.

- LCP was identified in the form of cream lower paint systems located throughout the eaves and ceiling of the building.
- LCP was suspected in the form of cream upper paint systems located throughout the eaves and ceiling of the building.
- LCP was suspected in the form of red upper paint systems located throughout external features of the building.

- Remove flaking lead containing paint to eaves and ceiling throughout the property and stabilise via over painting in accordance with AS4361.2-2017 Guide to Hazardous Paint Management and relevant legislation.

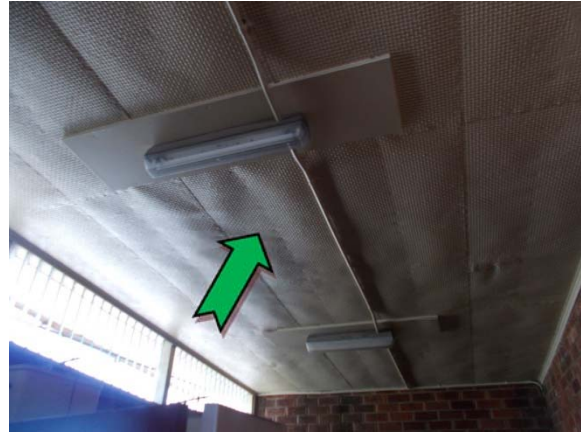
Interior, ground level	Throughout	Ceiling	Cream - upper coloured paint system	Lead Paint - Swab	-	Suspected Positive	-	Low	Fair	Low	10 m ²	Confirm status by quantitative test method, maintain in current condition, over paint with a lead-free paint as part of ongoing maintenance. Remove under controlled conditions in accordance with AS 4361.2:2017 Guide to hazardous paint management prior to renovation or demolition works.	-	-	2
Interior, ground level	Throughout	Ceiling	Cream - lower coloured paint system	Lead Paint - Swab	-	Positive	-	Low	Fair	Low	10 m ²	Remove flaking sections and over paint with a lead-free paint. Remove under controlled conditions in accordance with AS 4361.2:2017 Guide to hazardous paint management prior to renovation or demolition works.	-	-	2
Throughout	-	-	-	Ozone Depleting Substances	-	-	-	-	-	-	-	No suspect ODS's identified at the time of the assessment.	-	-	-

Photo 2. Interior, throughout, ceiling – non asbestos-containing textured coatings; suspected lead-containing cream upper paints; and lead-containing cream lower paint systems.

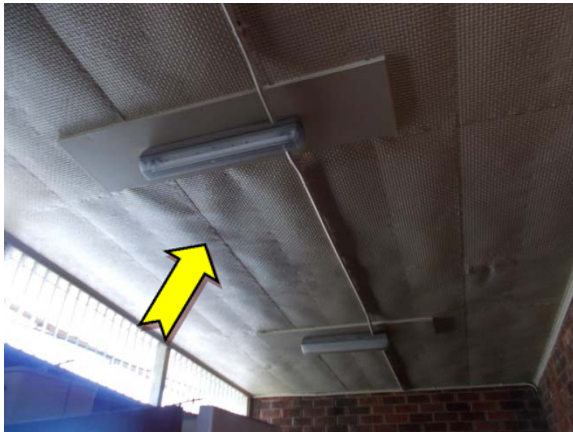
Photo 3. Interior, throughout, single tubed fluorescent light fittings – suspected PCB-containing capacitors.

- PCBs were suspected within the capacitors of the single tubed fluorescent light fittings located throughout the building.

- Electrical fittings suspected of containing PCB oil capacitors should be treated as containing PCB oils until such time as evidence suggest otherwise e.g. further assessed.
- Electrical fittings that contain or suspected to contain PCB oil-containing capacitors should be removed as hazardous/regulated waste under controlled working conditions prior to the demolition or refurbishment works in accordance with the *Polychlorinated Biphenyls Management Plan, Revised Edition April 2003*.

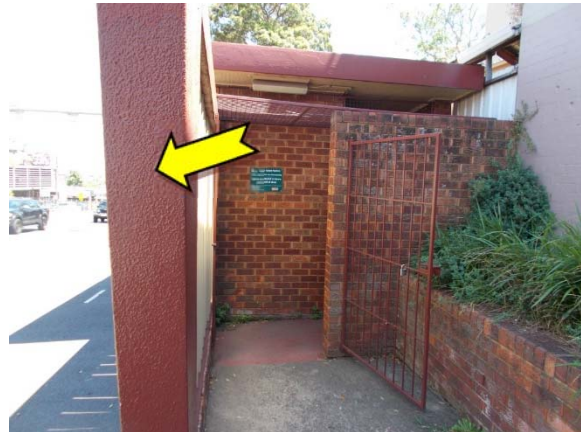
Photo 4. Exterior, throughout, features – suspected lead-containing red upper paint system.
